# ***Saltash Town Council***

# Schedule of Condition

We have been instructed by Saltash Town Council to prepare a schedule of condition of the windows and doors to the Grade II listed building Saltash Library, Callington Road, Saltash, PL12 6DX. Instructions were received on 6<sup>th</sup> October 2022. The schedule of condition will be used to support a planning and listed building consent application for the following works:

# Heritage Impact Assessment

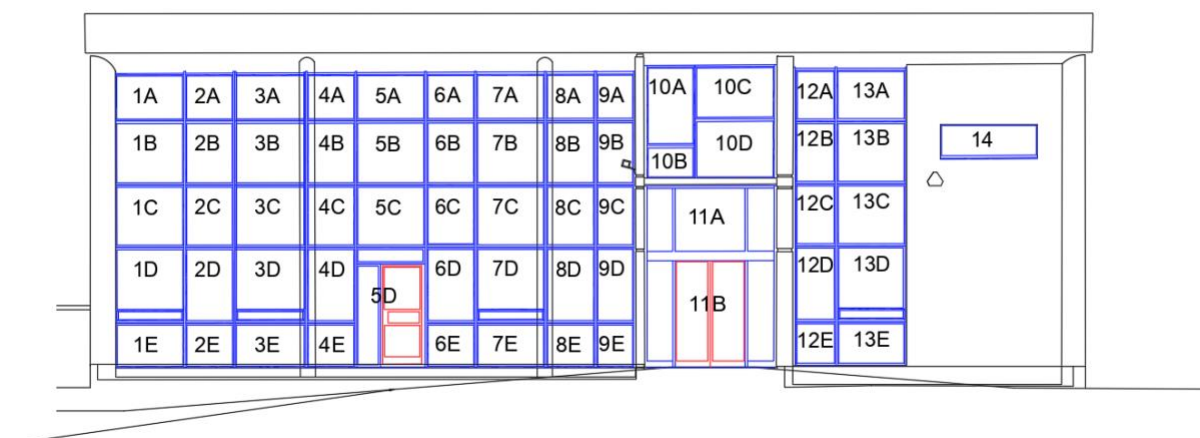
**Figure 1: West elevation**

The west elevation windows are split into three principal bays with a large glazed section to the north side, the entrance area with concrete piers stepped forward and a further smaller full height glazed bay to the south of the entrance area. The glazing is described from north to south with numbered columns as indicated on the elevation drawing figure 1.

The glazed curtain walling to the principal elevation is formed with slender aluminium frames inserted between vertical steel columns. Set forward from the glazing are 2 shuttered concrete elliptical piers. Column 1 to the north side abuts the projecting roughcast rendered masonry wall externally, and a rough plastered internal wall. The external reveal shows signs of disturbance to the render, where presumably repairs have been made in the past. There is a bullnosed hardwood timber lining forming the external reveal, butted directly against the fenestration. This showed signs of minor rot at its base but was otherwise intact. The lining is painted in white, and the paint is heavily peeling throughout. The lining has been formed in three principal sections with diagonal scarf joints, and would be easy to repair in situ. The southern reveal against column 9 is formed with a similar painted hardwood lining set against the shuttered concrete wall. The timber linings could be retained but will require low level scarf repair and redecoration.

The columns of glazing are divided with box sectional steel columns running the full height from the concrete slab base up to the cast concrete roof structure. The steel appears to insert into the concrete top and bottom and performs an important structural role in supporting the curtain walling. The steel columns show signs of corrosion through white paint, although were

generally considered serviceable. These will require removal of loose paint and redecoration in an appropriate galvanising paint.

The frames are also prone to flex in high winds and do not sit square between the columns in some cases. This will lead to draughts and water ingress, both of which have been reported by the caretakers of the building. The structural integrity of the framing is considered to have been comprised by the replacement glazing, which uses more slender beads. Furthermore the external surfaces of the aluminium frames are beginning to corrode. Progressive corrosion to the casements can be expected over the coming years, which will eventually lead to complete failure of the window systems.

There are several opening windows including centre pivot casements at high level on the west elevation controlled by a cable winding system. There are also low level top hung casements to the west screen. The hinges, catches and winding systems are all largely defective.

There is an entrance door to the centre of the west glazed screening. This is considered to be an original fixture, although again the original single glazing has been replaced with slim line double glazed units, by altering the depth of the beading in the same way as described above. The hinges to the door have broken in the past and been crudely replaced with a new set of surface mounted hinges. The door could not be opened at the time of inspection and the location of the key is not known. The door shows the same level of corrosion as the surrounding window casements. The glazed curtain wall is considered to have reached the end of its useful life.

The principal glazed curtain walling and bays to Saltash Library are in excess of 60 years old and are showing signs of severe degradation. These have also been adapted and modified in the past, which has further compromised the integrity of these fixtures. The aluminium casements are now considered to be beyond repair and have passed the end of their useful lifespans. It is recommended that they are replaced as part of cyclical maintenance to the building. The steel columns which divide the glazed screens could potentially be retained, subject to appropriate refurbishment and ongoing maintenance.

Replacement of the glazed curtain walling and bays provides an opportunity to upgrade the buildings thermal efficiency and overall performance. Equivalent aluminium glazed units would not be available off the shelf, and bespoke manufacture would lead to excessive costs and compromised structural integrity. It is recommended that modern aluminium double glazed units are installed to match the existing fenestration layouts. These would have slightly deeper sections to the frames, which would improve the overall durability and performance. This will allow for appropriate maintenance of the building and upgrade of thermal efficiency whilst maintaining the buildings architectural integrity.

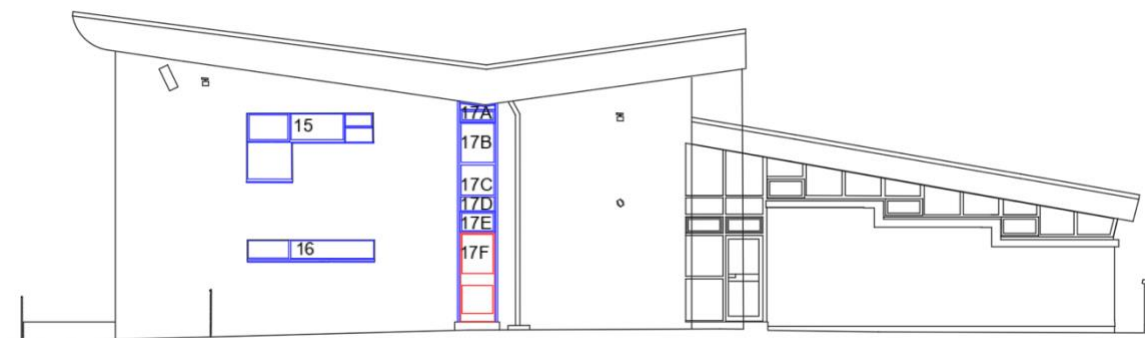
**Figure 2: South elevation**

The projecting bays to the north and south walls are set between the roughcast rendered walls with hardwood timber linings (see figures 2 & 4). The glazed casements are divided with steel box sectional columns, which are fixed to the concrete upper roof structures, although do not penetrate the lower level concrete slabs. These are painted white with flaking paint over galvanised steel, matching those to the principal curtain walling. Improvements to the columns are recommended to include brushing back loose paint and corrosion and decorating with galvanising paint.

The glazing to the bays is also formed in the same configuration as the principal curtain walling, with a mixture of original single and replacement double glazing. Again the glazing beads have been replaced with reduced section beads to double glazed replacements.

It is noted that the south bay comprises mainly the original single glazing, with only some areas replaced with double glazing. There is an entrance door at ground floor level to the south bay, which matches the description of the principal elevation door, and was operational.

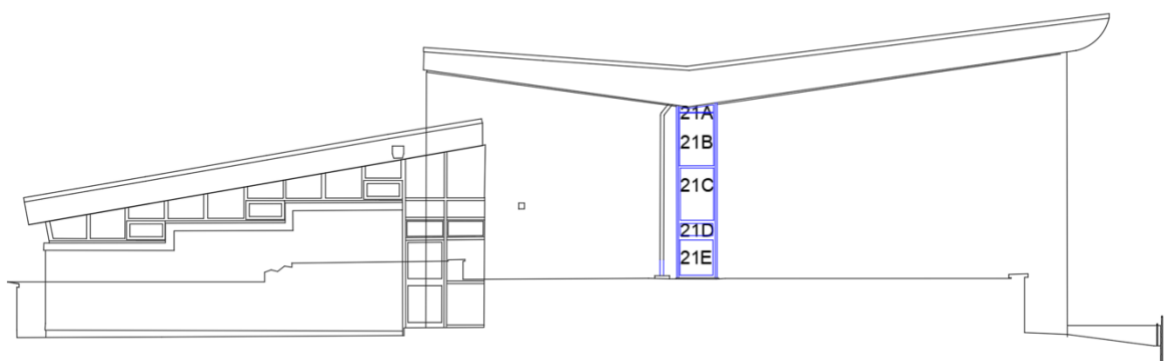
**Figure 4: North elevation**

It is noted that all casements within the outward faces of the bays are beaded externally with glazing set back into the frames in a reverse configuration when compared to other windows throughout the building. This has presumably occurred due to difficulties in inserting the glazing internally within the bay window during construction. The external beading presents a security risk, where glazing could potentially be removed externally without significant damage or noise.

The glazed bays display similar levels of degradation to the principal curtain walling, with corrosion to casements, seized openers, degrading putties and beads and misted double glazing. Again these are considered to have reached the end of their useful lifespans.

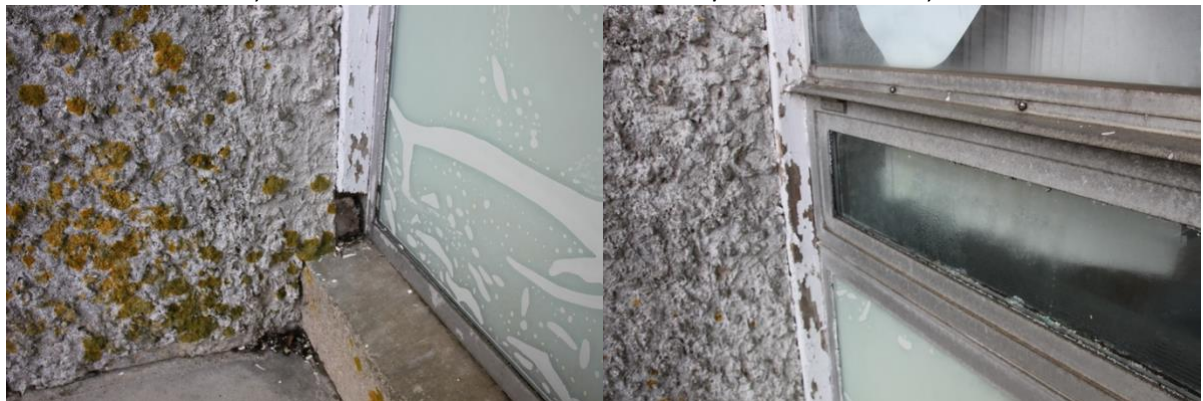
Window 1E

<b>1E</b>	Aluminium framed fixed casement with slim line double glazing inserted and sealed with putty. Banafix window safety film fitted externally.	Corrosion to external surfaces of frame. Glazing putty degrading. Window film bubbled.	Replace casement and glazing.
<b>2A</b>	Aluminium framed fixed casement with slim line double glazing inserted and sealed with putty.	Corrosion to external surfaces of frame.	Replace casement and glazing.
<b>2B</b>	Aluminium framed fixed casement with slim line double glazing inserted and sealed with putty.	Corrosion to external surfaces of frame. Double glazing misted.	Replace casement and glazing.
<b>2C</b>	Aluminium framed fixed casement with slim line double glazing inserted and sealed with putty.	Corrosion to external surfaces of frame. Glazing putty degrading.	Replace casement and glazing.
<b>2D</b>	Aluminium framed fixed casement with slim line double glazing inserted and sealed with silicone mastic.	Corrosion to external surfaces of frame.	Replace casement and glazing.

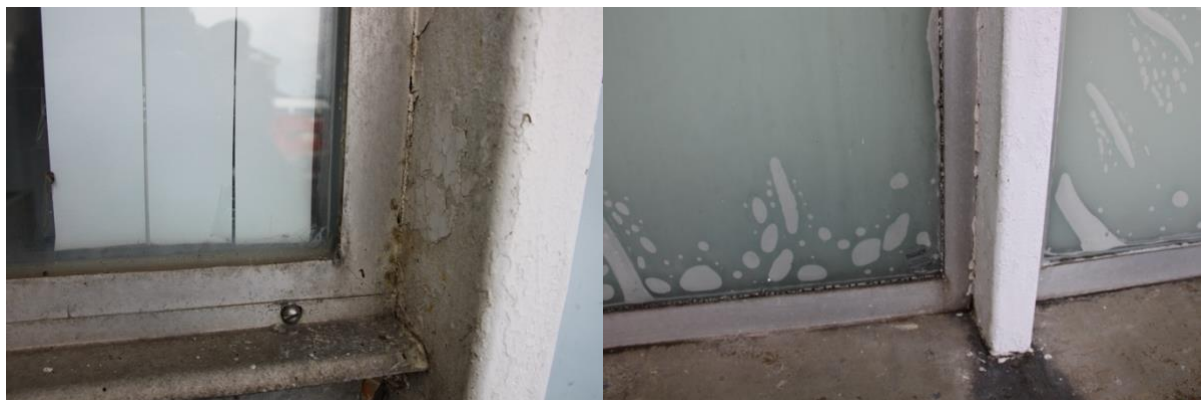
Window 2E

<b>2E</b>	Aluminium framed fixed casement with slim line double glazing inserted and sealed with putty. Banafix window safety film fitted externally.	Corrosion to external surfaces of frame. Double glazing misted. Glazing putty degrading. Window film bubbled.	Replace casement and glazing.
<b>3A</b>	Aluminium framed casement with centre pivot opener controlled with cable wound mechanism to south reveal. Slim line double glazing inserted and sealed with putty.	Opening casement seized shut. Corrosion to external surfaces of frame.	Replace casement, glazing and opening mechanism.
<b>3B</b>	Aluminium framed fixed casement with slim line double glazing inserted and sealed with putty.	Corrosion to external surfaces of frame. Double glazing misted.	Replace casement and glazing.
<b>3C</b>	Aluminium framed fixed casement with slim line double glazing inserted and sealed with putty.	Corrosion to external surfaces of frame. Double glazing misted.	Replace casement and glazing.

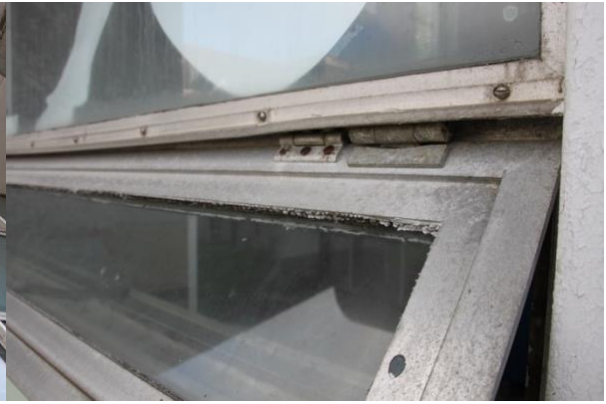
Window 3D

<b>3D</b>	Aluminium framed split casement with a transom at low level and top hinged opener to base. Slim line double glazing inserted and sealed with silicone mastic to fixed pane and putty to opener.	Corrosion to external surfaces of frame. Hinges and catch to opener stiff but operational. Hinges crudely replaced with surface mounted fittings. Both panes of glazing misted over.	Replace casement and glazing.
<b>3E</b>	Aluminium framed fixed casement with slim line double glazing inserted and sealed with putty. Banafix window safety film fitted externally.	Corrosion to external surfaces of frame. Double glazing misted. Glazing putty degrading. Window film bubbled.	Replace casement and glazing.
<b>4A</b>	Aluminium framed fixed casement with slim line double glazing inserted and sealed with putty.	Corrosion to external surfaces of frame. Glazing putty degrading.	Replace casement and glazing.
<b>4B</b>	Aluminium framed fixed casement with slim line double glazing inserted and sealed with putty.	Corrosion to external surfaces of frame. Glazing putty degrading.	Replace casement and glazing.

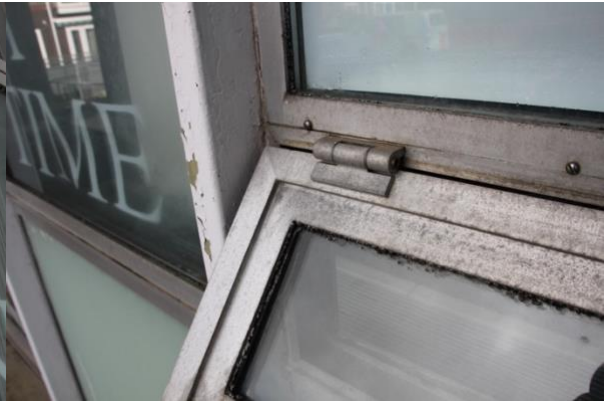
Window 7D

<b>7D</b>	Aluminium framed split casement with a transom at low level and top hinged opener to base. Slim line double glazing inserted and sealed with silicone mastic to fixed pane and putty to opener.	Corrosion to external surfaces of frame. Hinges and catch to opener stiff but operational. Both panes of glazing misted over.	Replace casement and glazing.
<b>7E</b>	Aluminium framed fixed casement with slim line double glazing inserted and sealed with putty. Banafix window safety film fitted externally.	Corrosion to external surfaces of frame. Double glazing misted. Glazing putty degrading. Window film bubbled.	Replace casement and glazing.
<b>8A</b>	Aluminium framed fixed casement with slim line double glazing inserted and sealed with putty.	Corrosion to external surfaces of frame. Glazing putty degrading.	Replace casement and glazing.
<b>8B</b>	Aluminium framed fixed casement with slim line double glazing inserted and sealed with putty.	Corrosion to external surfaces of frame. Glazing putty degrading.	Replace casement and glazing.

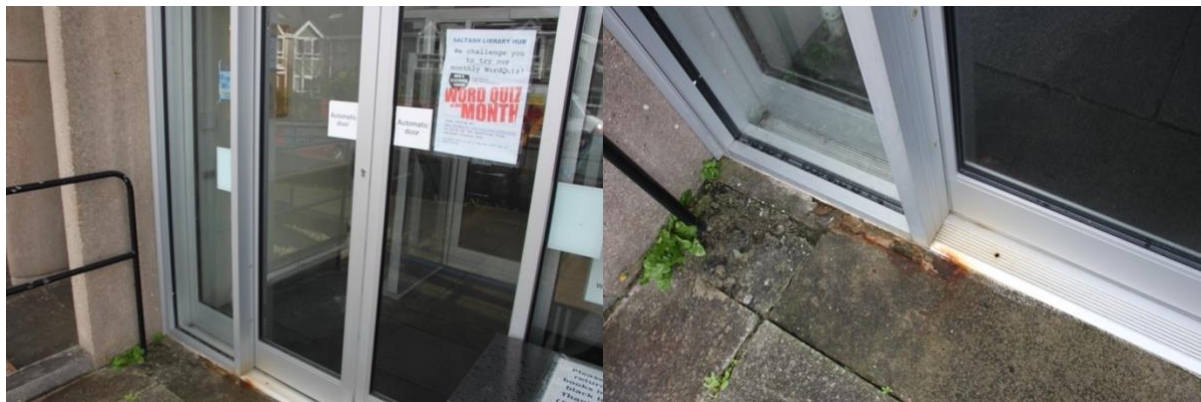
Door 11B

<b>11B</b>	Modern powder coated aluminium symmetrical frames with central automatic opening sliding door. Fitted with single glazed panels in rubber seals.	Intact and serviceable.	Clean and renew seals within 5 years. Ensure opening mechanisms and runners are regularly lubricated and serviced.
<b>12A</b>	Aluminium framed fixed casement with slim line double glazing inserted and sealed with putty.	Corrosion to external surfaces of frame. Glazing putty degrading.	Replace casement and glazing.
<b>12B</b>	Aluminium framed fixed casement with slim line double glazing inserted and sealed with putty.	Corrosion to external surfaces of frame. Glazing putty degrading.	Replace casement and glazing.
<b>12C</b>	Aluminium framed fixed casement with slim line double glazing inserted and sealed with putty.	Corrosion to external surfaces of frame. Glazing putty degrading.	Replace casement and glazing.
<b>12D</b>	Aluminium framed fixed casement with slim line double glazing inserted and sealed with putty.	Corrosion to external surfaces of frame. Glazing putty degrading. Double glazing misted.	Replace casement and glazing.

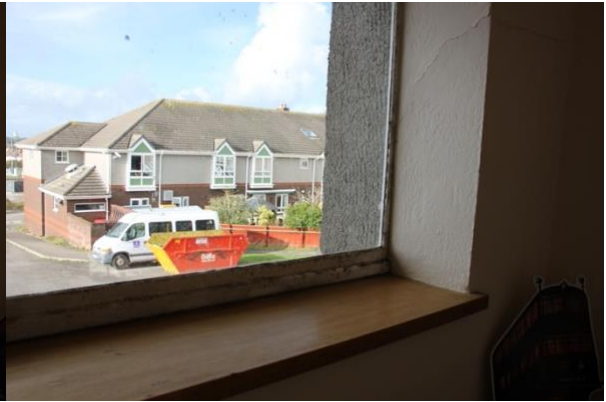
Window 14

<b>14</b>	High level horizontally orientated fixed steel Crittall window with single glazing. Painted white and set in deep reveals.	Window intact but paintwork degrading.	Ensure decorations are renewed on a 3-4 year cycle. Consider double glazing for improved thermal efficiency.
-----------	--	--	--

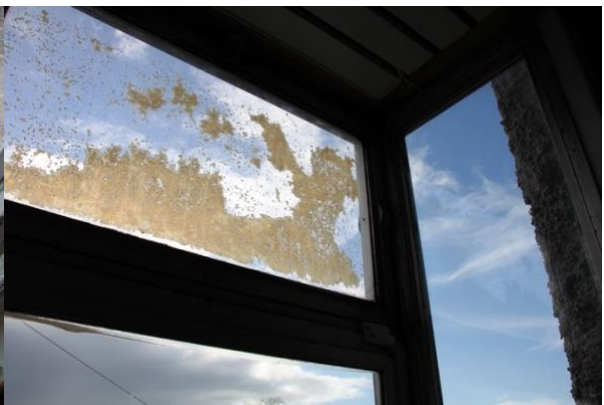
Window 17E

<b>17E</b>	Row of 5 aluminium framed casements with a mixture of single glazing and slim line double glazing inserted and sealed with putty. Transoms to side panels drop lower past door beneath.	Corrosion to external surfaces of frame. Glazing putty degrading.	Replace casements and glazing.
<b>17F</b>	Door to centre set within aluminium frames with low level lights to each side. Glazed door with central aluminium transom section. Glazing formed with single glazed panels set in putty to door and side panels with aluminium battens. Banafix film to door and side panel.	Corrosion to external surfaces of frame. Glazing putty degrading. Door serviceable but lock and catch are stiff.	Replace casements, door and glazing.
