**REPORT ON VISUAL ASSESSMENT FOR THE PRESENCE OF RAAC
CONCRETE WITHIN SALTASH TOWN COUNCIL ESTATE**

SALTASH TOWN COUNCIL

Prepared By: James M Barron MRICS	Date: 22 September 2023	Rev: A 6 October 2023
Checked By:

Job Ref: 4310

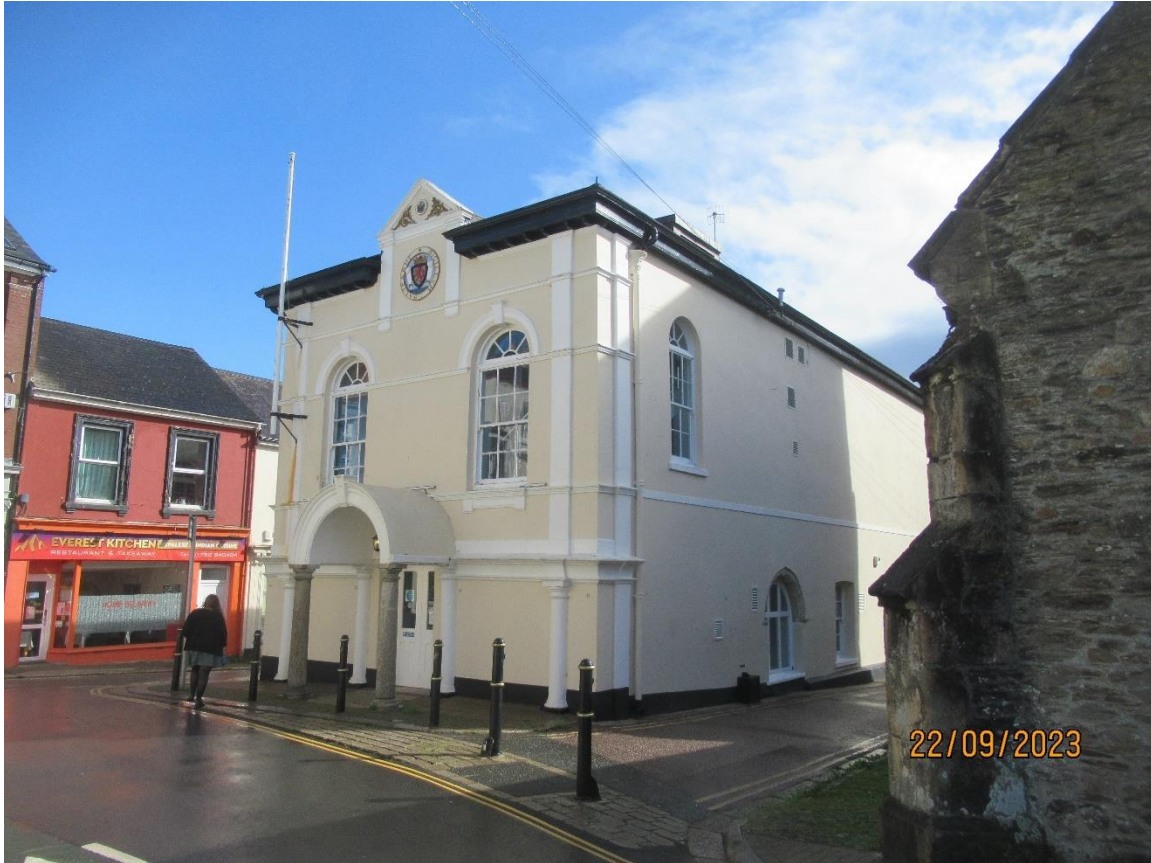
Saltash Guildhall

Within the limitations of this assessment, no RAAC concrete materials have been identified and the risk from RAAC concrete is negligible.

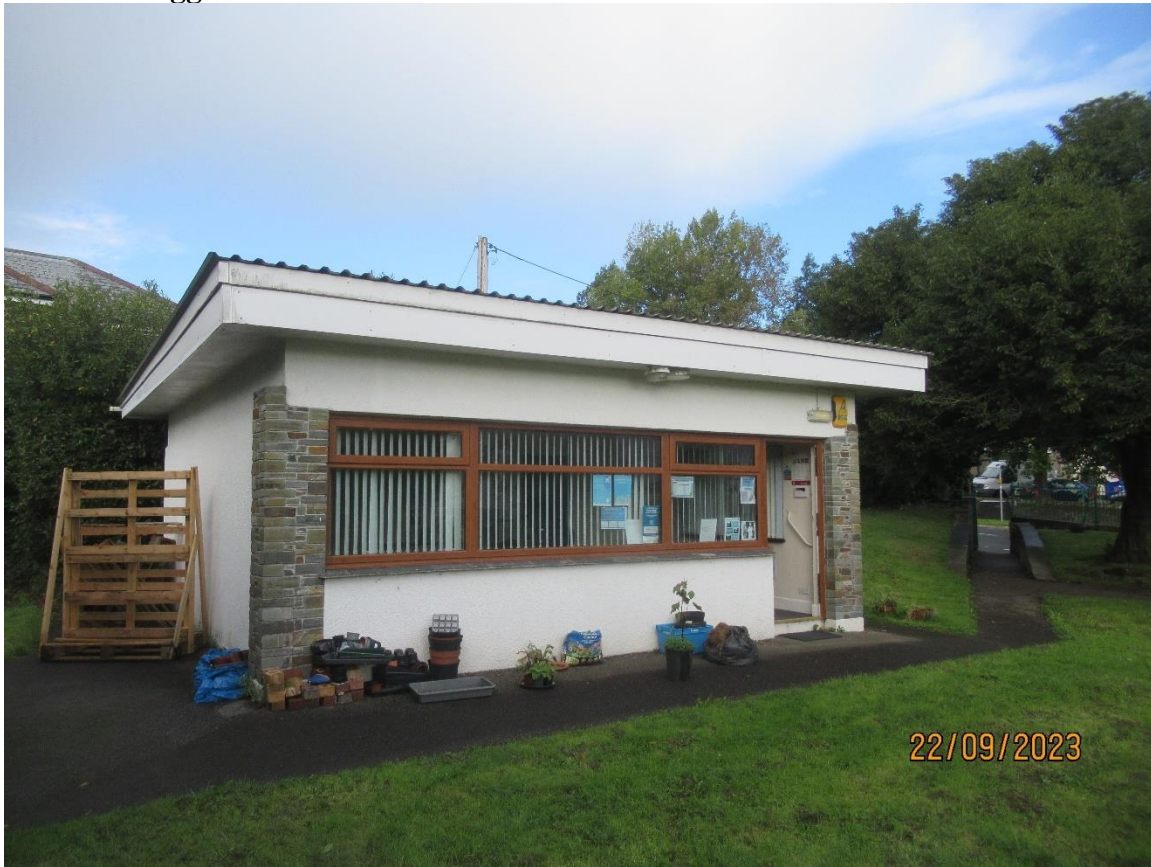
Maurice Huggins Room

This building is most likely to have a concrete flat roof structure which is underlined inside with timber battens and plasterboard and has a sheet metal roof covering across.

A small test drill hole was formed with a light fitting removed in this room with Town Council staff present. This small exposure area was not conclusive as to the nature and consistency of the concrete.

We recommend a more through test inspection to determine the nature of the concrete roof at this building.

This can be done either from inside by removing a section of ceiling or perhaps more easily from outside by cutting through a section of overhanging soffit. You would need to check your asbestos register first to ensure that the soffits are not asbestos containing materials before test sampling through.

Once the plasterboard or soffit material is removed, that should expose the concrete structure where a test drill could be carried out. If the concrete is dense, it will not be RAAC.

In summary, for this building, further investigation work is recommended.

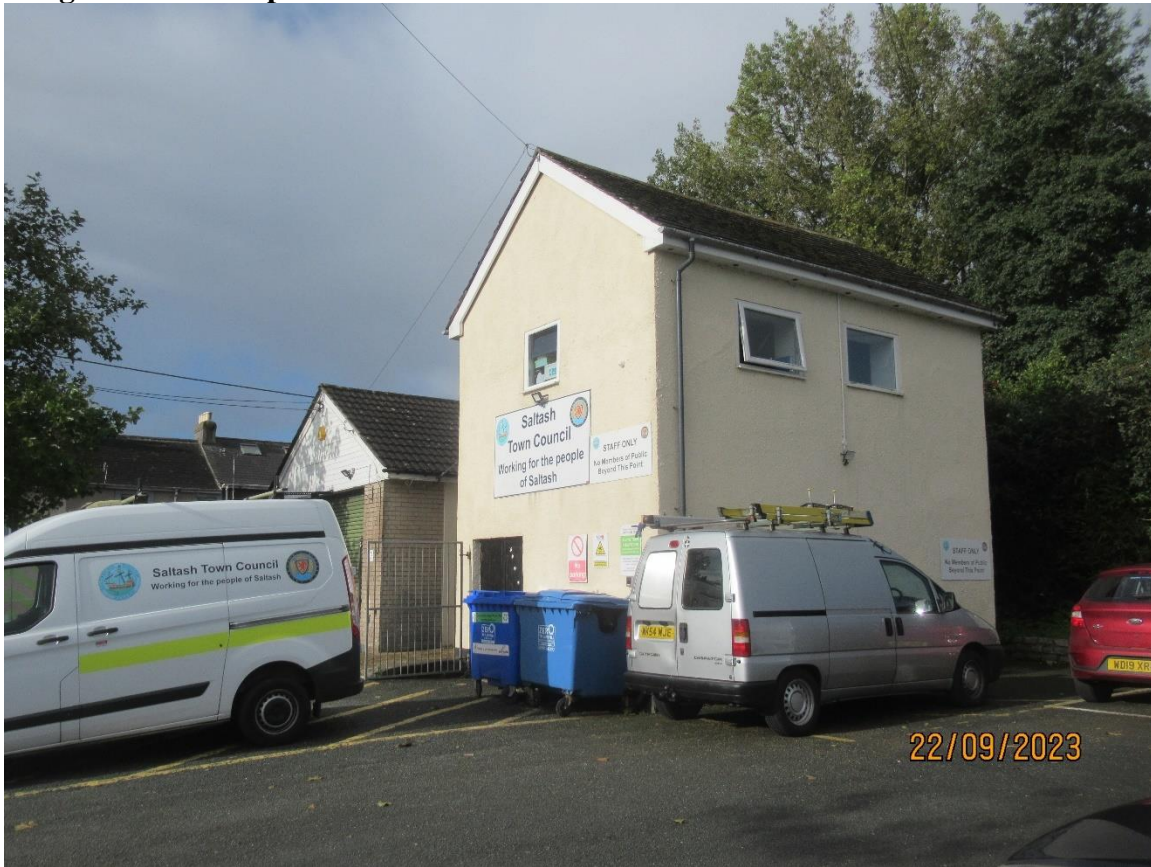
Longstone Park Depot

Within the limitations of this assessment, no RAAC concrete materials have been identified and the risk from RAAC concrete is negligible.

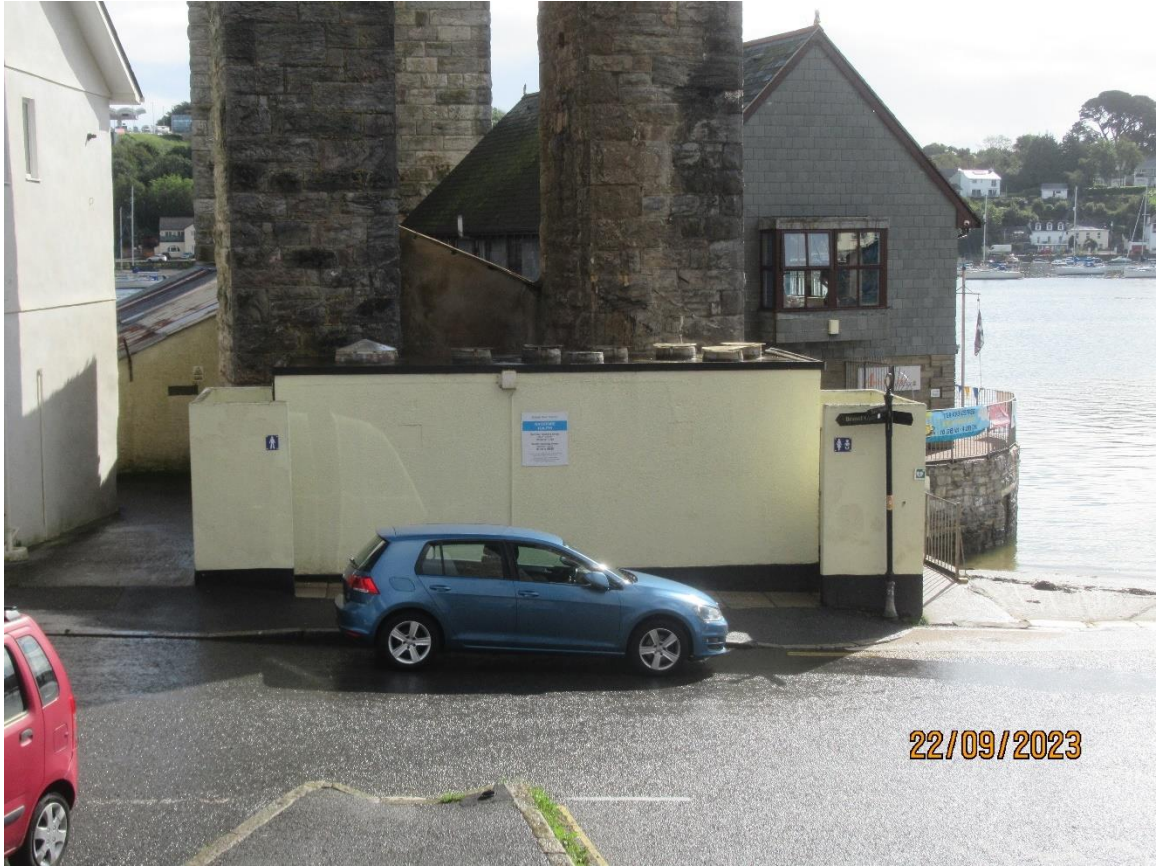
Waterside Public Toilets

This single storey toilet block does have a concrete flat roof. However, this roof is visible from above with an asphalt style covering and rendered and decorated under from inside the male and female WC areas. The roof is thick concrete with no characteristics of RAAC concrete roof planks. Despite there being a concrete roof here, there is no evidence of defect and negligible risk of the concrete being

RAAC, rather traditional reinforced concrete roof slab. No further works is considered necessary.

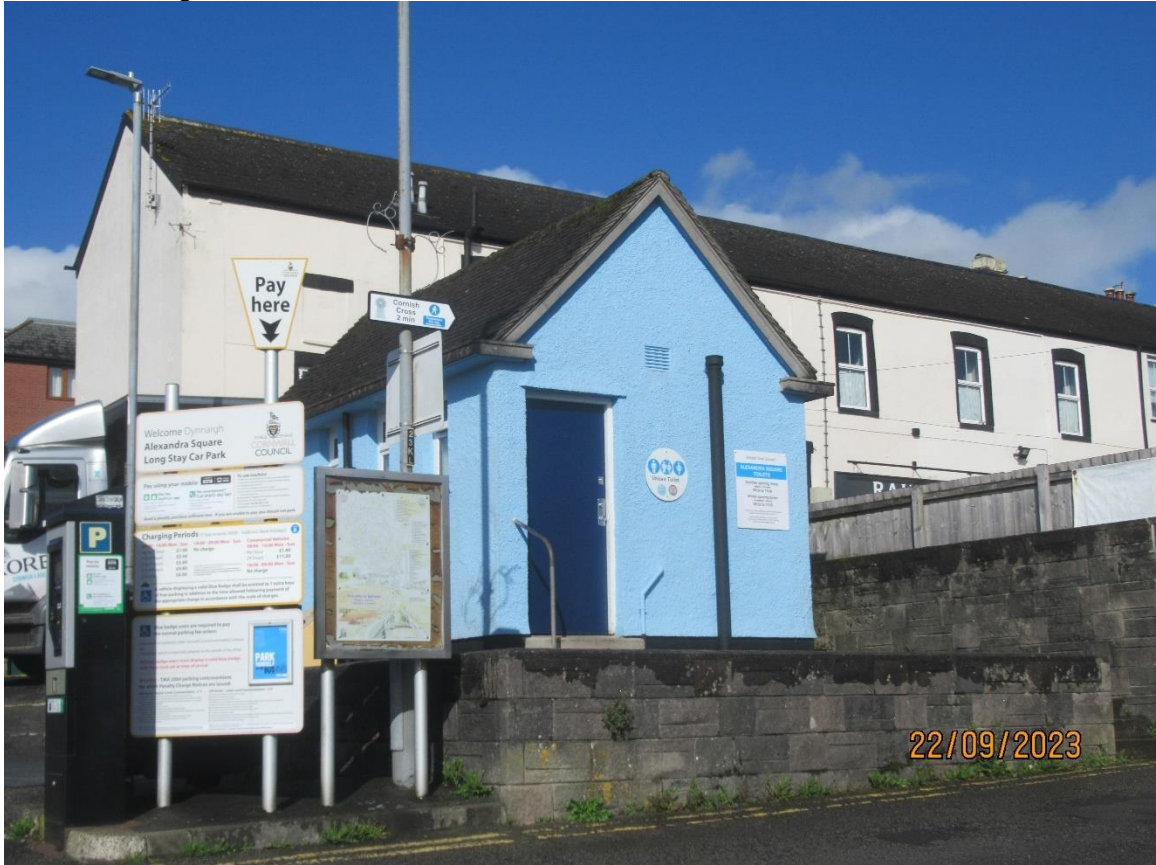
Alexander Square Public Toilets

Within the limitations of this assessment, no RAAC concrete materials have been identified and the risk from RAAC concrete is negligible.

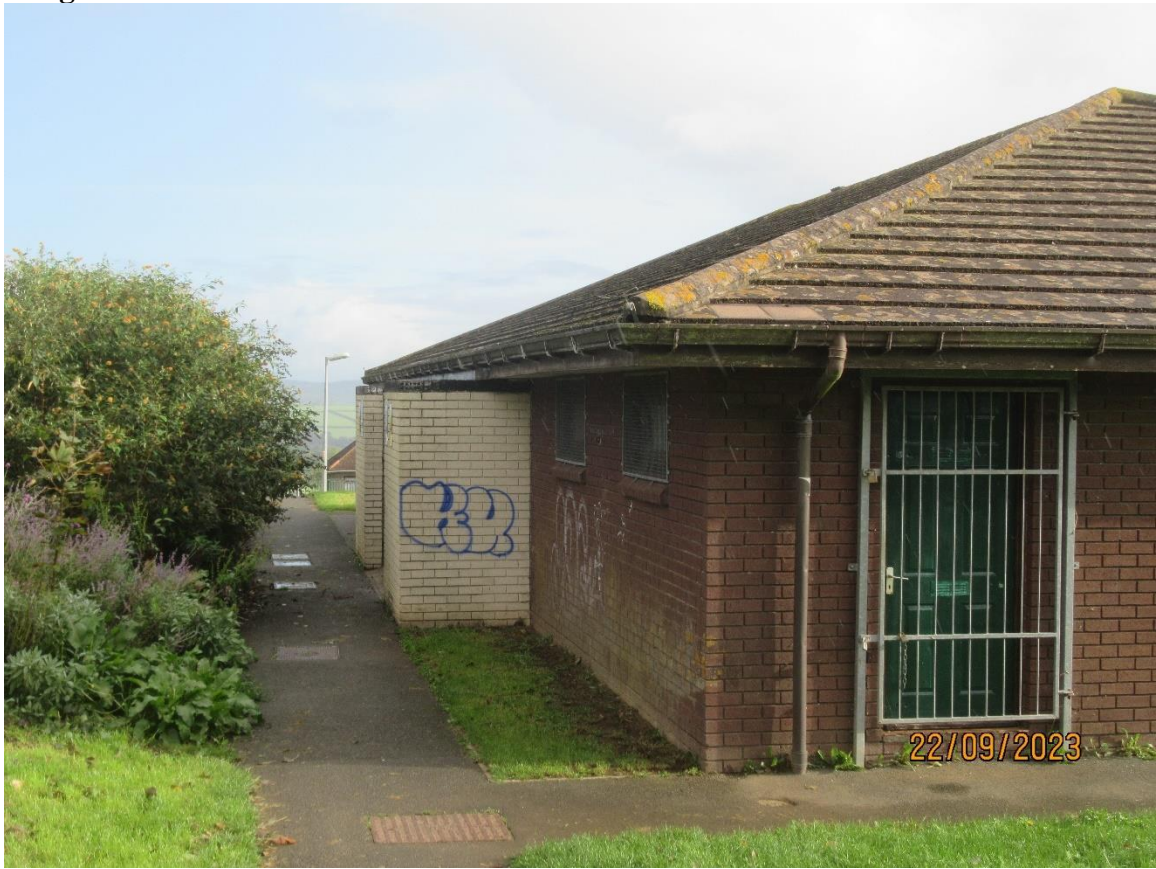
Longstone Public Toilets

Within the limitations of this assessment, no RAAC concrete materials have been identified and the risk from RAAC concrete is negligible.

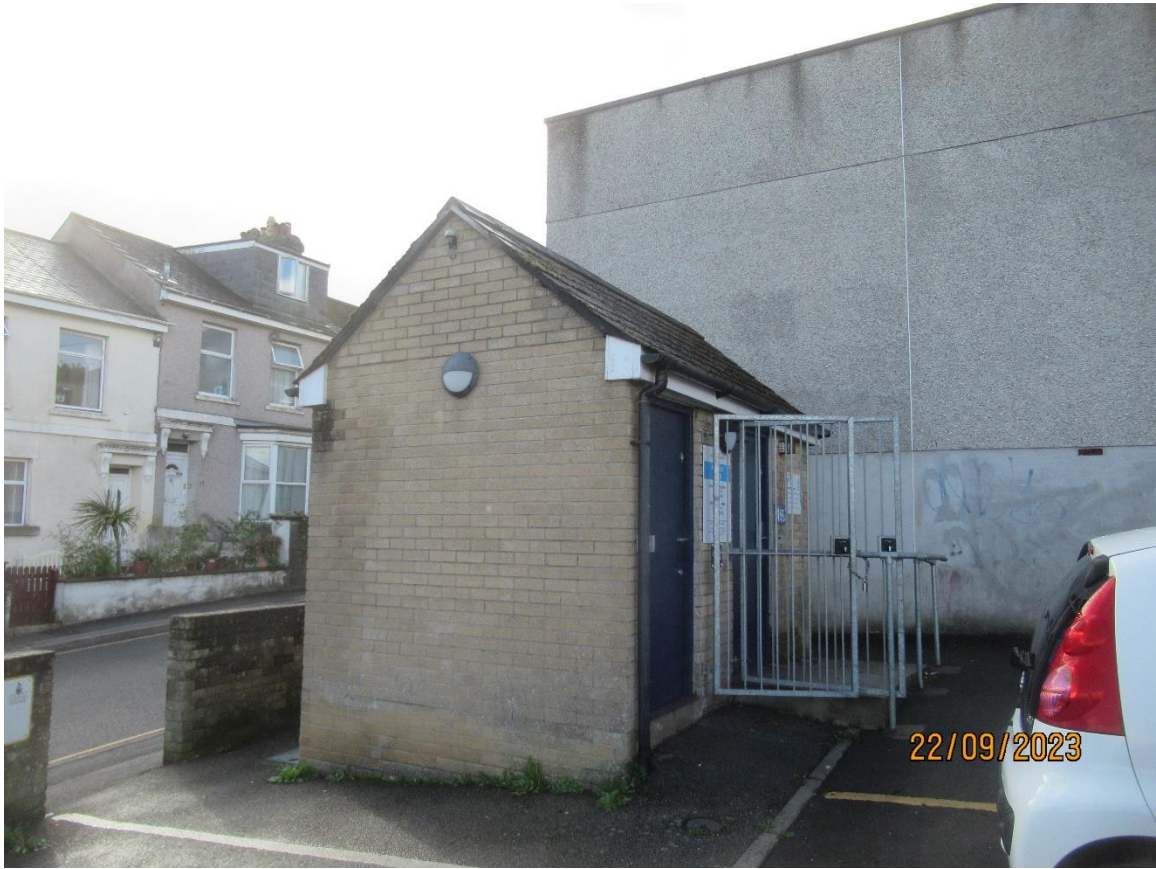
Belle Vue Public Toilets

Within the limitations of this assessment, no RAAC concrete materials have been identified and the risk from RAAC concrete is negligible.

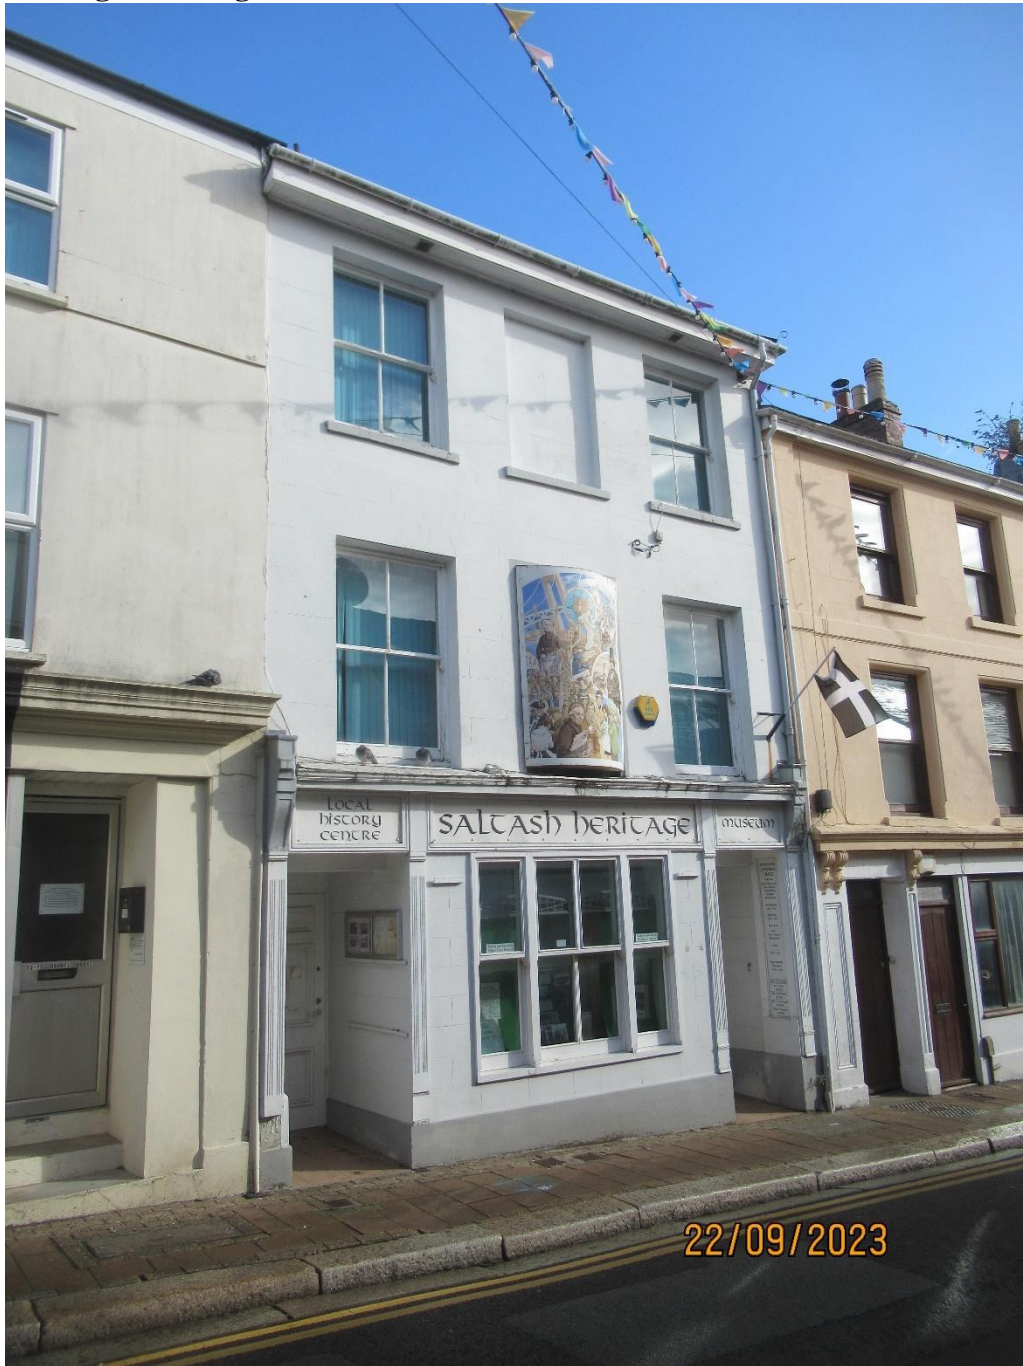
Heritage Building

Within the limitations of this assessment, no RAAC concrete materials have been identified and the risk from RAAC concrete is negligible.

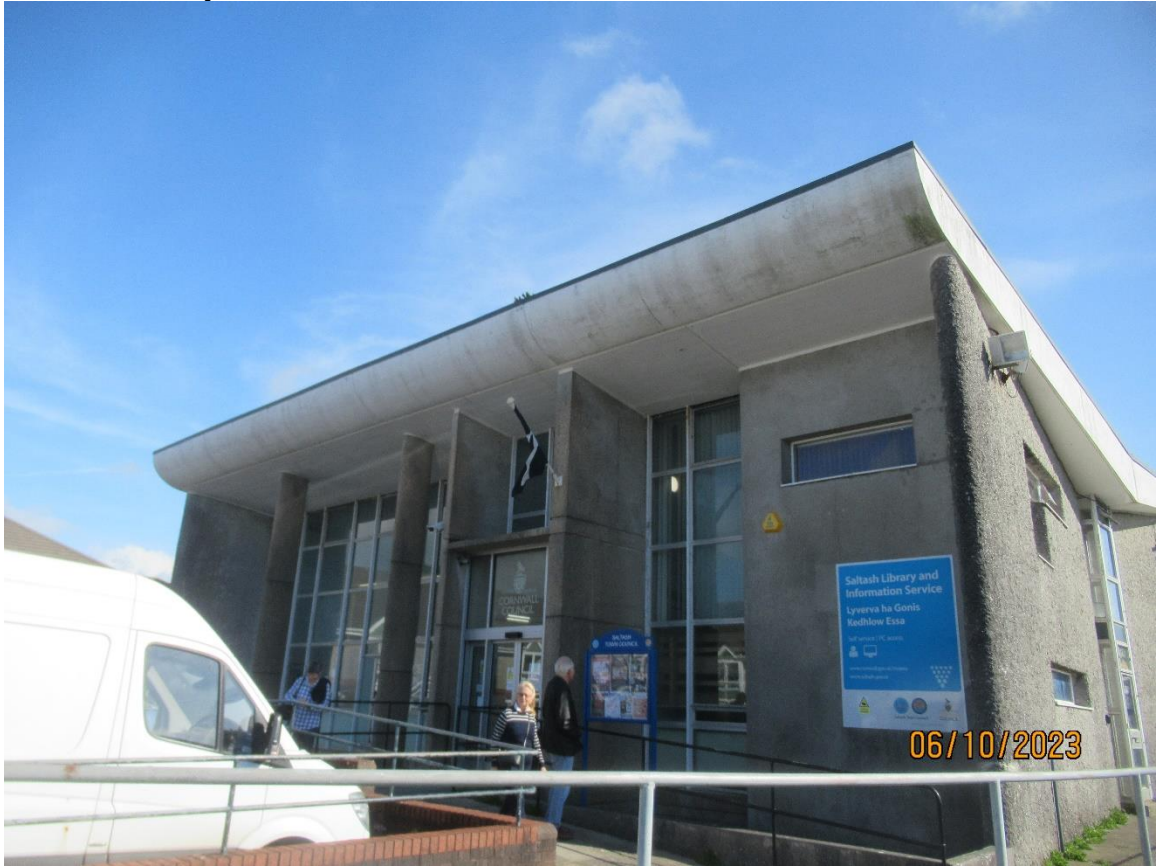
Saltash Library

Within the limitations of this assessment, no RAAC concrete materials have been identified and the risk from RAAC concrete is negligible.
