CONDITION REPORT AND FORECAST BUDGET COSTS

VARIOUS BUILDINGS SALTASH TOWN COUNCIL

FOR SALTASH TOWN COUNCIL

Prepared By:	James M Barron MRICS	Date: 14 October 2024	Rev:
Checked By:	JANA A	Job Ref: 4452

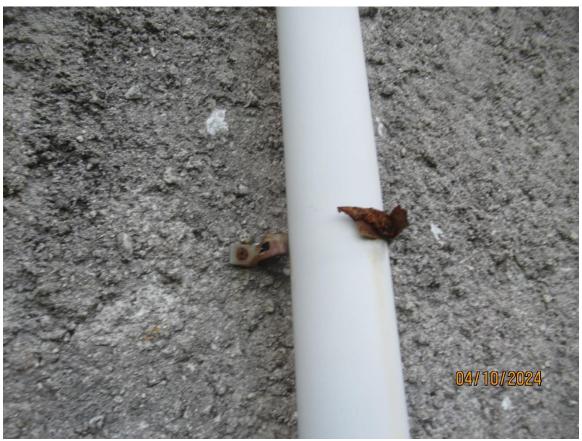
P2 – library downpipe bracket

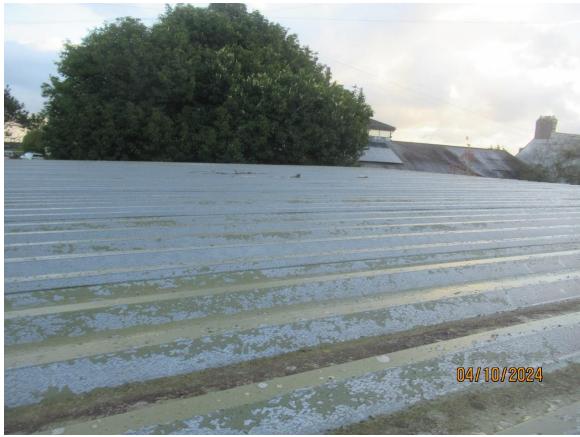
P6 – Maurice Huggins roof

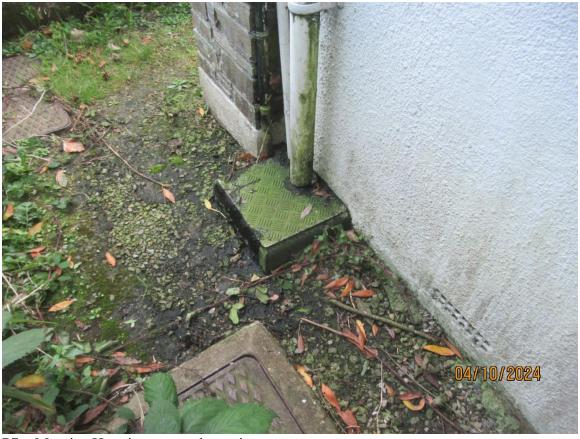
P7 – Maurice Huggins mossy downpipe

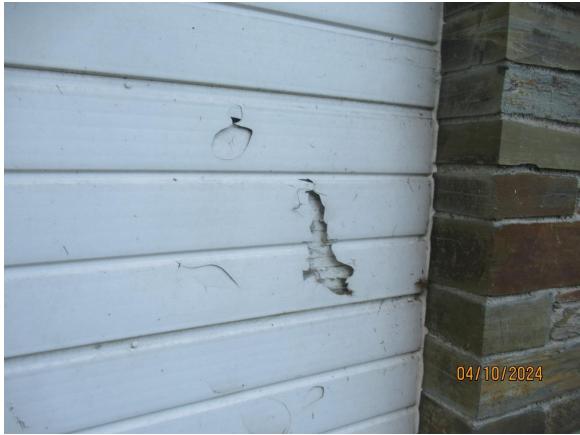
Walls	jointing good. Decoration worn.	Prepare and paint.	€ 1,000.00	-	£ 1,000.00	
	Brown PVC door and ribbon window to front and side. White PVC to rear. PVC					
Windows and Doors	cladding blocks door opening right hand elevation.	Repair cladding board.	£ 150.00			P8
Elevation Photos						P9, P10
INTERNAL						
	Floor coverings carpet throughout with vinyl sheet in kitchen and WCs. Slight					
	scutting and cosmetic wear but noor coverings remain good.	None anticipated.				
MAURICE HUGGINS ROOM						
TOTALS		TOTALS	£ 1,750.00	,	£ 1,000.00

P8 – cladding board

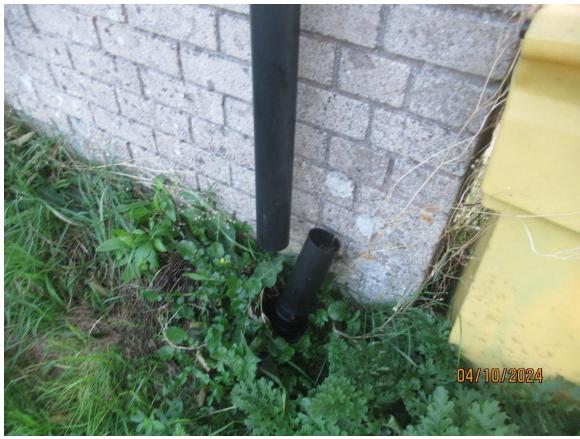
P11 – broken drainpipe

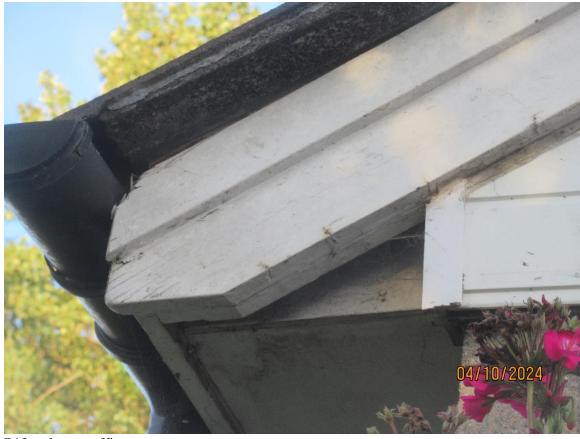
P12 – depot soffit

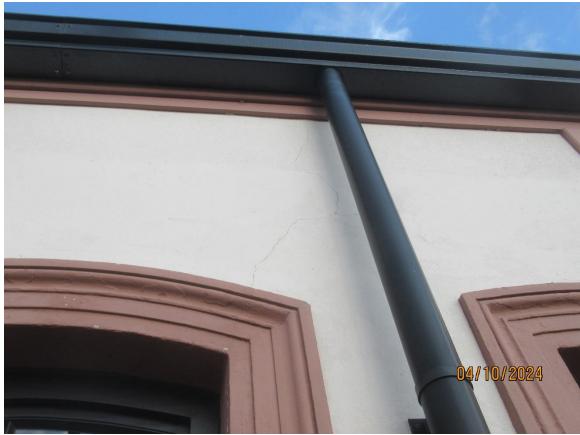
P19 – typical crack in building

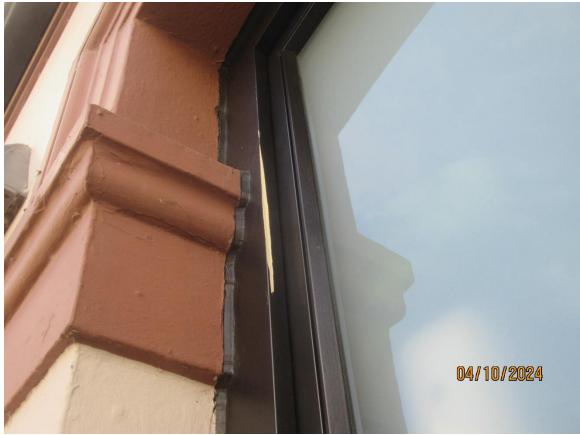
Wooden factory finish windows replaced circa 2020. Minor scuffing to factory					
	finish in isolated areas.	Minor touch ups in matching colour.	£ 200.00			P19, P20
INTERNAL						
	Self finished screed floor. STC in discussion with contractor regarding cracking					
	across floor through building contract.	None anticipated.				
ISAMBARD HOUSE TOTALS		TOTALS	£ 200.00	200.000 £ 8,000.002

P20 – touch up window

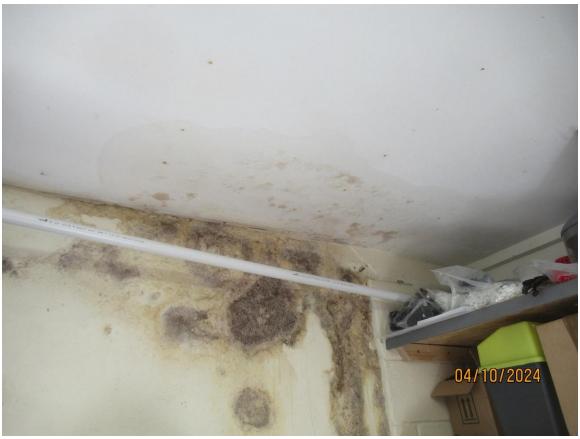
P21 – depot internal concrete wall in store
