*Damage inspection*

***Saltash Town Council /  
Jubilee Pontoon***

*Inspection location: Jubilee Pontoon, Jubilee Green, Saltash, Cornwall, PL12 6JD*

# *‘Jubilee Pontoon’*

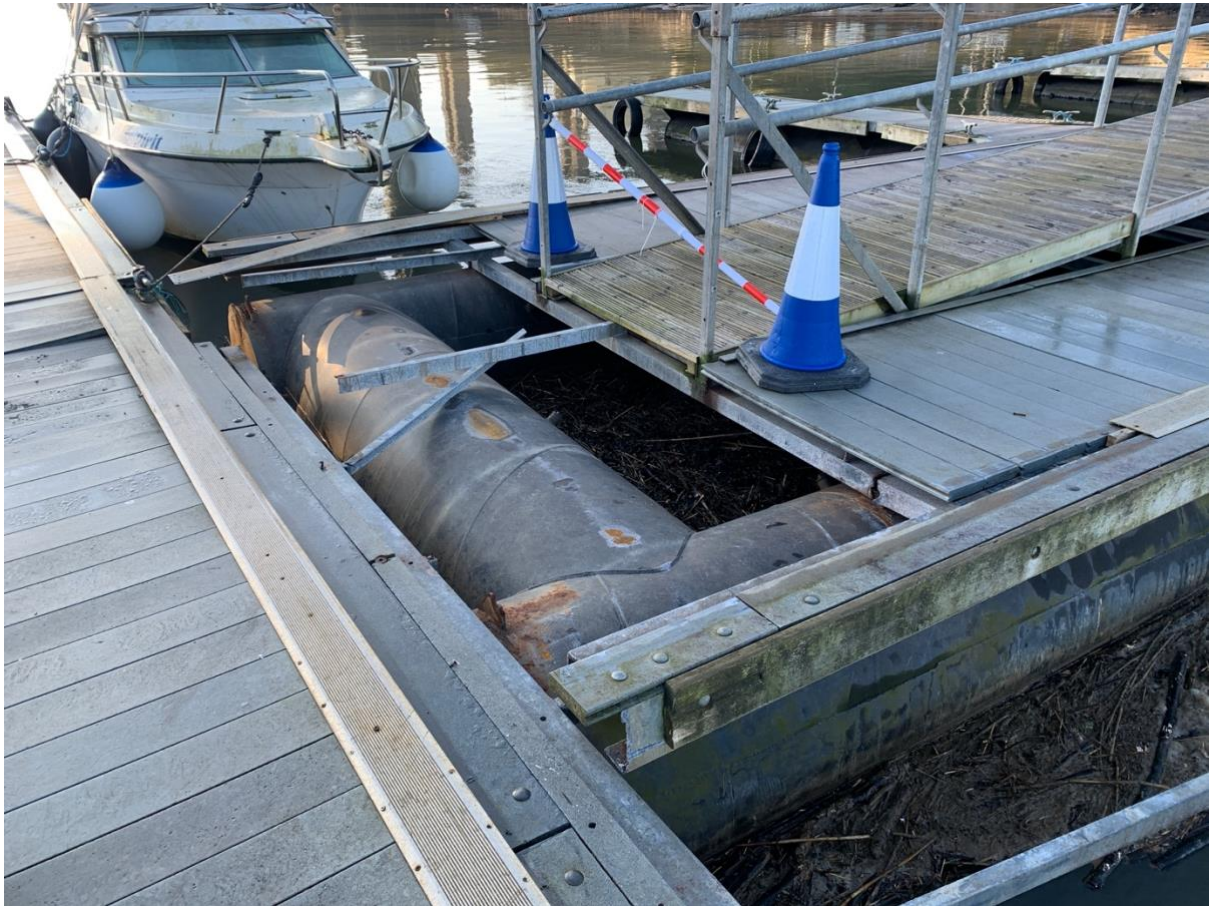
- The damage starts where the two main pontoon sections join, which is at the end of the brow. The decking boards have been removed since the repairers report, giving better access to the connections, supports and floats.

- On the walkway pontoon, five angled deck board supports, made from galvanised steel have become detached from the frame structure.
- Welded brackets attached to the floats beneath have snapped. There is some localised corrosion to the floats which may have contributed.

Damage at end of walkway pontoon

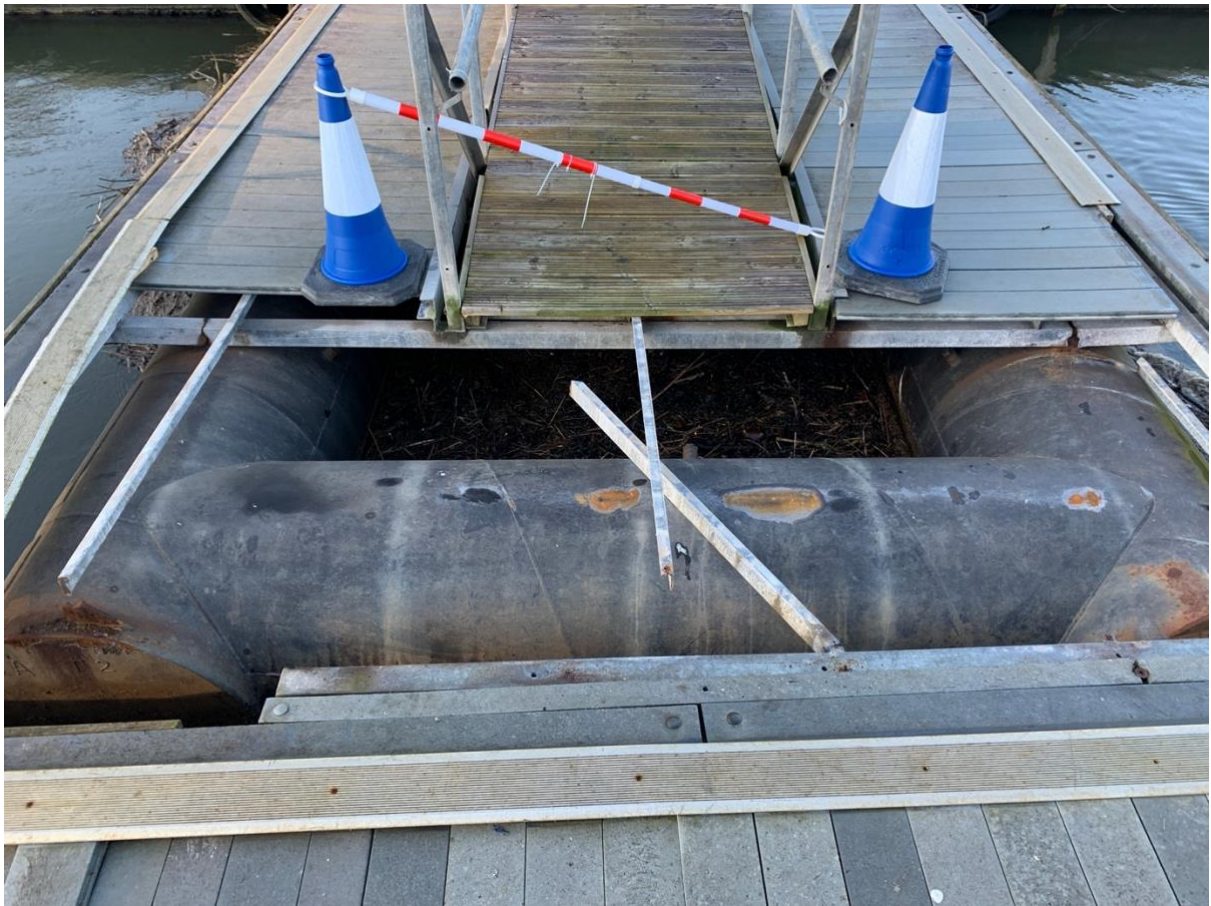
Damage at end of walkway pontoon

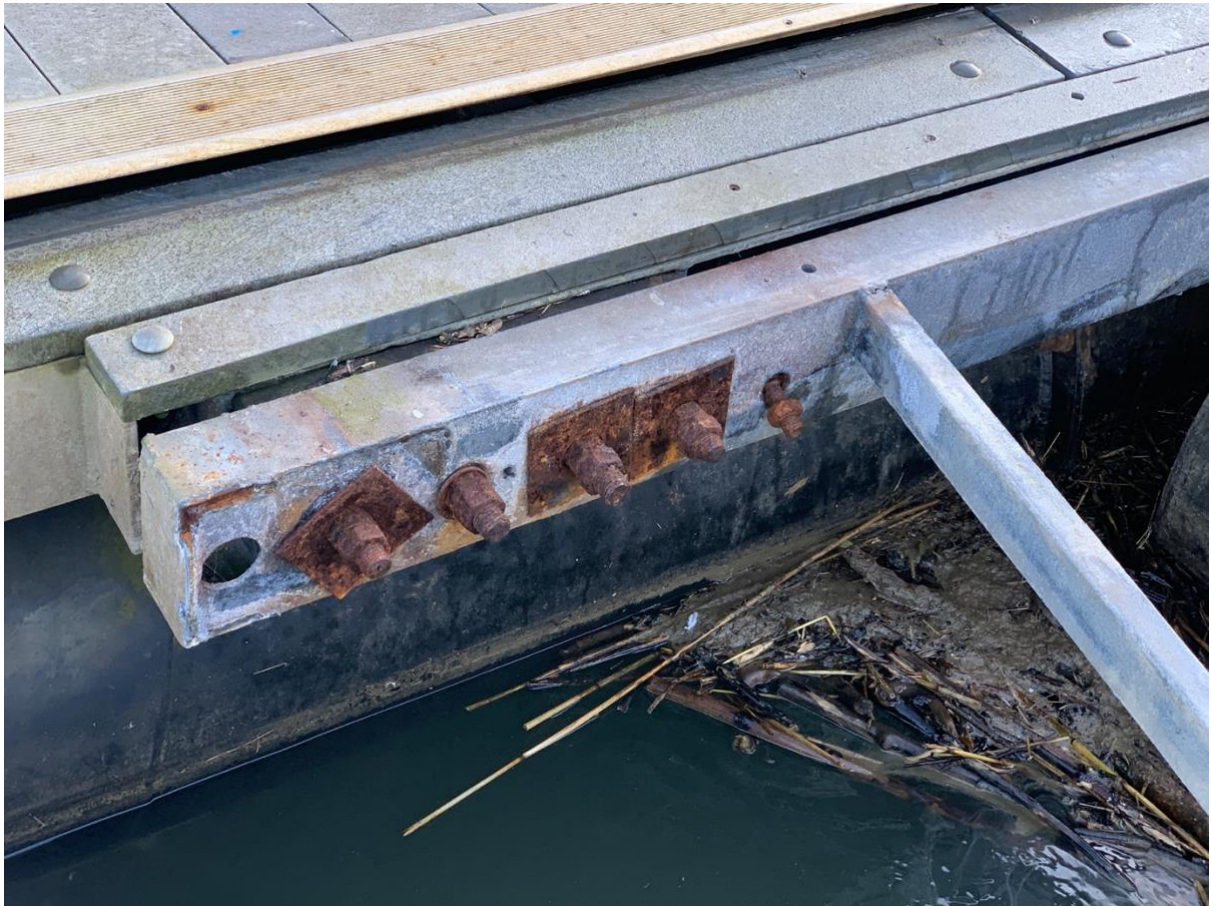
- Where these brackets are attached to the frame structure, the frames were found to have snapped in two locations.
- The connections between the two pontoons have sheared. It was noted that nuts and bolts were severely corroded in these locations. One bolt has clearly been moving and has ovalled its opening.

Corroded bolts on waterside pontoon join

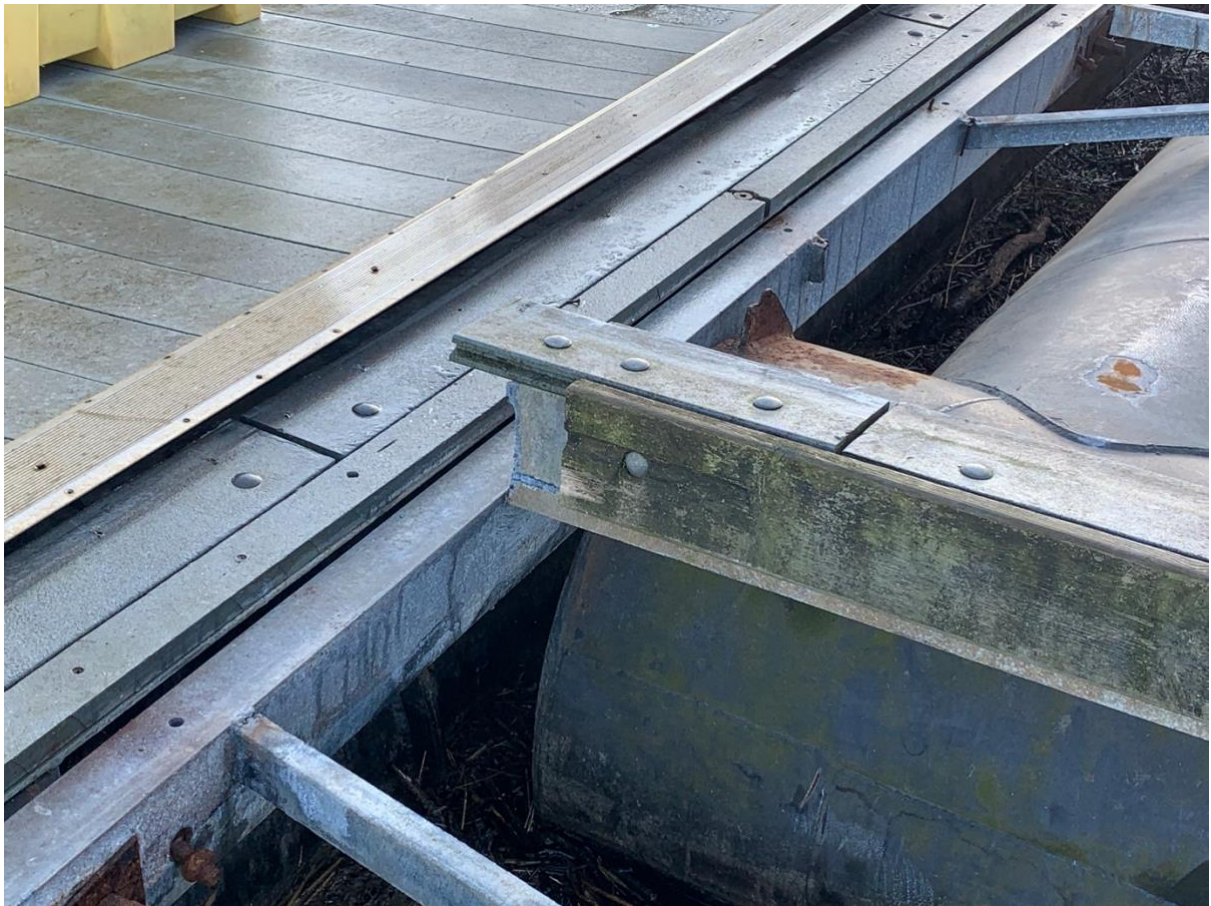
- The side sections from the walkway pontoon are damaged where they meet the waterfront pontoon section. Boards are out of alignment which indicates possible twisting.

Broken side section on walkway pontoon

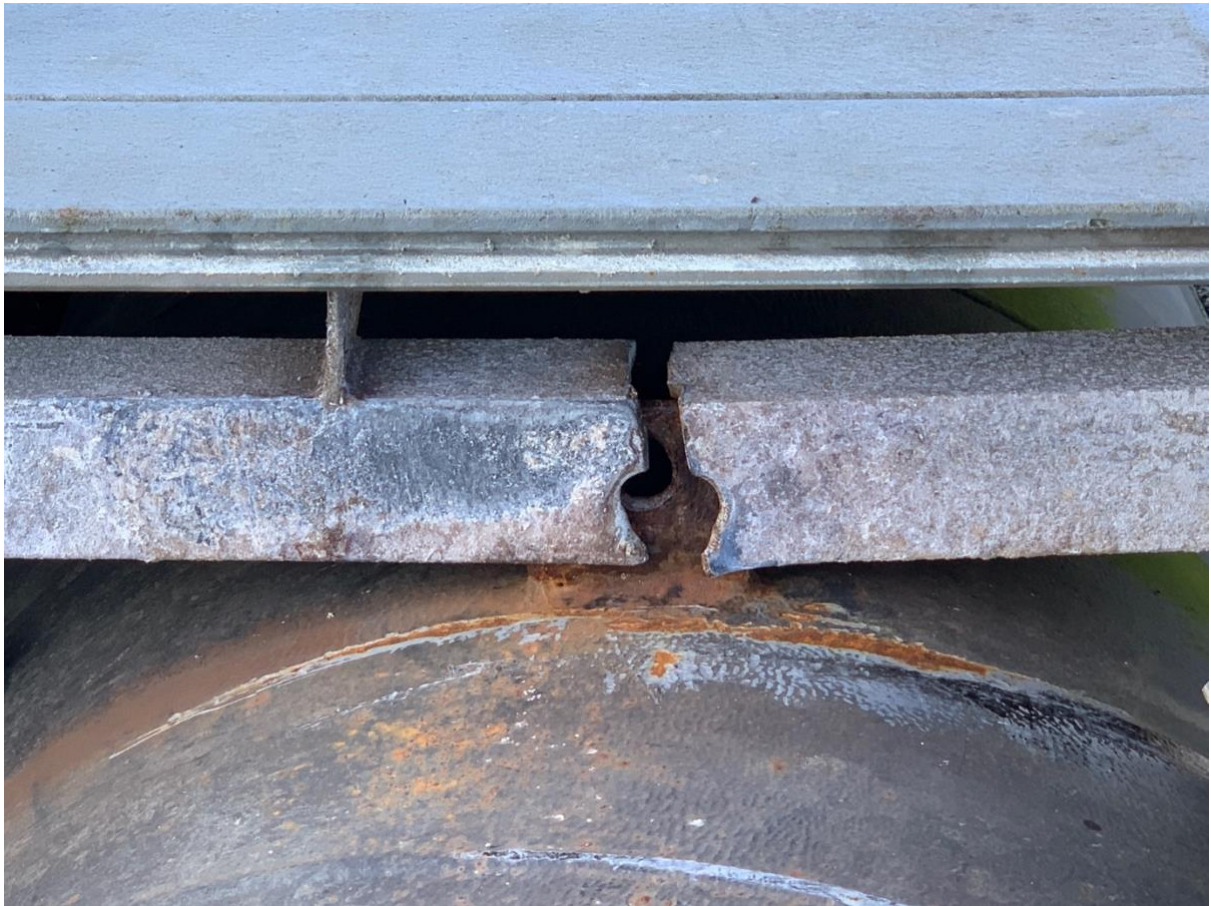
Broken float frame on walkway pontoon. Note the corrosion

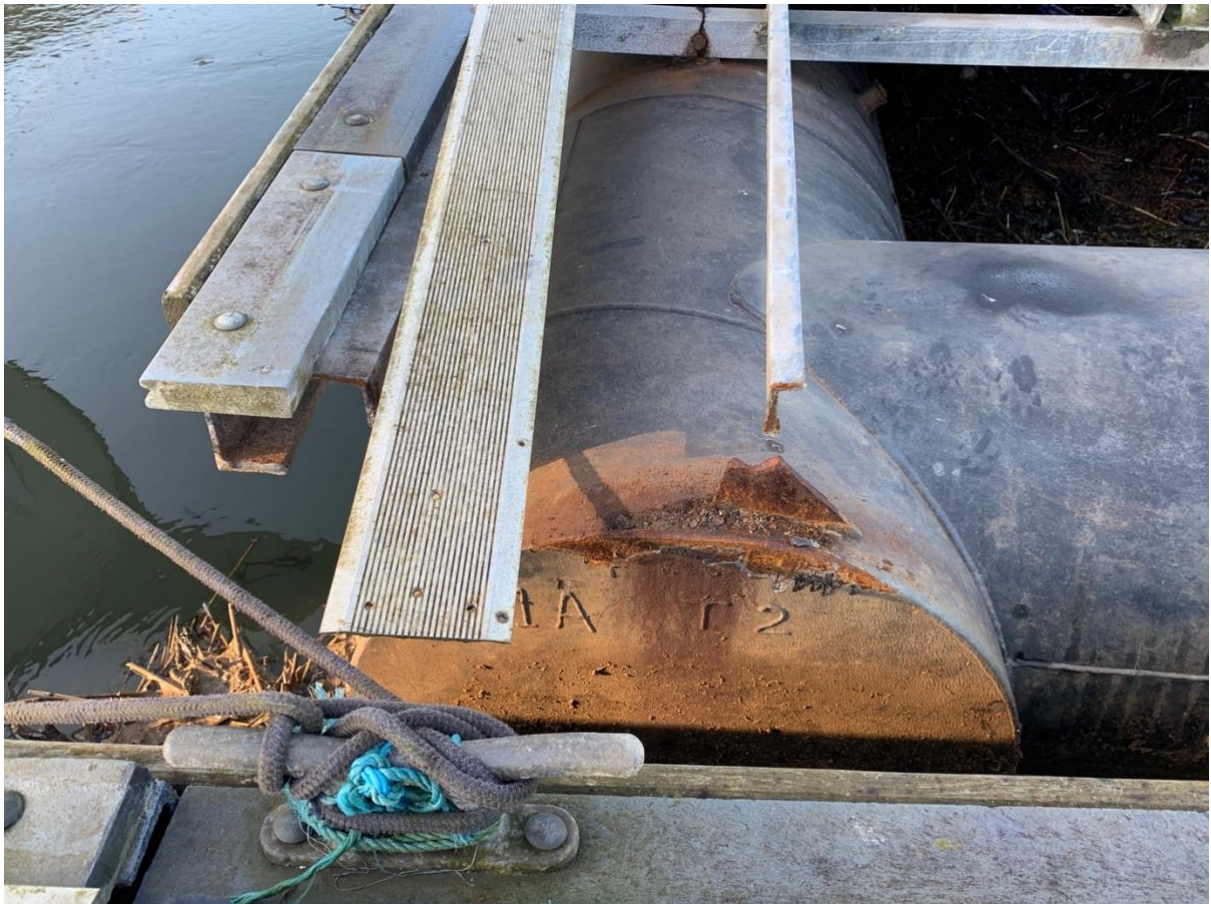
Broken side section on the other side of the pontoon.

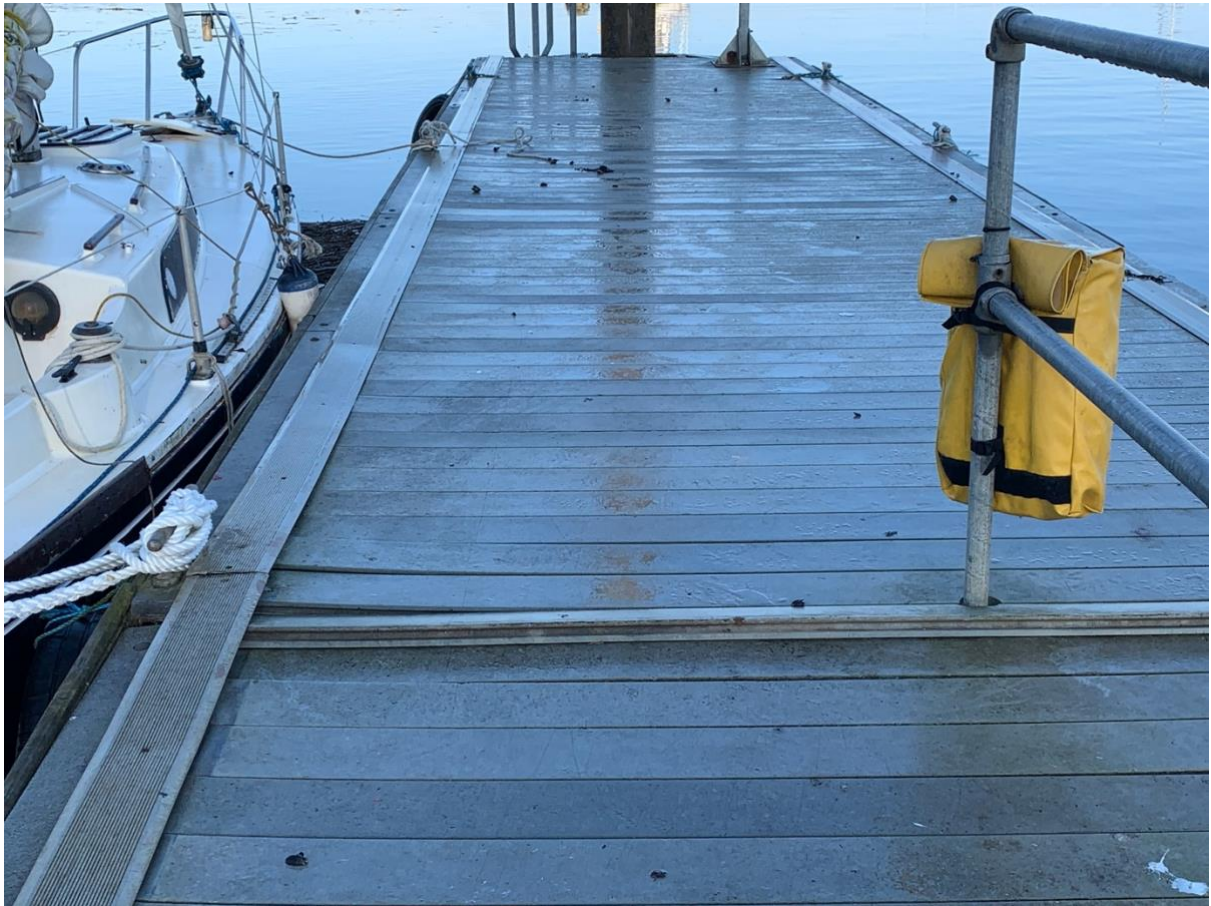
- On the waterfront pontoon section, that forming the top of the T, the longitudinal and transverse boards have risen where it meets the other main pontoon and again, further along on the left-hand side over a length of around 1m. The timber boards mounted as fendering have also been damaged. This also indicates potential twisting to the frame beneath.

Boards raised, indicating twist, on waterside pontoon

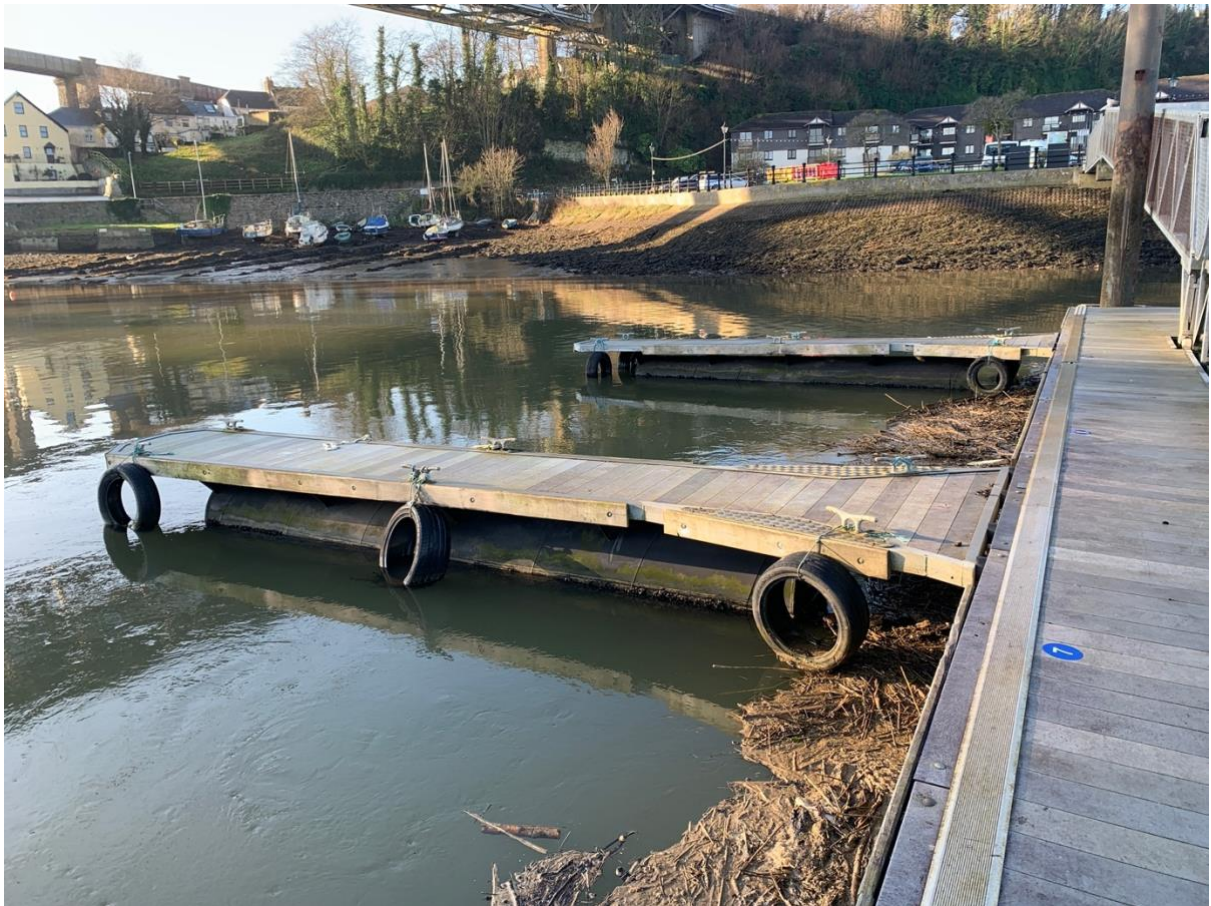
- The repairers report states finding damage between the walkway and finger pontoons, but this was not immediately visible at the inspection. It is difficult to confirm with the deck boards in place but it is possible that there is some damage.

Finger pontoon links look unaffected but should be checked

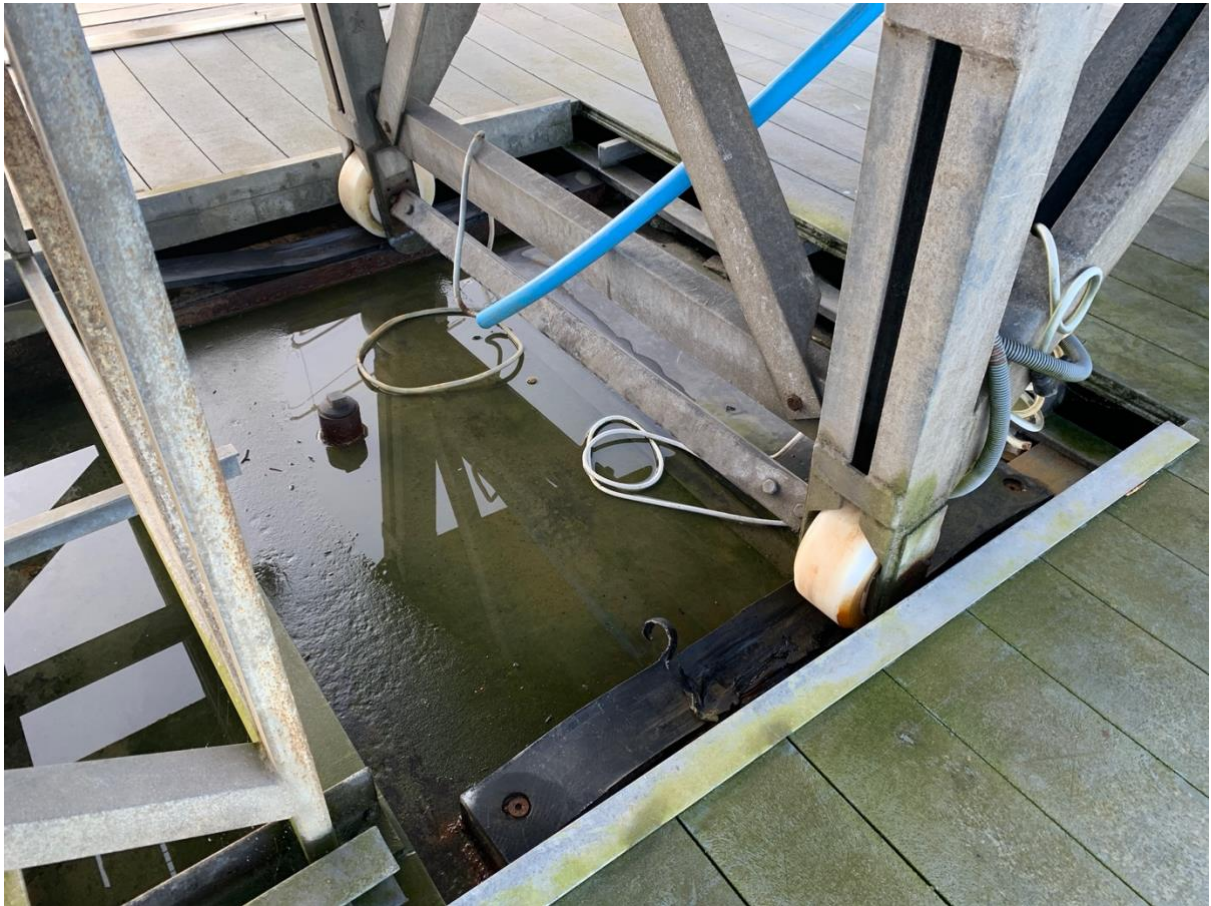
Brow roller

- Areas of the floats are showing signs of corrosion.
- The four piles, used to hold the pontoon arrangement in position and to allow it to move with the tide, are corroded.
- The roller arrangement that allows the brow to move on the pontoon has worn.
- On the finger pontoon for berth 2, the timber fendering has broken.
- Water is held on top of the brow pontoon. It appears to have no drainage in this location which means that there is a greater chance of corrosion developing.

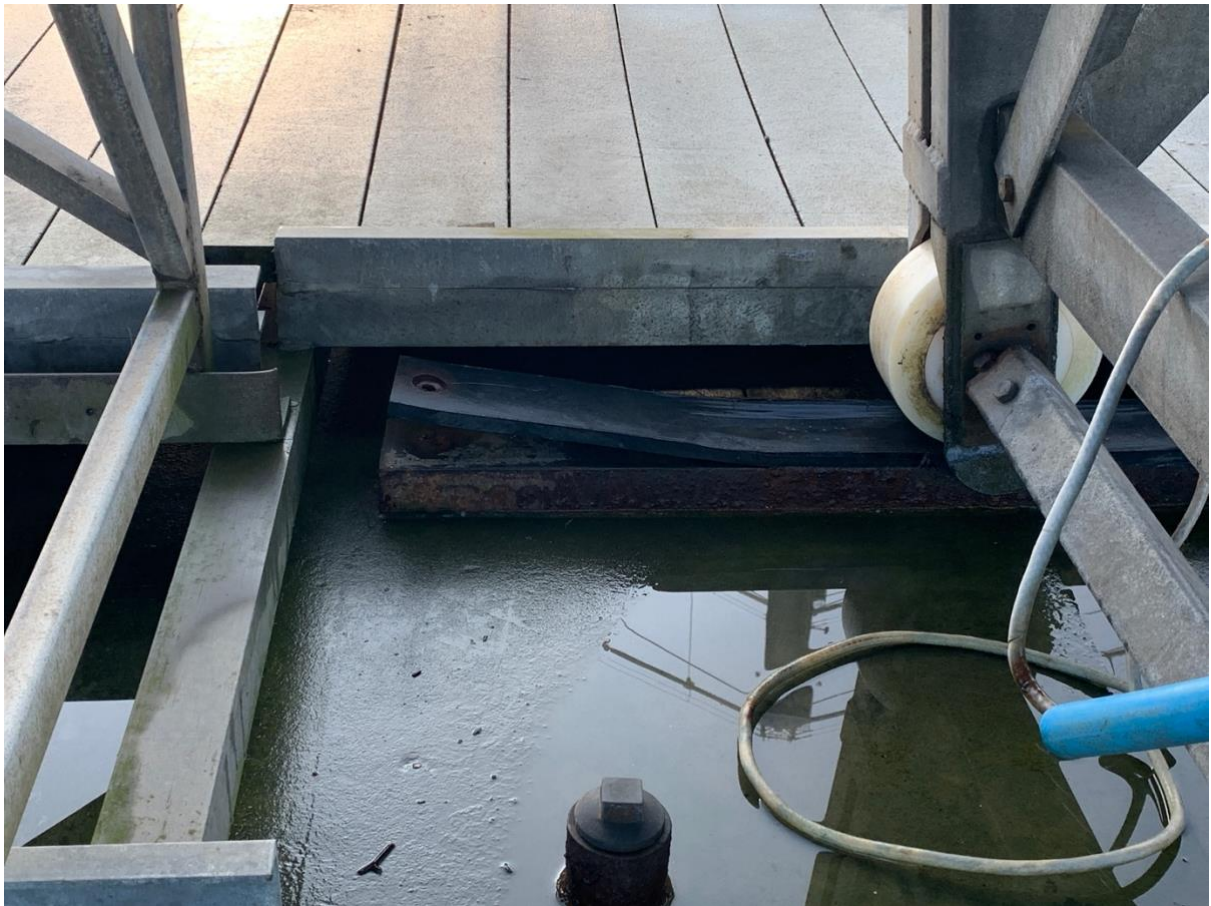
Pad needs securing

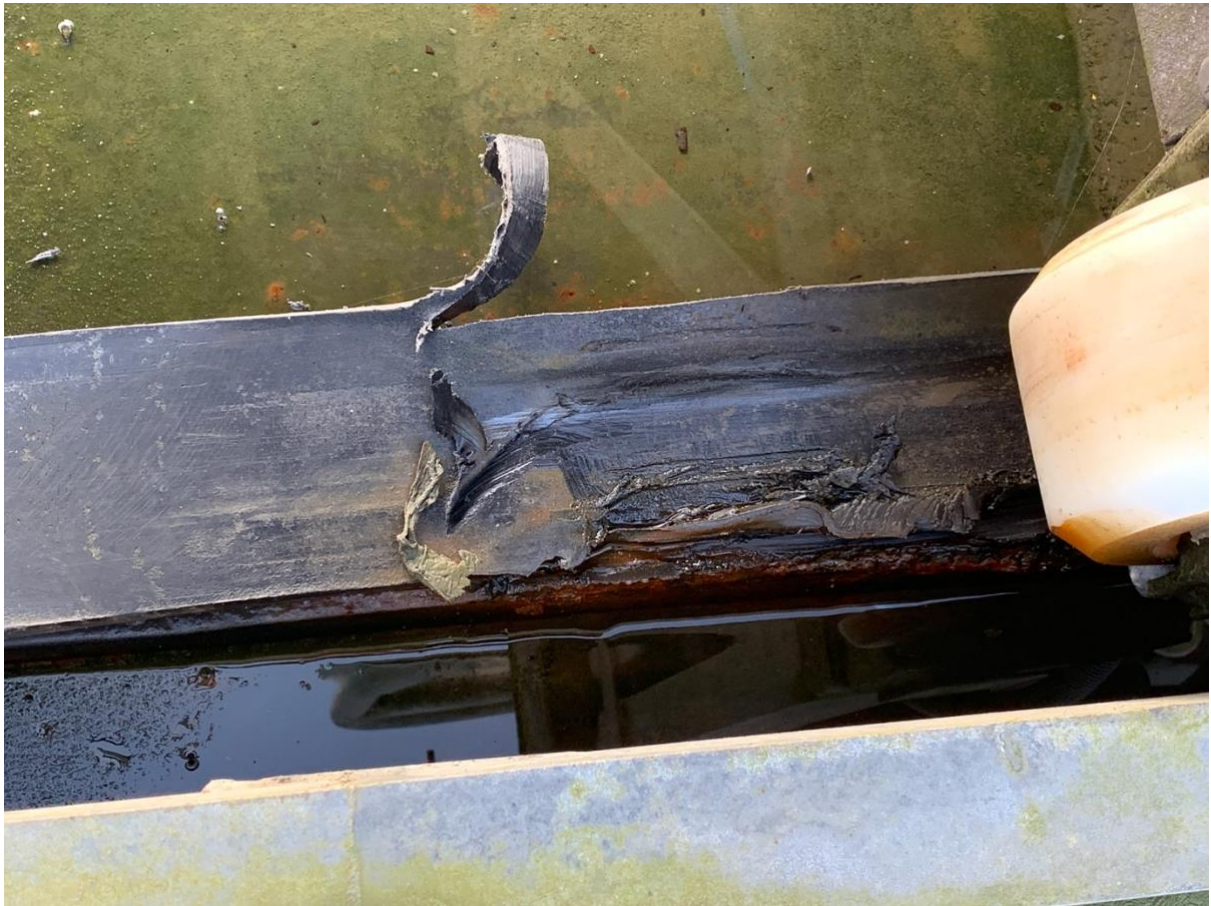
Pad needs replacing

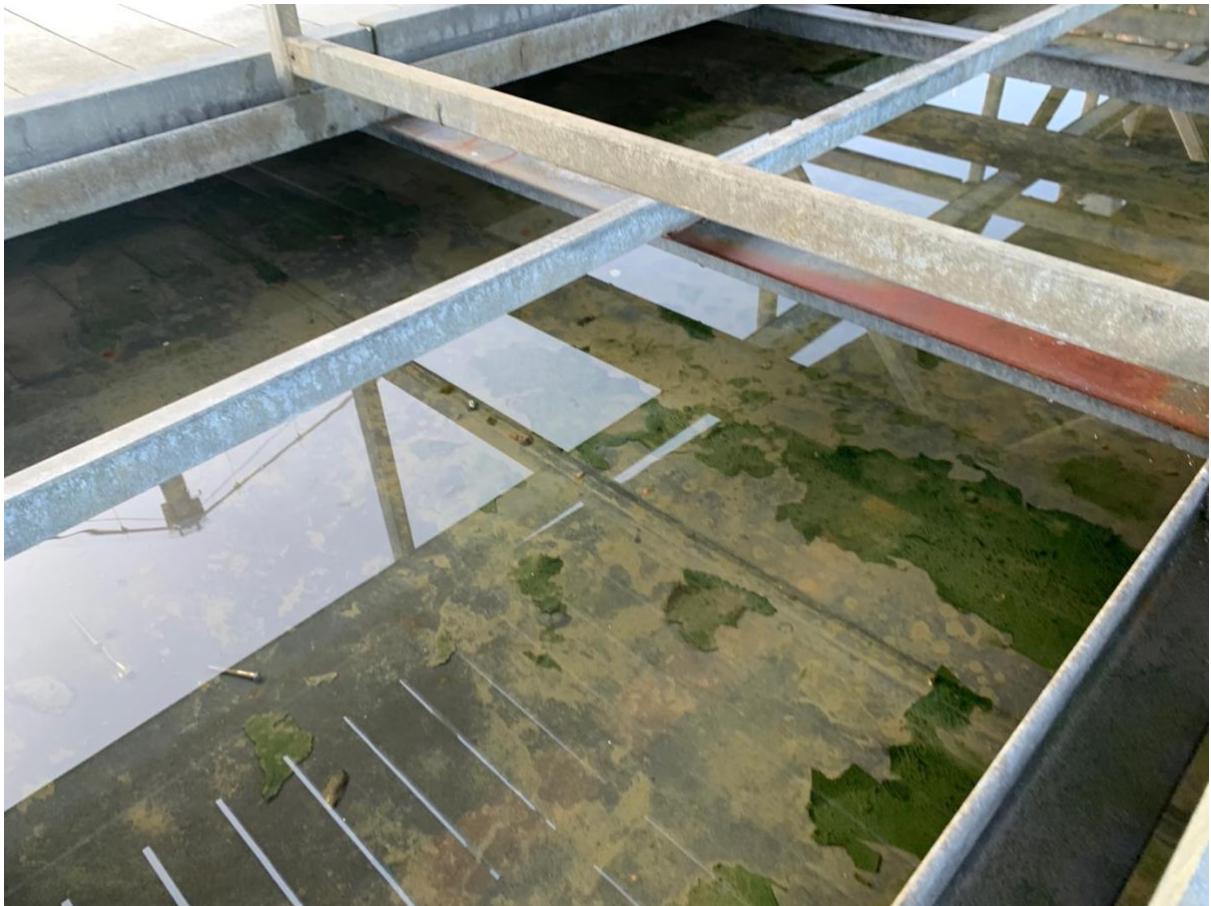
Water in top of walkway pontoon

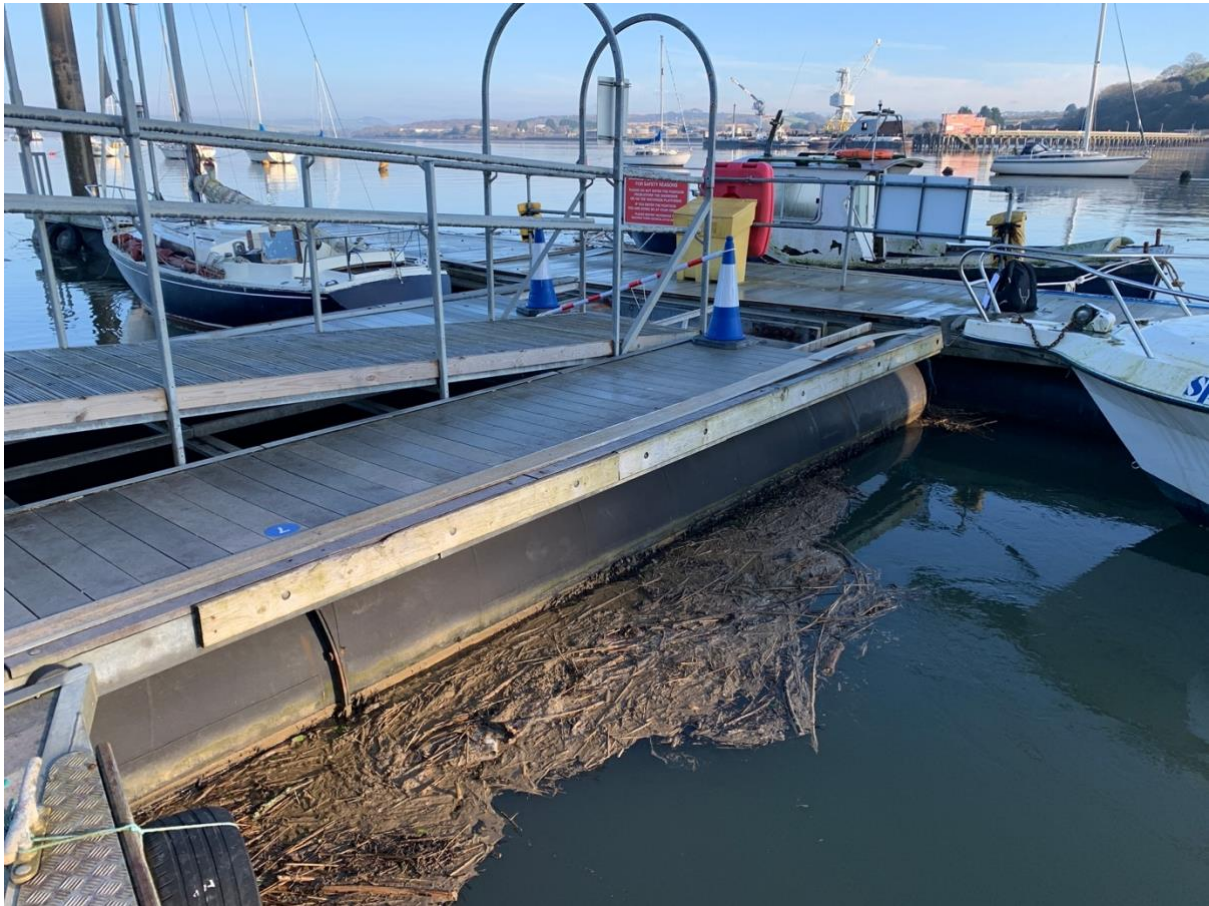
- The floats, which support the pontoon arrangement are showing signs of fouling at the waterline and below. It was also noted at a previous visit that raw sewage can gather in this area.

Walkway pontoon fouling

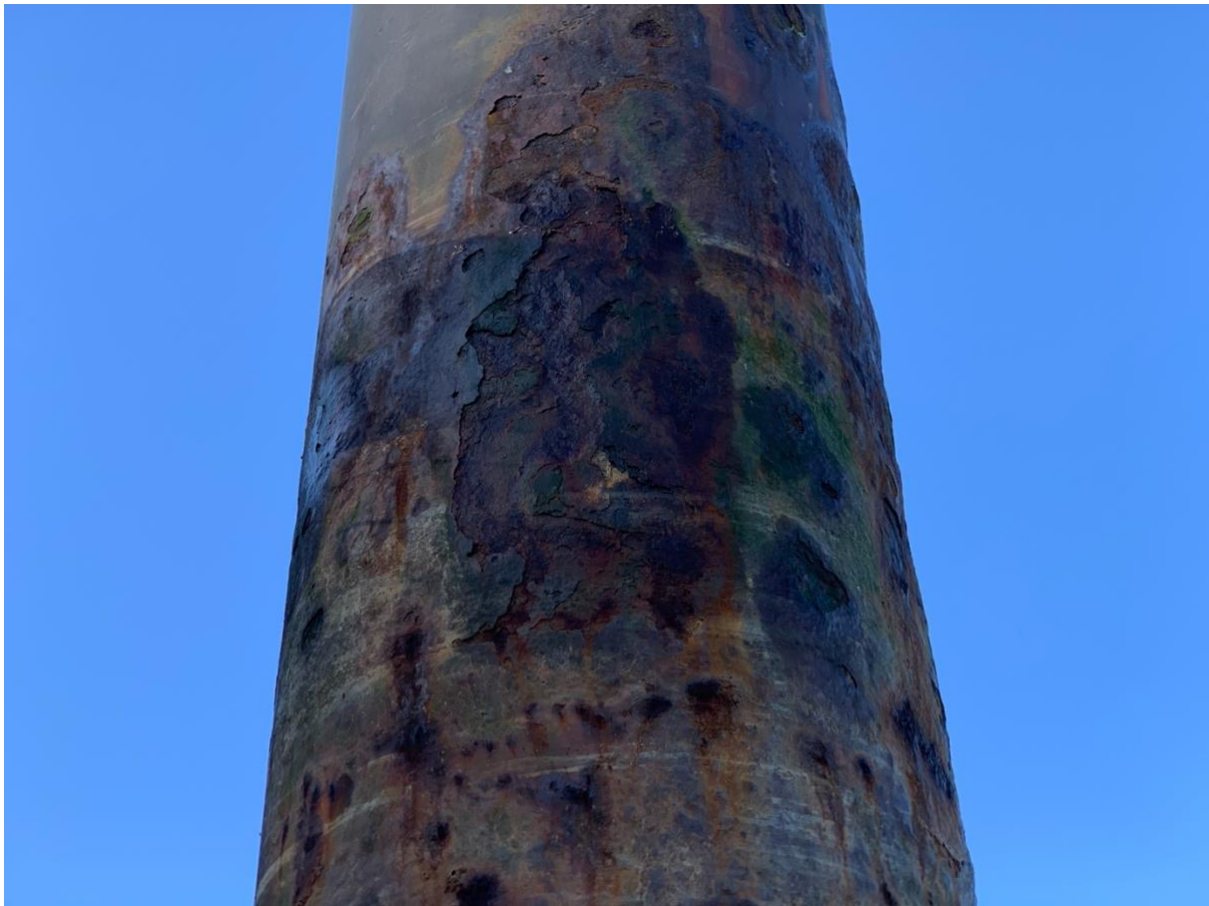
Pile corrosion
