Cornwall County Council

Saltash Landing Stage Pontoons

July 2015

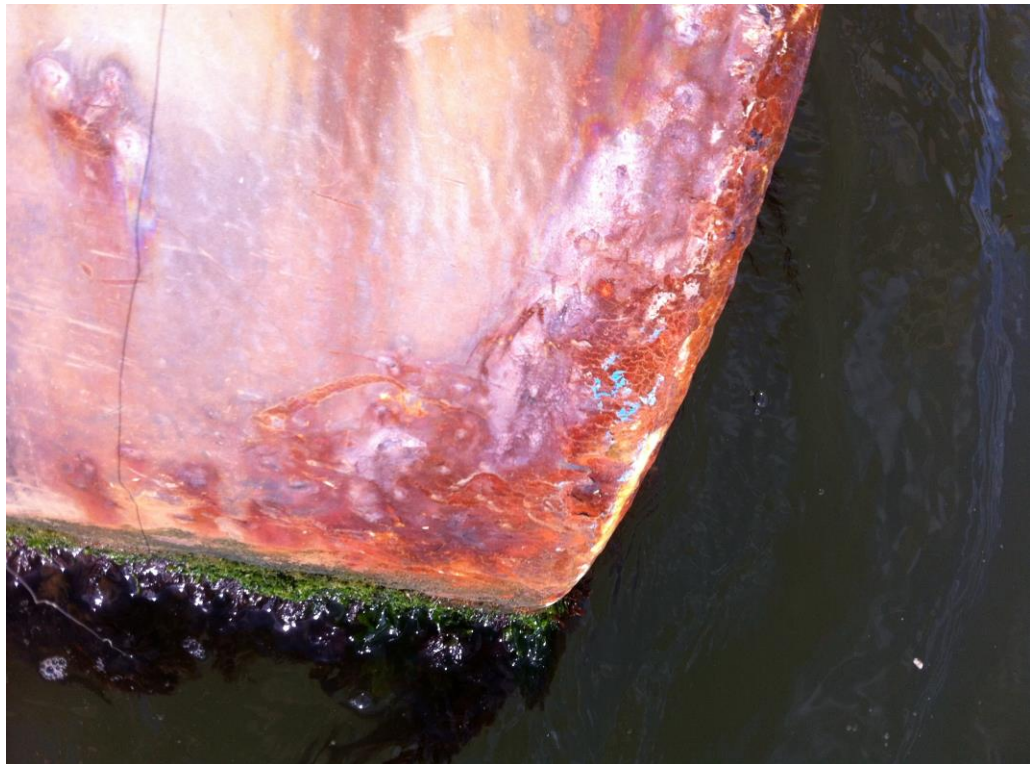
1. It is unknown what the original steel tube thickness was on installation, but based on age and average rate of corrosion (based on previous experience from identical Docking Solutions Landing Pontoon structures) it is assumed original plate thickness to be 8mm. Whilst UT measurements appear very uniform throughout, these readings do not give us the integrity of the welds. It is these points which are areas of concern. (Marked in red on diagram 6.1) Please see photographs below. UT measurements cannot be taken on welds as the surfaces are too corroded and uneven. Further chipping/cleaning is not preferred as this may cause damage/remove sections of weld, potentially leading to flooding and sinking of steel tubes. The end capping welds of all steel tubes were of most concern, whilst some spiral welds also displayed similar corrosion characteristics.

30m Pontoon Outer Tube North - Weld Pitting & Corrosion

7. Two broken cleats were replaced with new (identical) on the upstream outer face of the 30m pontoon section.
8. Recommendation - Carry out full refurbishment of tube sections to extend working lifespan. (Clean, shot blast, weld repairs, marine coatings, cathodic protection system – TMS have recently carried out these same works for another Local Authority)

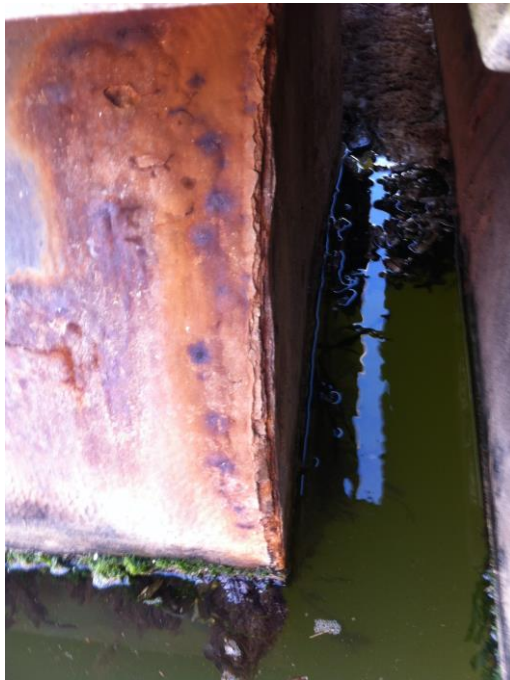
30m Pontoon Outer Tube North
Corrosion & pitting on end welds

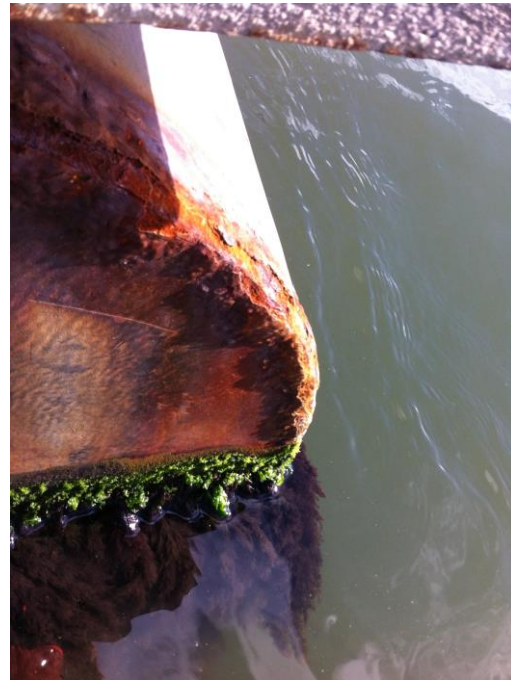
30m pontoon – Outer Tube South - severe

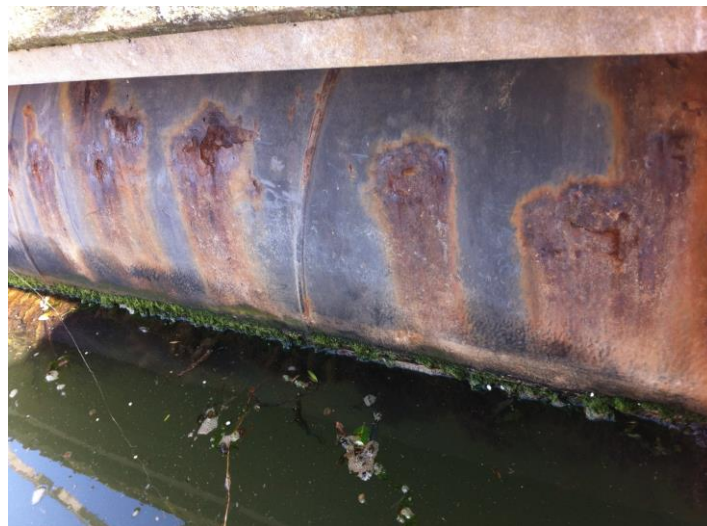
2. Areas of flaky rust were removed, to reveal blackened (illustrating oxidation) pitted steel surfaces which were at times too uneven to allow UT measurements. At these points it must be assumed that the steel thickness is thinner than the uniform 6mm average. (see photograph below).
