# To receive an update on the Guildhall external repairs and redecoration work and consider any actions and associated expenditure.

Report to: Property Maintenance Sub Committee

Date of Report: 20 February.

## 1. Guildhall exterior snagging

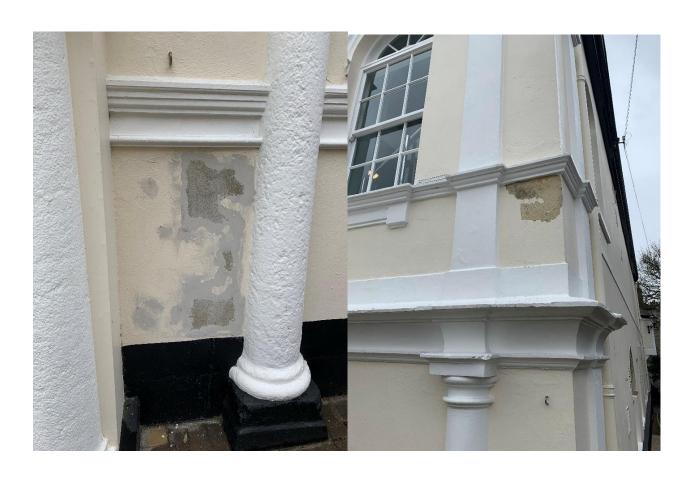
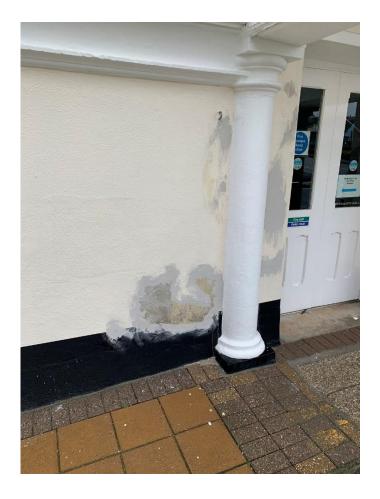
The pictures below show some of the defect work that has started and yet to be finished.

Opening and closing of the windows is causing some issues, Jones Builders is looking into this - there is an element of swelling during warm and cold temperatures due to the material.

Barron Surveying liaised with the appointed contractor Jones Builders to arrange for the defects to be complete at the earliest opportunity – these works started on 5 February 2025.

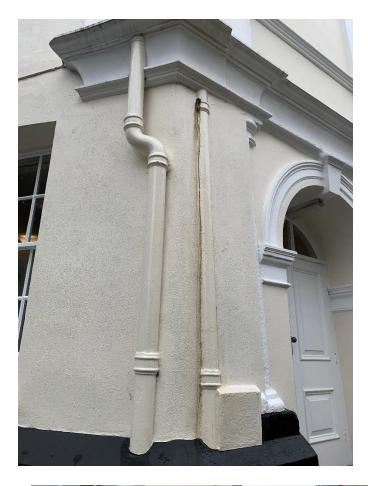
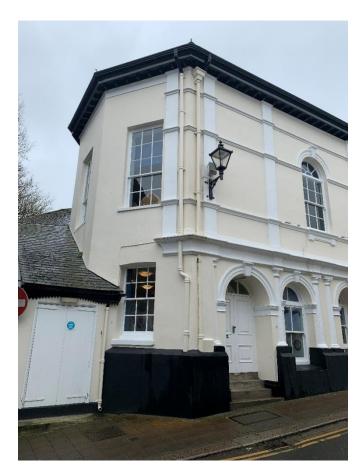
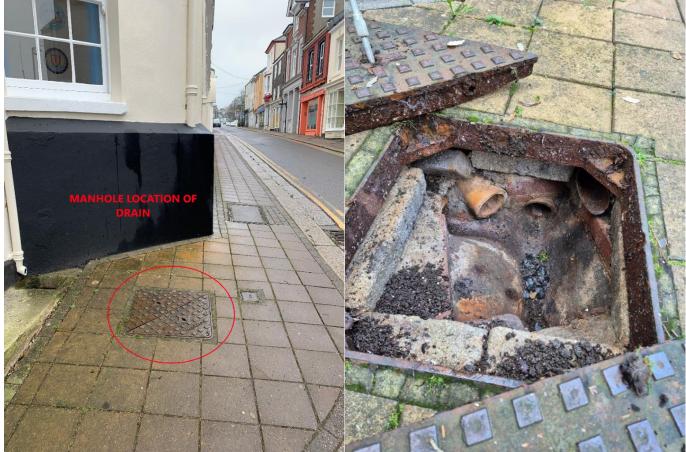
The Guildhall has also suffered from a blocked downpipe located to the top left Fore Street side of the building. See images for reference. This has created rainwater running down the exterior of the wall when it rains heavily. The cast iron downpipe may also be damaged internally, it is partly half buried in the wall. This may have rusted from the inside which could be the reason for the damp showing on the interior wall to the Town Clerks office.

A recent visit by a specialised drain contractor carried out a camera inspection to the drain located in the pavement as above. This has also shown that the downpipe is not working correctly with a potential blockage toward the base of the pipe. On this basis STC have appointed the contractors to dig open the pavement to expose the downpipe so that a camera can then be used to go up the drainpipe to assess any further blockages. Once the blockage has been located, they will then look to either unblock the pipe or to show the interior condition of the pipe along with any other repairs required.

Quoted amount for this part of the work £2,183. There may be additional costs required for any replacement pipe or lining to the downpipe.

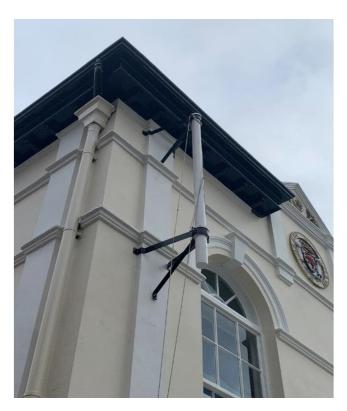
During the recent storm prior to Christmas the wooden flagpole was snapped. We have been working on various options for a new replacement pole. Due to the structure of the old wooden pole and the fixing brackets, this has proven difficult.

We are now in the process of removing the fixing brackets to have them fabricated to take a new 6-meter lightweight pole. This will likely be a fiberglass style for strength, flexibility and reduced noise. The adjusted brackets and refitting will take a little time as they will be sent away for the work.

Once the new brackets are back in place the new pole can be fitted. A delivery time on a new pole is difficult due the supplier's delivery schedule.

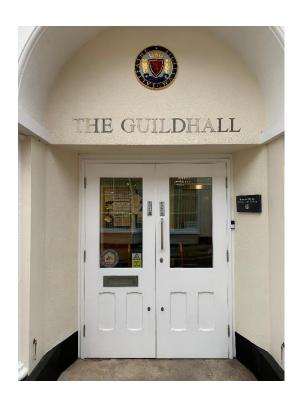
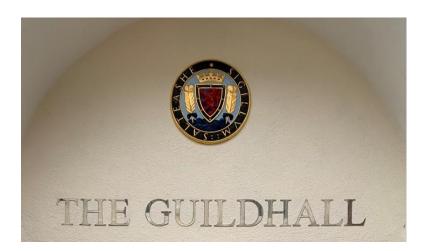
The Town Council mural that sits above the entrance doors to the Guildhall has been renovated and repainted by South West Signs and reinstalled by the Service Delivery Team to its rightful place.
