## APPENDIX A – Cormac’s Structural Engineer comments

Please find below a statement on what I believe is happening in the floor to cause the cracking in the top layer of screed.

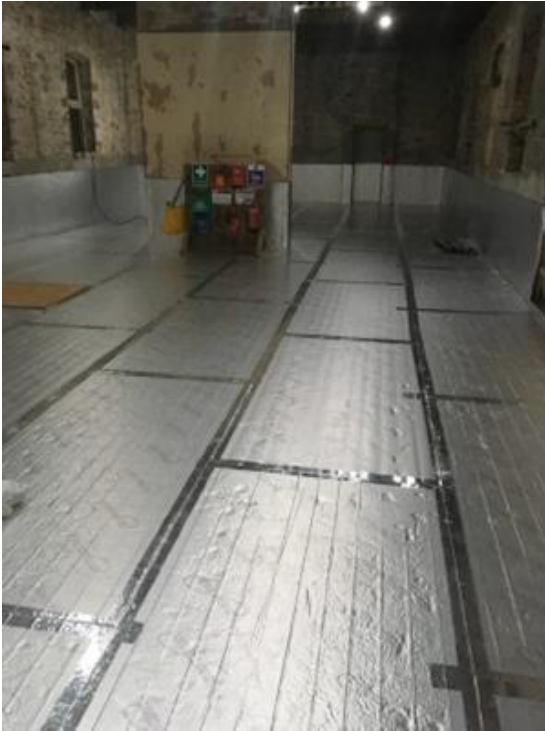
Photo 1

I do not believe that the cracking seen at the surface of Saltash Station floor is due to reflective cracking as a result of anything below the insulation boards or due to the boards themselves as the boards are staggered in the direction across the room and the crack is relatively straight, photos 1 & 4.

My recommendation is to install a straight 10mm deep movement joint in the top layer of screed in the location of the surface crack between the corners of the doormat wells, and where the crack deviates from this line it could be filled with concrete repair grout of a similar colour to the screed. The cracks in the café floor could also be repaired with the concrete repair grout without the need for a movement joint.

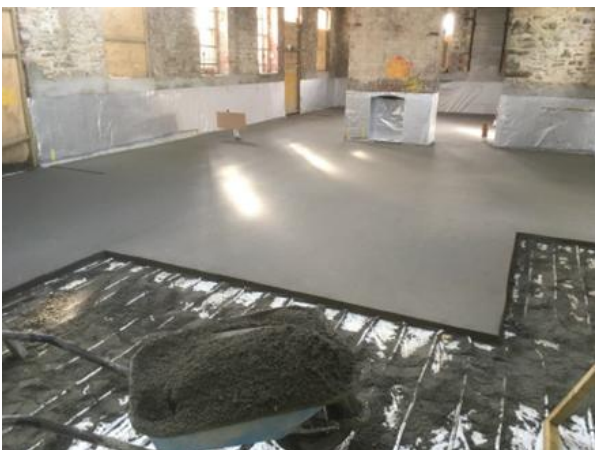
Photo 2

Looking at photo 2, it can be seen that the heating pipes bend almost directly beneath the edge of the screeded bay, it is possible that the edge of the screeded bay would be a weak line in the screed and so if the screed were to shrink a crack would form there. The bends in the heating pipes may restrain the screed around them causing the screed along the line of the bay edge to break up and form a larger crack. The screeding bays probably resulted in the crack in the lower layer of screed, the line of which is shown in photo 3 with tape over it. This tape would have distributed the stress concentration at the crack in the lower screed and prevented a crack along the same line, known as reflective cracking, from forming in the top 10mm layer of screed.

I believe that the crack in the top layer of screed is independent of the crack in the lower screed and that the lower screed does not require any further work.
