CONDITION REPORT AND FORECAST BUDGET COSTS

**VARIOUS BUILDINGS
SALTASH TOWN COUNCIL**

FOR SALTASH TOWN COUNCIL

2025 UPDATE

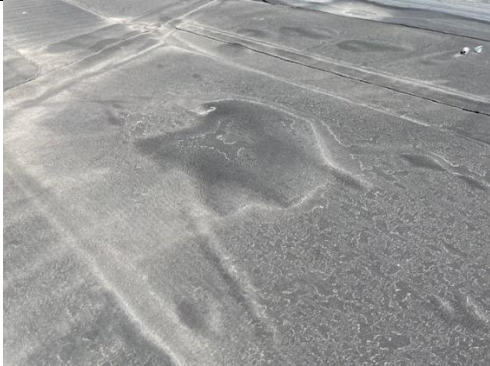
2 – Library Roof – blister due to vapour trapped behind membrane

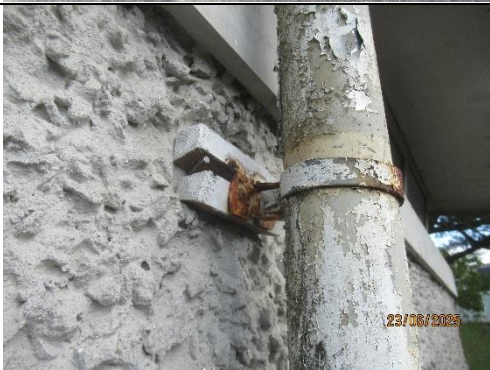
3 – Library rear roof brackets

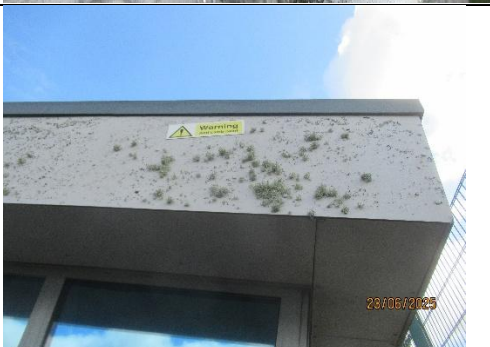
4 – Mossy particle board fascias and soffits

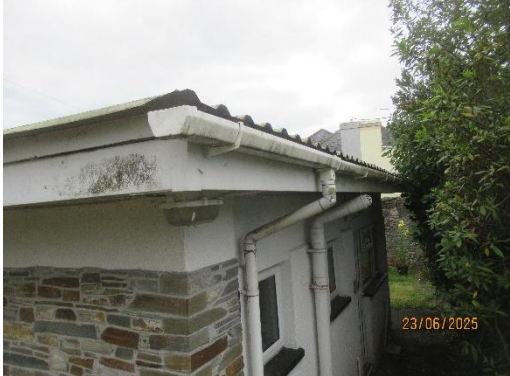
8 – Maurice Huggins Room Gutters

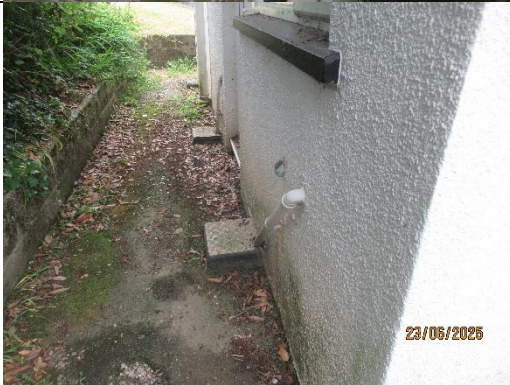
A photograph showing the exterior of a building. The roof has dark tiles and a white gutter. Below the gutter is a wall made of rough-hewn stone. A white downpipe runs vertically down the side of the building. A date stamp '23/06/2025' is visible in the bottom right corner of the photo.
9 – Rendered walls Maurice Huggins Room

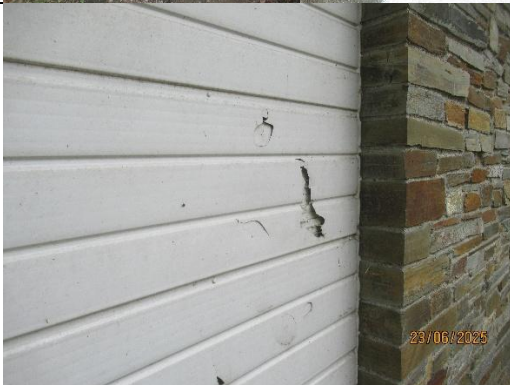
A close-up photograph of a white rendered wall. A white downpipe is attached to the wall. To the left of the wall is a garden path covered with fallen leaves. A date stamp '23/06/2025' is visible in the bottom right corner of the photo.
10 – Cladding board Maurice Huggins Room

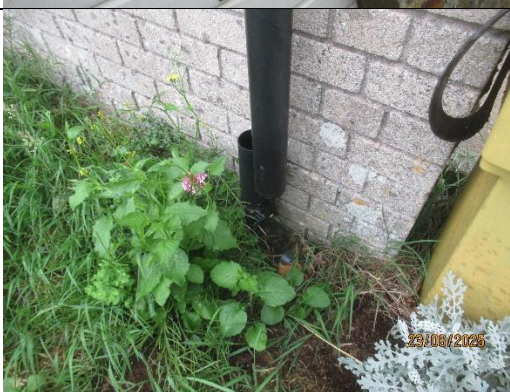
A close-up photograph of white horizontal cladding boards. There is a small hole and some peeling paint on one of the boards. To the right is a corner of a stone wall. A date stamp '23/06/2025' is visible in the bottom right corner of the photo.
11 – Broken downpipe depot garage

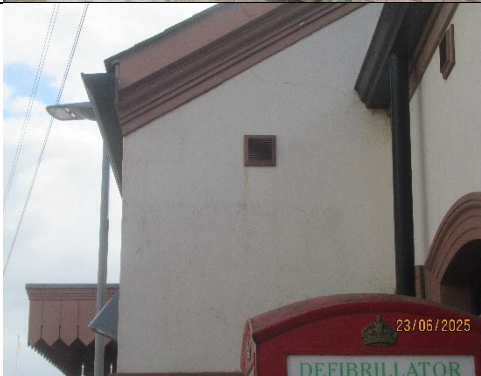
12 – Timber fascia depot garage	  A photograph showing the exterior of a building with a white timber fascia and a black downspout. A date stamp '23/06/2025' is visible in the bottom right corner.
13 – Timber store door depot office	  A photograph of a black timber store door set in a white wall. A blue bin is visible to the right. A date stamp '23/06/2025' is visible in the bottom right corner.
14 – roller door depot	  A photograph of a green roller door on a brick wall. A flower basket is hanging above the door. A date stamp '23/06/2025' is visible in the bottom right corner.
15 – Isambard House wall cracking

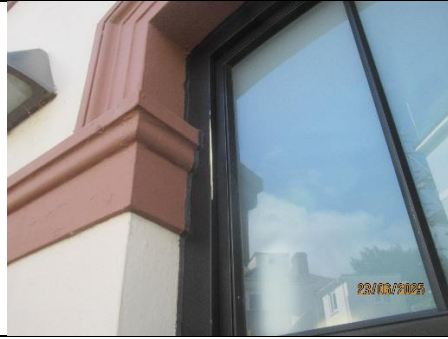
16 – Timber window touch ups Isambard House
