## CONDITION REPORT AND FORECAST BUDGET COSTS

**VARIOUS BUILDINGS  
SALTASH TOWN COUNCIL**

**2025 UPDATE**

<b>Prepared By: James M Barron MRICS</b>	<b>Date: 20 June 2025</b>	<b>Rev:</b>
<b>Checked By:</b>

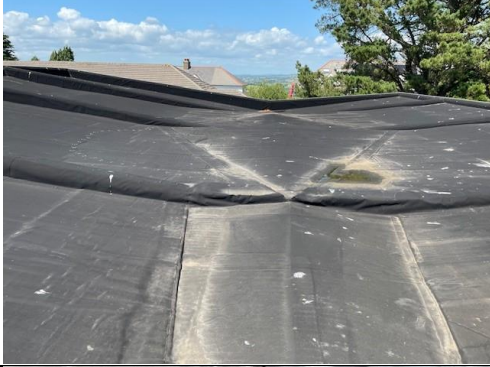
PHOTO NUMBER	PHOTOGRAPH
1 – Library Roof

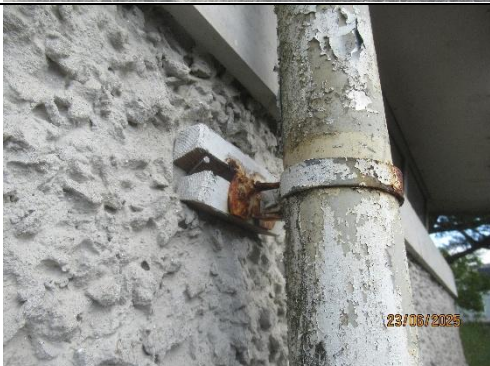
3 – Library rear roof brackets

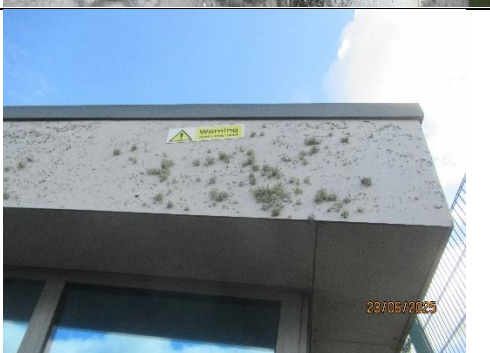
4 – Mossy particle board fascias and soffits

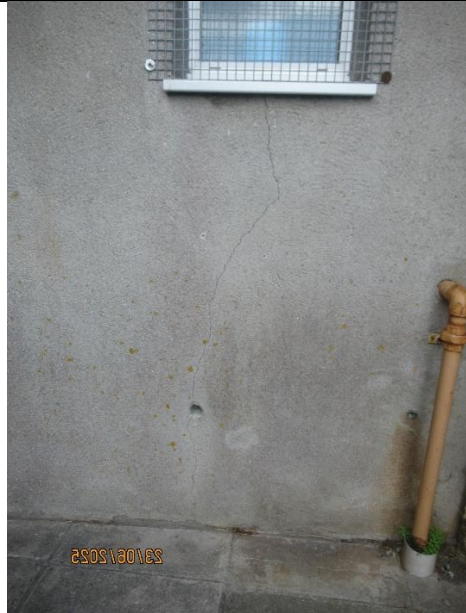
5 – crack library wall

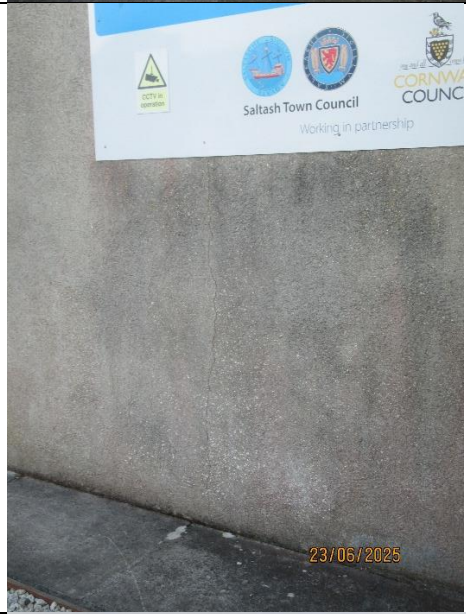
6 – Crack Library wall

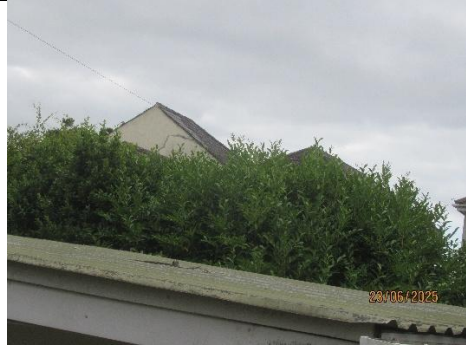
7 – Maurice Huggins Room Roof

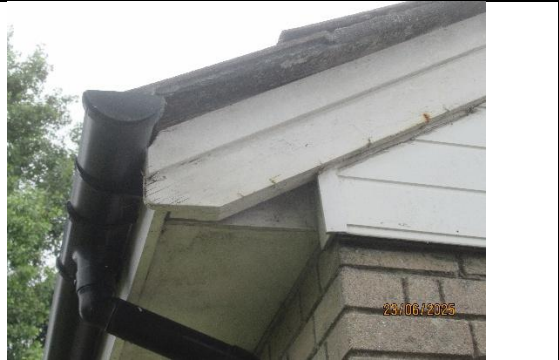
12 – Timber fascia depot garage

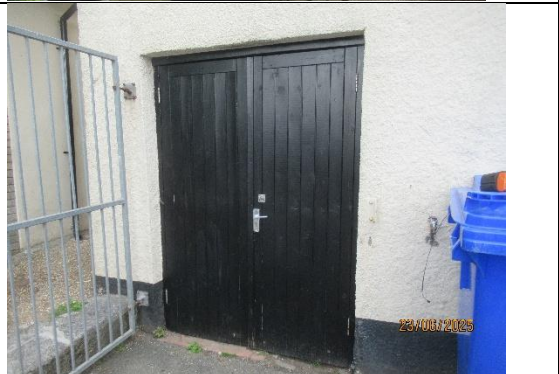
13 – Timber store door depot office

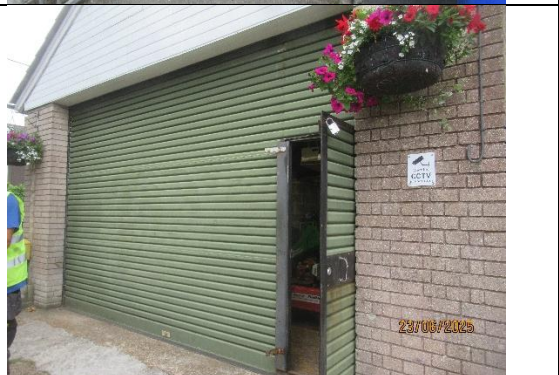
14 – roller door depot

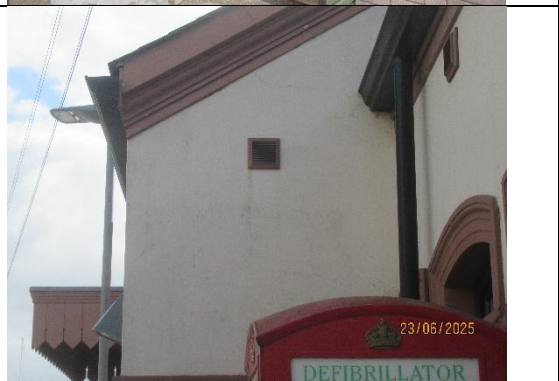
15 – Isambard House wall cracking
