Schedule of Condition

Windows and Doors at Saltash Library

9th November 2022

6.0 Schedule of Condition

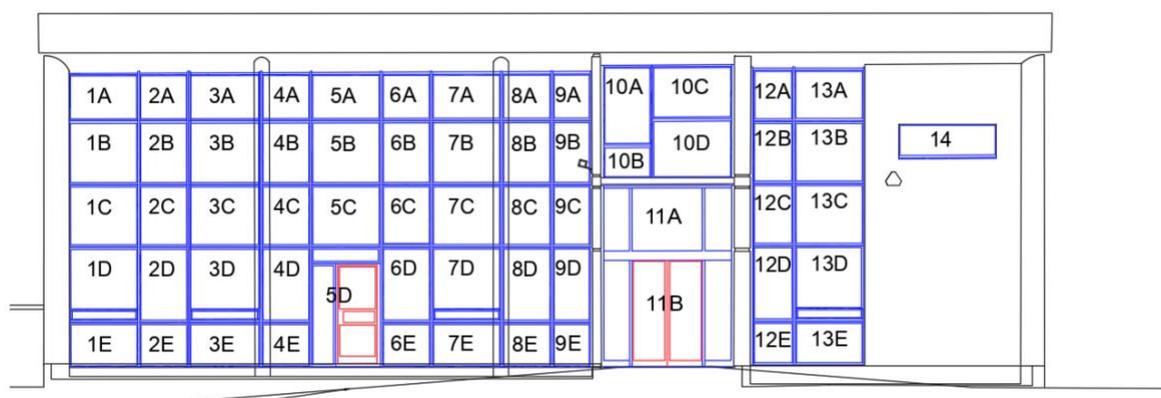
Figure 1: West elevation

The glazed curtain walling to the principal elevation is formed with slender aluminium frames inserted between vertical steel columns. Set forward from the glazing are 2 shuttered concrete elliptical piers. Column 1 to the north side abuts the projecting roughcast rendered masonry wall externally, and a rough plastered internal wall. The external reveal shows signs of disturbance to the render, where presumably repairs have been made in the past. There is a bullnosed hardwood timber lining forming the external reveal, butted directly against the fenestration. This showed signs of minor rot at its base but was otherwise intact. The lining is painted in white, and the paint is heavily peeling throughout. The lining has been formed in three principal sections with diagonal scarf joints, and would be easy to repair in situ. The southern reveal against column 9 is formed with a similar painted hardwood lining set against the shuttered concrete wall. The timber linings could be retained but will require low level scarf repair and redecoration.

The columns of glazing are divided with box sectional steel columns running the full height from the concrete slab base up to the cast concrete roof structure. The steel appears to insert into the concrete top and bottom and performs an important structural role in supporting the curtain walling. The steel columns show signs of corrosion through white paint, although were

The glazed screens are primarily double glazed, although the original installation would have been single glazed. Slim line double glazed panels have been inserted to the majority of the original windows, presumably by Cornwall Council in the latter part of the 20th century. This has been achieved by removing the L section aluminium beading and either cutting down or replacing with lower profile beading. The reduced beading then accommodates the slightly thicker, slim line double-glazed units, which are held in place with a mixture of putties, mastics, resins and mechanical fixings. The fixtures are all heavily degraded and prone to draughts, with many of the double-glazed units misted over.

The frames are also prone to flex in high winds and do not sit square between the columns in some cases. This will lead to draughts and water ingress, both of which have been reported by the caretakers of the building. The structural integrity of the framing is considered to have been comprised by the replacement glazing, which uses more slender beads. Furthermore the external surfaces of the aluminium frames are beginning to corrode. Progressive corrosion to the casements can be expected over the coming years, which will eventually lead to complete failure of the window systems.

There are several opening windows including centre pivot casements at high level on the west elevation controlled by a cable winding system. There are also low level top hung casements to the west screen. The hinges, catches and winding systems are all largely defective.

There is an entrance door to the centre of the west glazed screening. This is considered to be an original fixture, although again the original single glazing has been replaced with slim line double glazed units, by altering the depth of the beading in the same way as described above. The hinges to the door have broken in the past and been crudely replaced with a new set of surface mounted hinges. The door could not be opened at the time of inspection and the location of the key is not known. The door shows the same level of corrosion as the surrounding window casements. The glazed curtain wall is considered to have reached the end of its useful life.

generally considered serviceable. These will require removal of loose paint and redecoration in an appropriate galvanising paint.

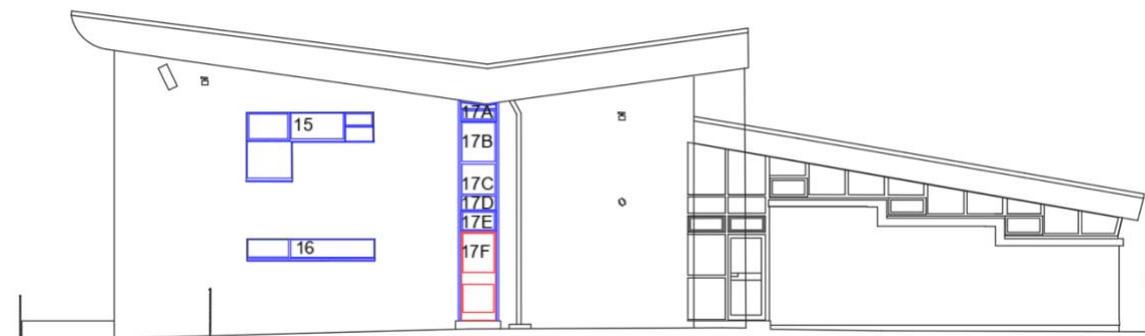
Figure 2: South elevation

The projecting bays to the north and south walls are set between the roughcast rendered walls with hardwood timber linings (see figures 2 & 4). The glazed casements are divided with steel box sectional columns, which are fixed to the concrete upper roof structures, although do not penetrate the lower level concrete slabs. These are painted white with flaking paint over galvanised steel, matching those to the principal curtain walling. Improvements to the columns are recommended to include brushing back loose paint and corrosion and decorating with galvanising paint.

The glazing to the bays is also formed in the same configuration as the principal curtain walling, with a mixture of original single and replacement double glazing. Again the glazing beads have been replaced with reduced section beads to double glazed replacements.

It is noted that the south bay comprises mainly the original single glazing, with only some areas replaced with double glazing. There is an entrance door at ground floor level to the south bay, which matches the description of the principal elevation door, and was operational.

The glazed bays display similar levels of degradation to the principal curtain walling, with corrosion to casements, seized openers, degrading putties and beads and misted double glazing. Again these are considered to have reached the end of their useful lifespans.

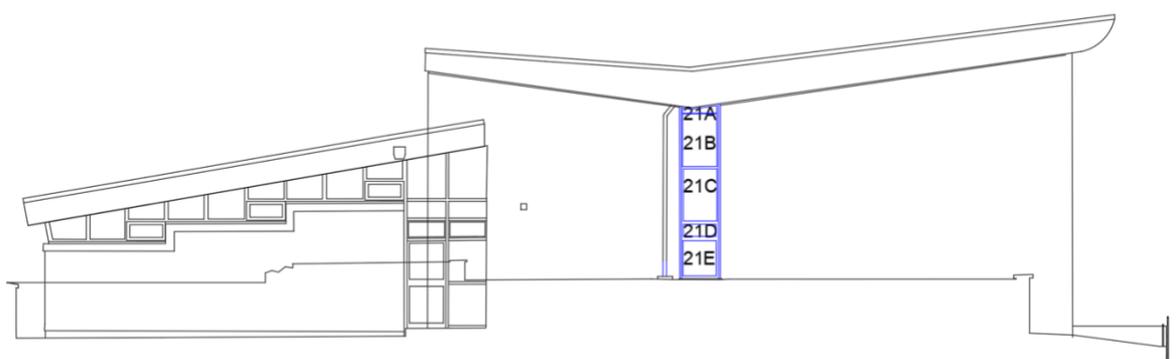
Figure 4: North elevation

The north bay is intersected by higher ground levels at the north end of the building, where the external ground rises above internal floors with a retaining wall built into the structure.

It is noted that all casements within the outward faces of the bays are beaded externally with glazing set back into the frames in a reverse configuration when compared to other windows throughout the building. This has presumably occurred due to difficulties in inserting the glazing internally within the bay window during construction. The external beading presents a security risk, where glazing could potentially be removed externally without significant damage or noise.

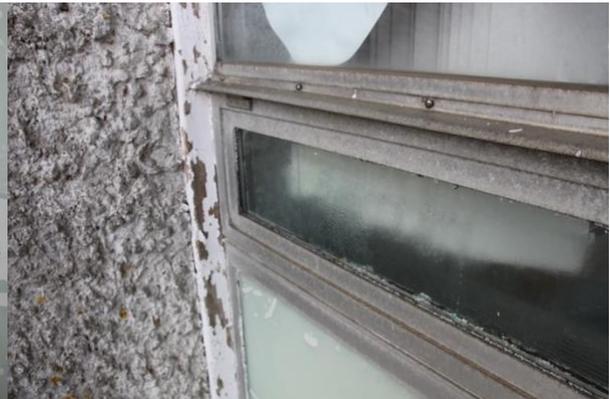
Window 1D

Ref	Description	Condition	Recommended Repairs
1A	Aluminium framed casement with centre pivot opener controlled with cable wound mechanism to south reveal. Slim line double glazing inserted and sealed with putty.	Opening casement seized shut. Corrosion to external surfaces of frame. Double glazing misted.	Replace casement, glazing and opening mechanism.
1B	Aluminium framed fixed casement with slim line double glazing inserted and sealed with putty.	Corrosion to external surfaces of frame. Double glazing misted.	Replace casement and glazing.
1C	Aluminium framed fixed casement with slim line double glazing inserted and sealed with putty.	Corrosion to external surfaces of frame. Glazing putty degrading.	Replace casement and glazing.
1D	Aluminium framed split casement with a transom at low level and top hinged opener to base. Slim line double glazing inserted and sealed with silicone mastic.	Corrosion to external surfaces of frame. Hinges and catch to opener stiff but operational. Both panes of glazing misted over.	Replace casement and glazing.

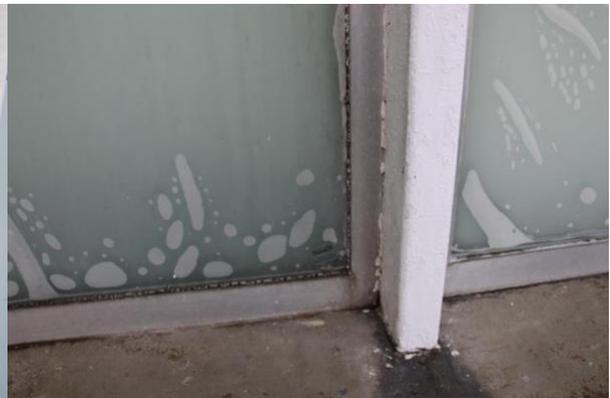
Window 2E

2E	Aluminium framed fixed casement with slim line double glazing inserted and sealed with putty. Banafix window safety film fitted externally.	Corrosion to external surfaces of frame. Double glazing misted. Glazing putty degrading. Window film bubbled.	Replace casement and glazing.
3A	Aluminium framed casement with centre pivot opener controlled with cable wound mechanism to south reveal. Slim line double glazing inserted and sealed with putty.	Opening casement seized shut. Corrosion to external surfaces of frame.	Replace casement, glazing and opening mechanism.
3B	Aluminium framed fixed casement with slim line double glazing inserted and sealed with putty.	Corrosion to external surfaces of frame. Double glazing misted.	Replace casement and glazing.
3C	Aluminium framed fixed casement with slim line double glazing inserted and sealed with putty.	Corrosion to external surfaces of frame. Double glazing misted.	Replace casement and glazing.

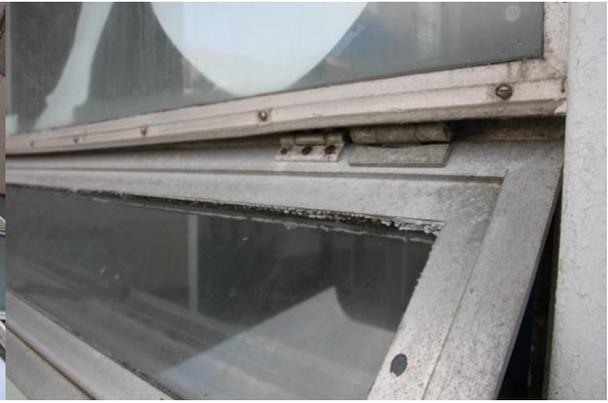
Window 3D

3D	Aluminium framed split casement with a transom at low level and top hinged opener to base. Slim line double glazing inserted and sealed with silicone mastic to fixed pane and putty to opener.	Corrosion to external surfaces of frame. Hinges and catch to opener stiff but operational. Hinges crudely replaced with surface mounted fittings. Both panes of glazing misted over.	Replace casement and glazing.
3E	Aluminium framed fixed casement with slim line double glazing inserted and sealed with putty. Banafix window safety film fitted externally.	Corrosion to external surfaces of frame. Double glazing misted. Glazing putty degrading. Window film bubbled.	Replace casement and glazing.
4A	Aluminium framed fixed casement with slim line double glazing inserted and sealed with putty.	Corrosion to external surfaces of frame. Glazing putty degrading.	Replace casement and glazing.
4B	Aluminium framed fixed casement with slim line double glazing inserted and sealed with putty.	Corrosion to external surfaces of frame. Glazing putty degrading.	Replace casement and glazing.

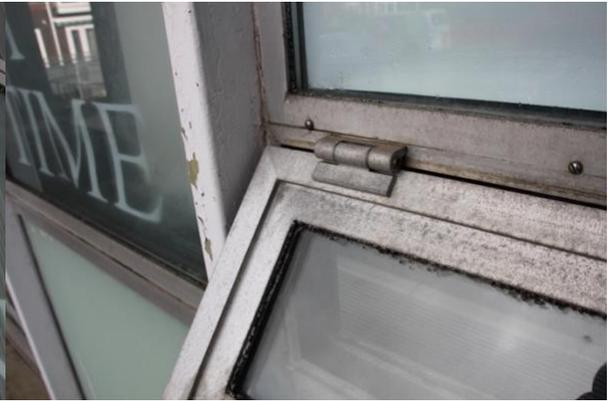
Window 7D

7D	Aluminium framed split casement with a transom at low level and top hinged opener to base. Slim line double glazing inserted and sealed with silicone mastic to fixed pane and putty to opener.	Corrosion to external surfaces of frame. Hinges and catch to opener stiff but operational. Both panes of glazing misted over.	Replace casement and glazing.
7E	Aluminium framed fixed casement with slim line double glazing inserted and sealed with putty. Banafix window safety film fitted externally.	Corrosion to external surfaces of frame. Double glazing misted. Glazing putty degrading. Window film bubbled.	Replace casement and glazing.
8A	Aluminium framed fixed casement with slim line double glazing inserted and sealed with putty.	Corrosion to external surfaces of frame. Glazing putty degrading.	Replace casement and glazing.
8B	Aluminium framed fixed casement with slim line double glazing inserted and sealed with putty.	Corrosion to external surfaces of frame. Glazing putty degrading.	Replace casement and glazing.

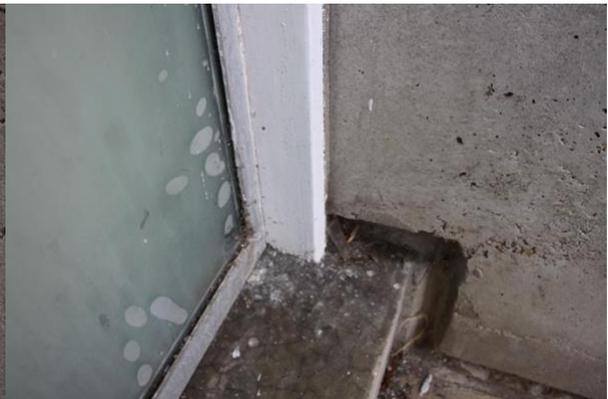
Window 9E

9E	Aluminium framed fixed casement with slim line double glazing inserted and sealed with putty. Banafix window safety film fitted externally.	Corrosion to external surfaces of frame. Double glazing misted. Glazing putty degrading. Window film bubbled.	Replace casement and glazing.
10A	Aluminium framed fixed casement with slim line double glazing inserted and sealed with putty.	Corrosion to external surfaces of frame. Glazing putty degrading.	Replace casement and glazing.
10B	Aluminium framed fixed casement with slim line double glazing inserted and sealed with putty.	Corrosion to external surfaces of frame. Glazing putty degrading.	Replace casement and glazing.
10C	Aluminium framed fixed casement with slim line double glazing inserted and sealed with putty.	Corrosion to external surfaces of frame. Glazing putty degrading.	Replace casement and glazing.
10D	Aluminium framed fixed casement with slim line double glazing inserted and sealed with putty.	Corrosion to external surfaces of frame. Glazing putty degrading. Double glazing misted.	Replace casement and glazing.

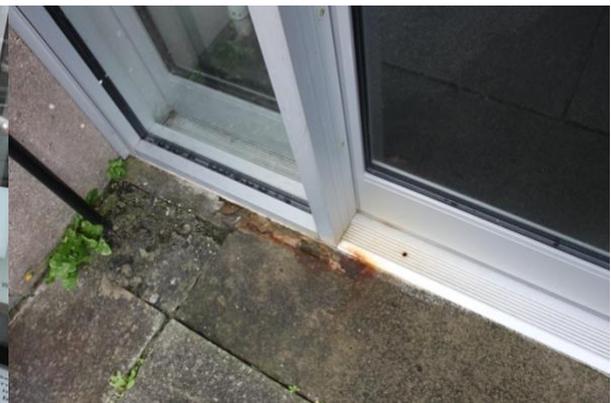
Door 11B

11B	Modern powder coated aluminium symmetrical frames with central automatic opening sliding door. Fitted with single glazed panels in rubber seals.	Intact and serviceable.	Clean and renew seals within 5 years. Ensure opening mechanisms and runners are regularly lubricated and serviced.
12A	Aluminium framed fixed casement with slim line double glazing inserted and sealed with putty.	Corrosion to external surfaces of frame. Glazing putty degrading.	Replace casement and glazing.
12B	Aluminium framed fixed casement with slim line double glazing inserted and sealed with putty.	Corrosion to external surfaces of frame. Glazing putty degrading.	Replace casement and glazing.
12C	Aluminium framed fixed casement with slim line double glazing inserted and sealed with putty.	Corrosion to external surfaces of frame. Glazing putty degrading.	Replace casement and glazing.
12D	Aluminium framed fixed casement with slim line double glazing inserted and sealed with putty.	Corrosion to external surfaces of frame. Glazing putty degrading. Double glazing misted.	Replace casement and glazing.

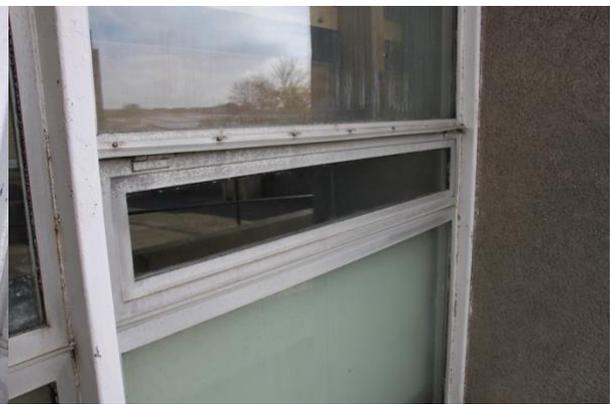
Window 13D

13D	Aluminium framed split casement with a transom at low level and top hinged opener to base. Slim line double glazing inserted and sealed with putty.	Corrosion to external surfaces of frame. Hinges and catch to opener seized shut. Both panes of glazing misted over.	Replace casement and glazing.
13E	Aluminium framed fixed casement with slim line double glazing inserted and sealed with putty.	Corrosion to external surfaces of frame. Glazing putty degrading. Double glazing misted.	Replace casement and glazing.

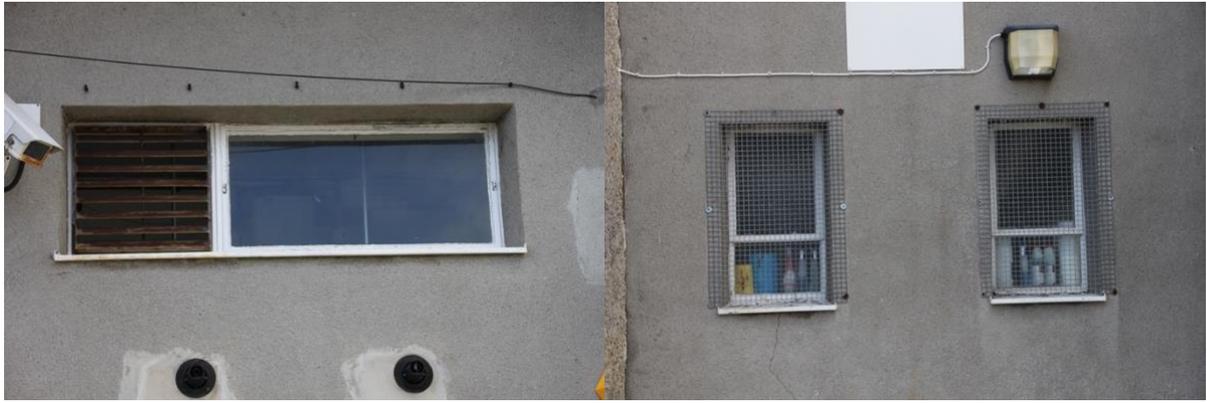
Window 18

Ref	Description	Condition	Recommended Repairs
18	First floor asymmetric horizontally orientated steel Crittall window with single glazing. The southern light has been replaced with a steel louvre to provide continuous ventilation to the boiler room internally. The adjacent light to the north is a centrally hinged hopper with catch. Painted white and set in deep reveals.	Window intact but paintwork degrading. Hinges and catches to stiff but serviceable. Louvres basic but serviceable.	Ensure decorations are renewed on a 3-4 year cycle. Ease and lubricate hinges and catches.
19	Steel Crittall window with obscure single glazing lighting the WC on the ground floor. Top hung opener with a modern lock internally. External galvanised steel security grill secured to the external wall.	Window intact but paintwork degrading. Hinges and catches to stiff but serviceable.	Ensure decorations are renewed on a 3-4 year cycle. Ease and lubricate hinges and catches.

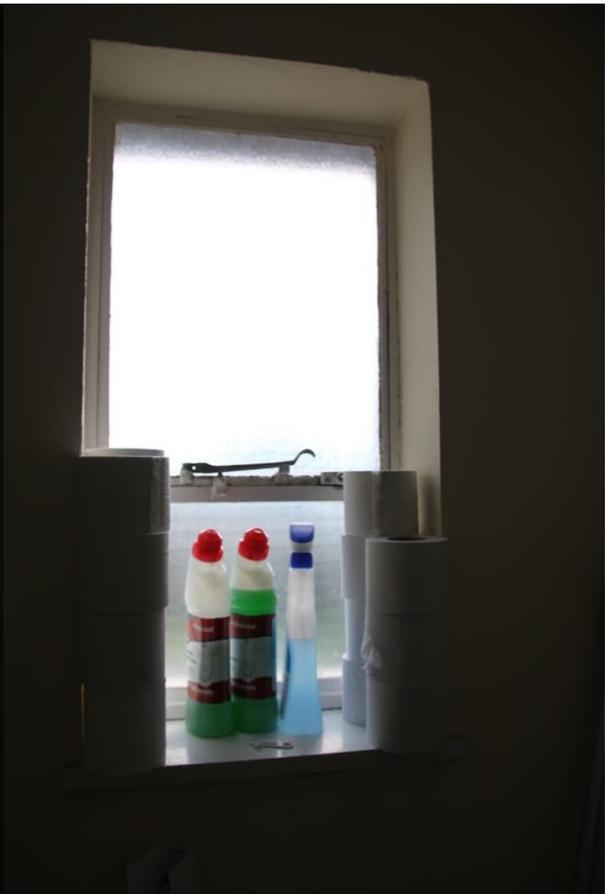
Window 20

20	Steel Crittall window with obscure single glazing lighting the WC on the ground floor. Top hung opener with a modern lock internally. External galvanised steel security grill secured to the external wall.	Window intact but paintwork degrading. Hinges and catches to stiff but serviceable.	Ensure decorations are renewed on a 3-4 year cycle. Ease and lubricate hinges and catches.
