BUILDING SURVEY REPORT

**Victoria Gardens
Callington Road
Saltash
PL12 4DL**

March 2018

RE: VICTORIA GARDENS, CALLINGTON ROAD, SALTASH

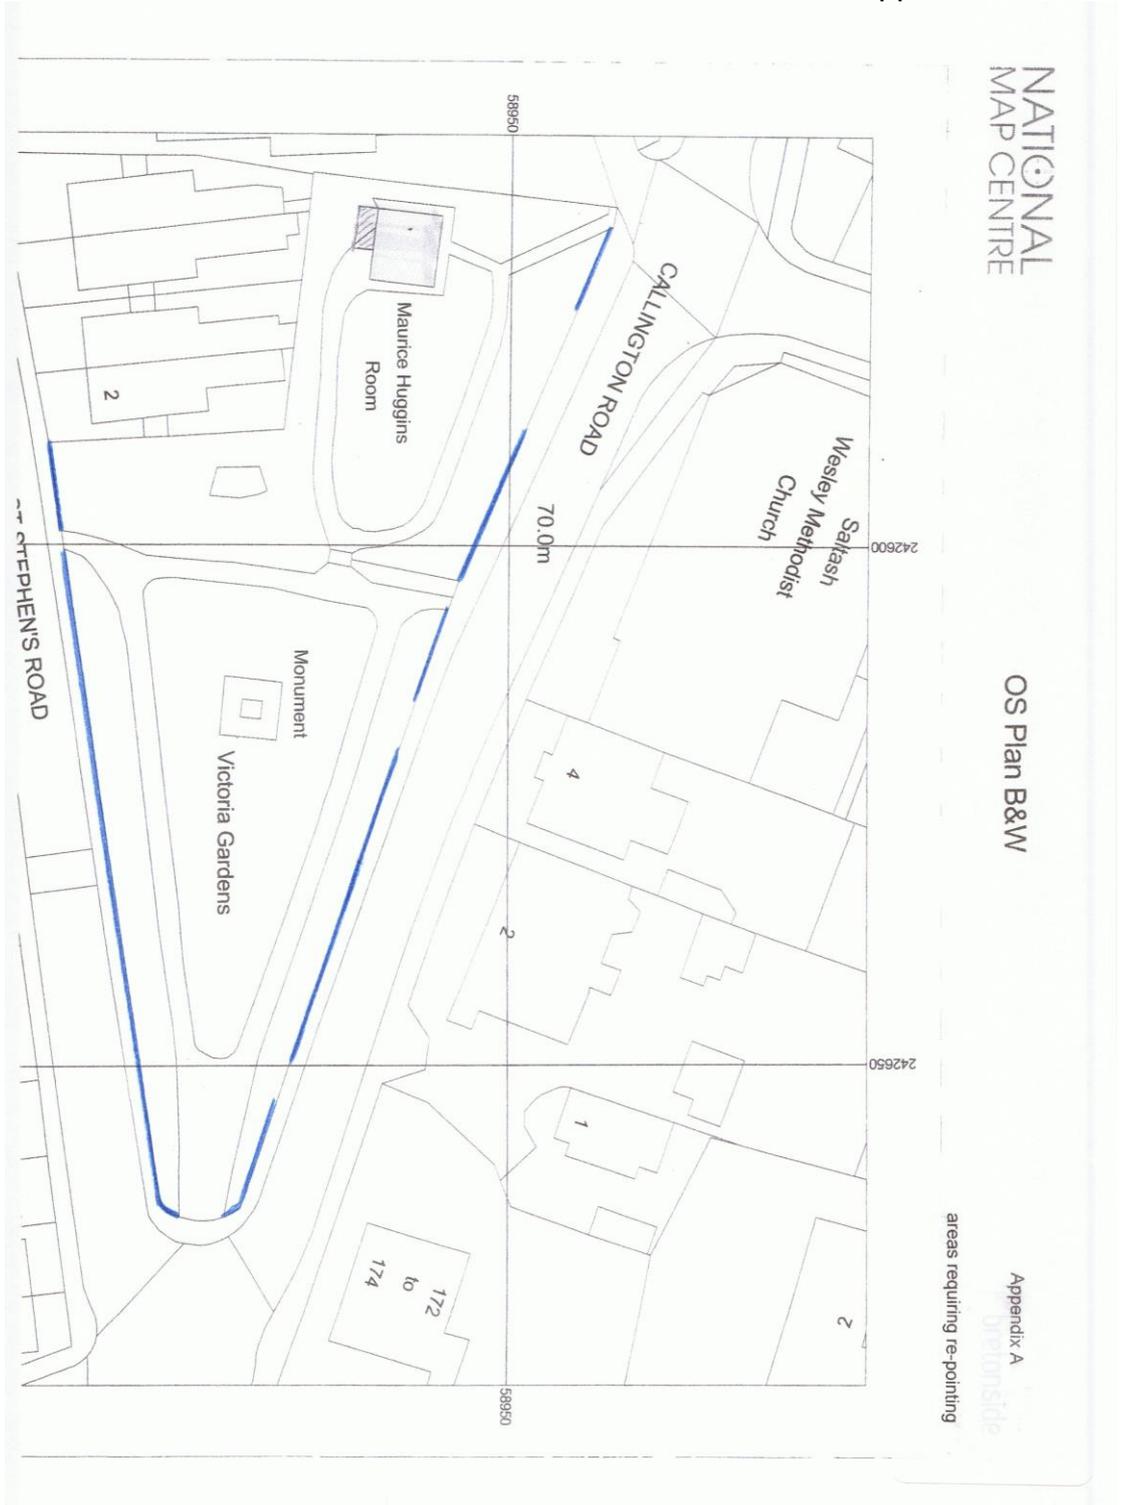
appendix A

There are minor areas of pointing to various sections of the walls – see Appendix A – and these defects are encouraged by weed growth in the walls.

I recommend that weeds be removed, defective areas of pointing raked out and the masonry re-pointed with a lime-based mortar.

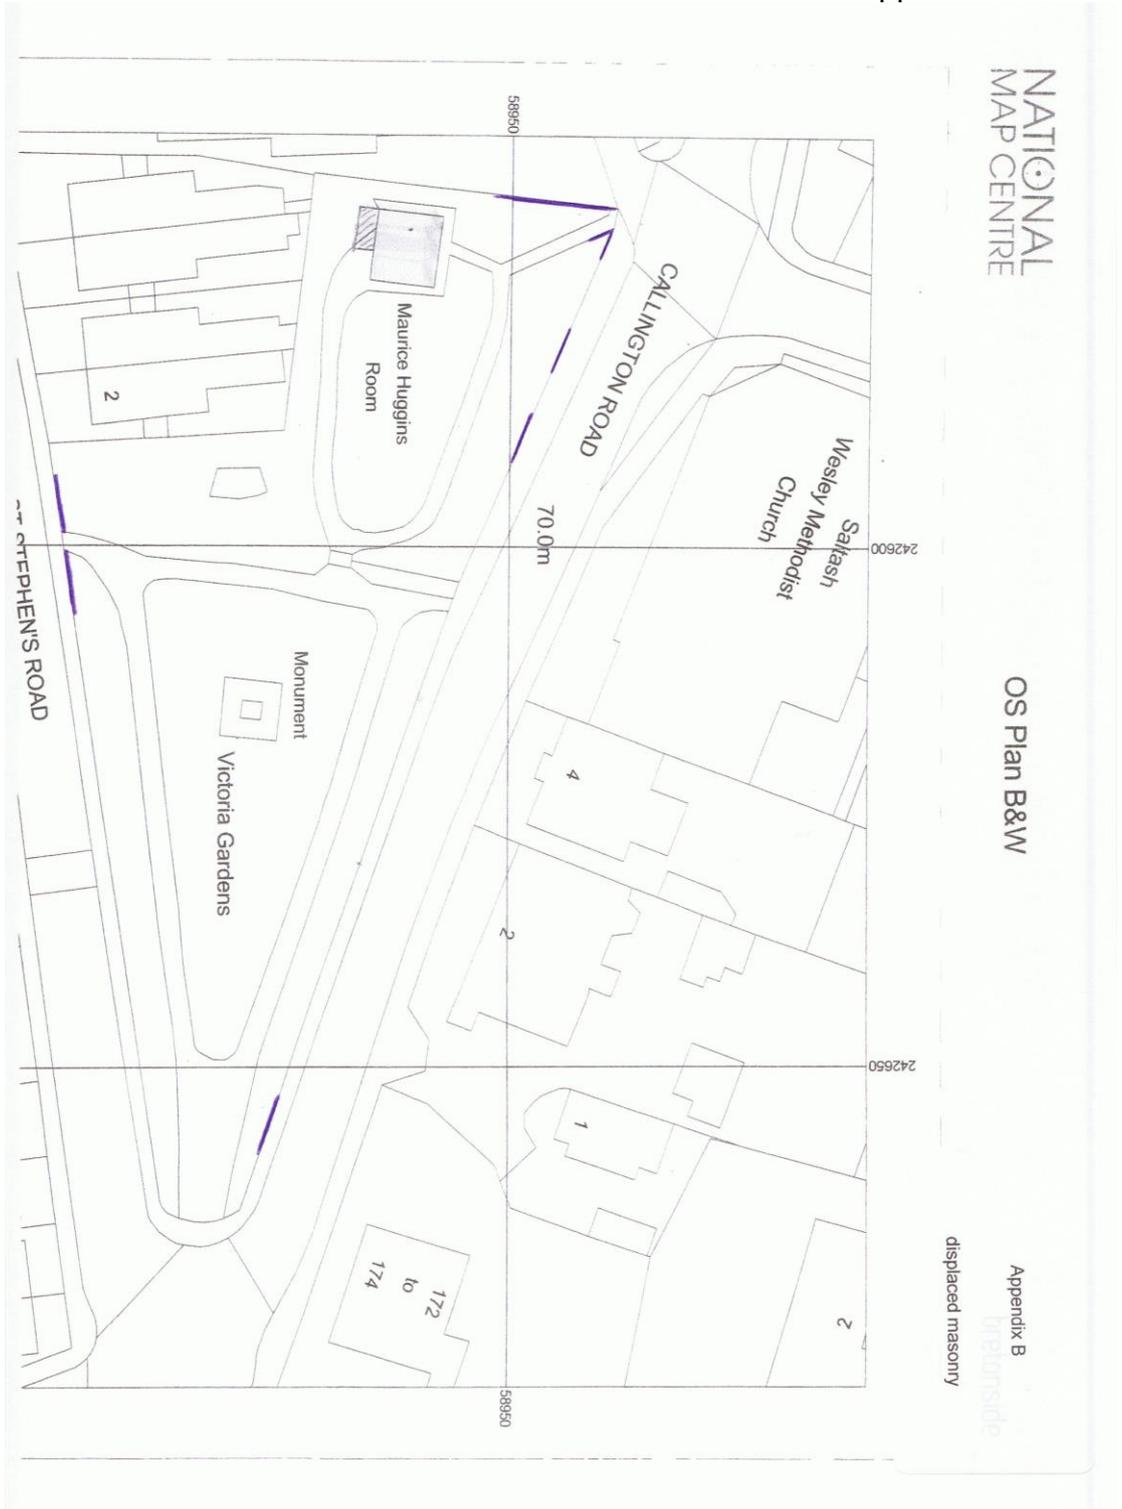
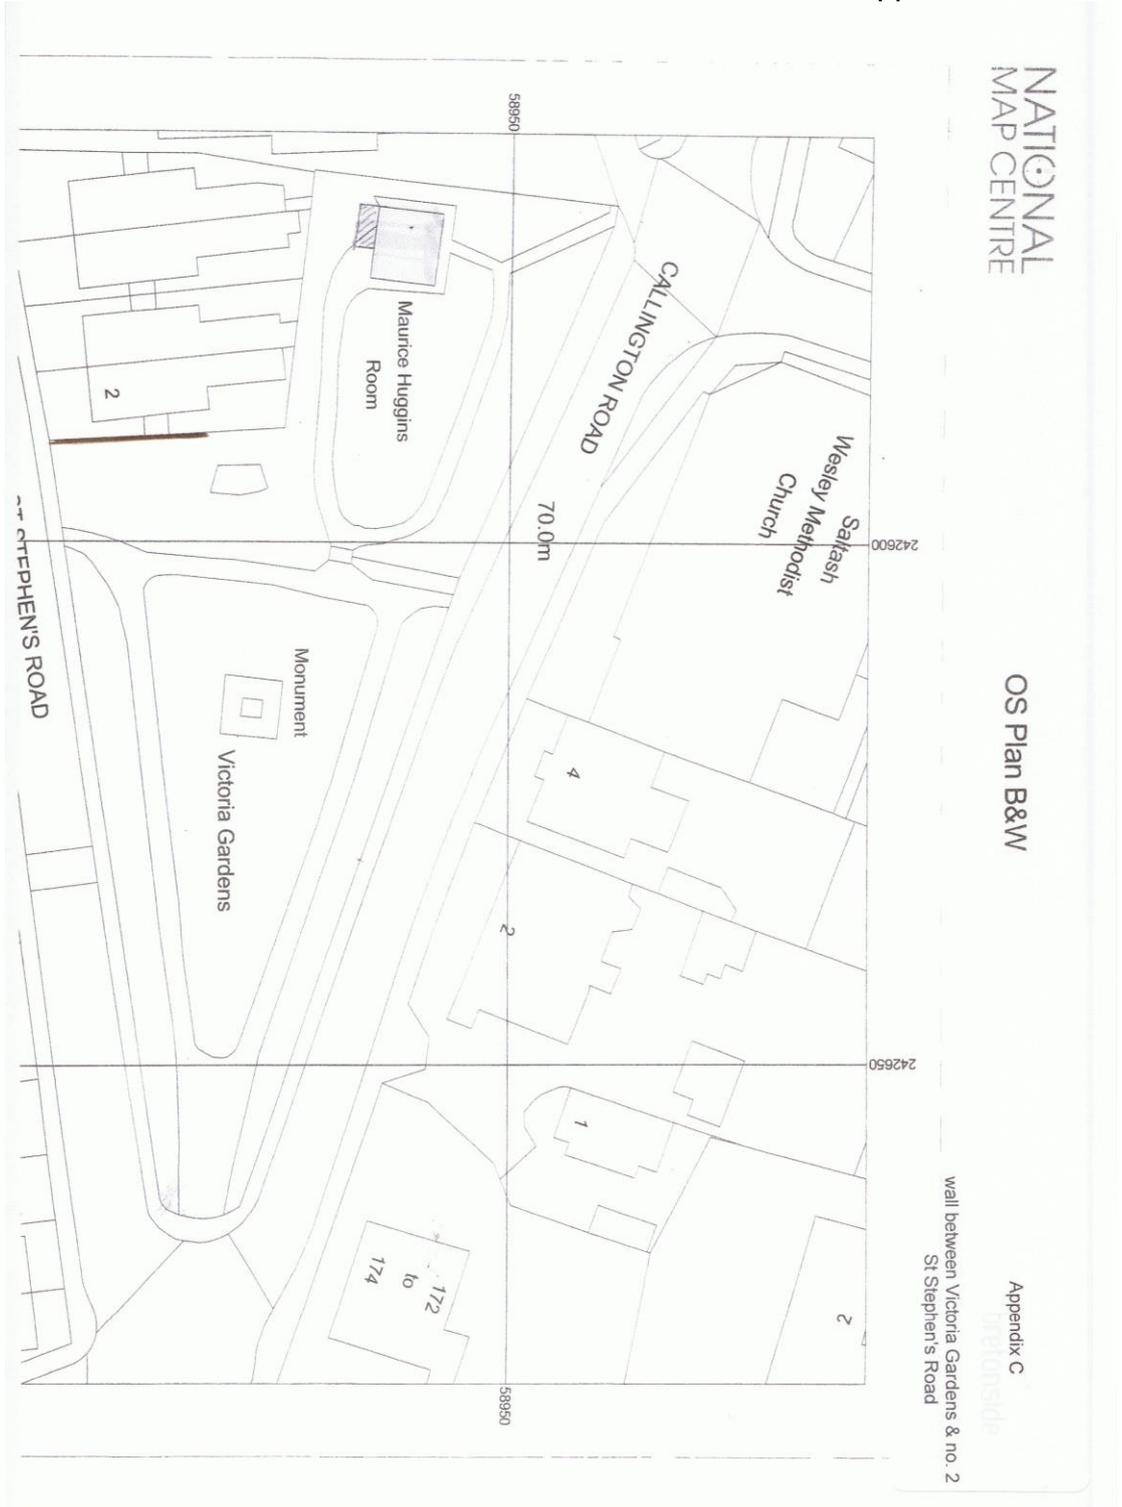
appendix B

There are a number of areas where displacement of individual stones has taken place to masonry to the north boundary wall – see Appendix B.

This is most evidenced at the lower end of the north boundary where an *Araucaria Araucana* tree (commonly known as a 'Monkey Puzzle' tree) has been left to its own devices and has spread. These trees will grow to heights in excess of 12 metres with an 8 metre spread over a long period of time and it is likely that this particular specimen was planted when the Gardens were originally laid out.

There is evidence of settlement around the top gate off Callington Road and also some minor damage to the dwarf masonry walls leading towards the Maurice Huggins Room – see Appendix B. These areas require some very minor reconstruction work.

Towards the upper end of the south boundary the wall is out of plumb with the wall leaning towards the footpath by up to 5 degrees over the height of the wall - see appendix B. This movement has occurred over a long period of time and cannot be prevented from continuing unless the back of the wall is excavated, pressure removed, and the wall taken down and rebuilt incorporating drainage and weep holes. I do not, however, consider this to be a priority at this time especially as masonry is in sound condition but regular monitoring is advised and should the wall deteriorate or become unstable rebuilding will have to be considered.

The displacement will continue if the tree is to stay in-situ. To prevent further deterioration of the wall, without removal of the tree, I suggest stainless steel strapping of the wall.

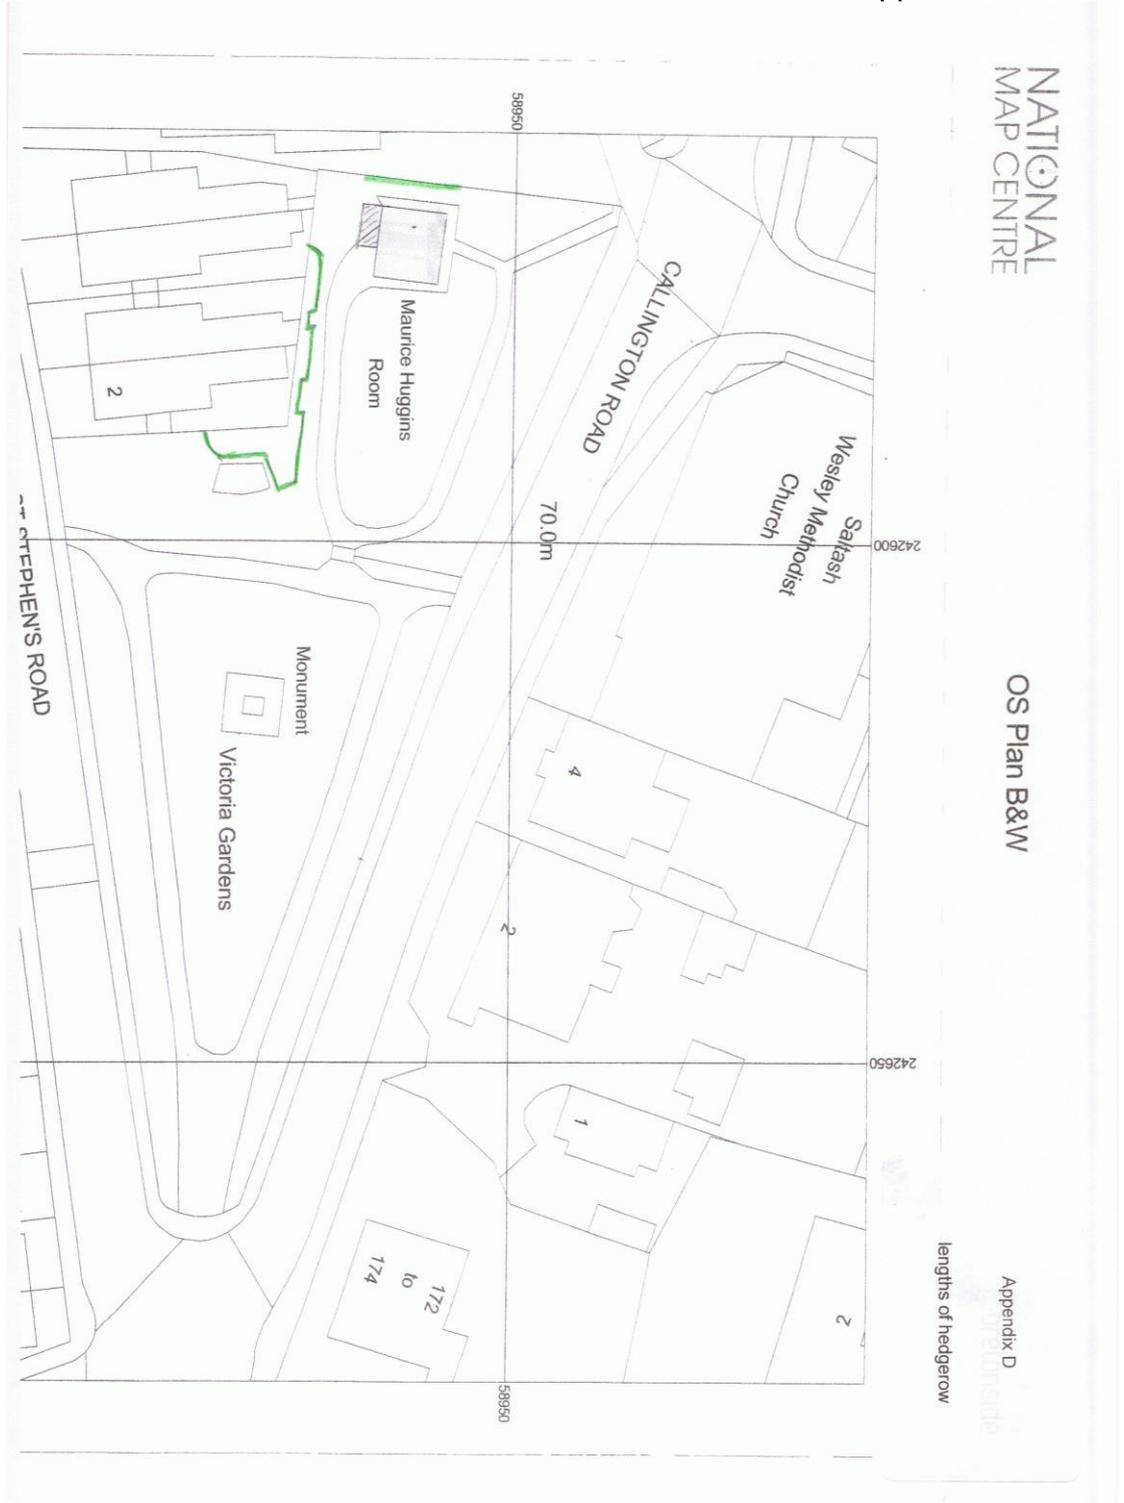
The section of wall between Victoria Gardens and no 2 St Stephen's Road – see Appendix C – is covered in ivy and other vegetation and can only be seen clearly from the private garden to no. 2 St Stephen's Road. This is, in effect, a party structure between the Gardens and no. 2 St Stephen's Road. From the limited inspection possible the wall appears sound. There follows a length of hedge approximately 2m- 3m in front of the wall comprising a mix of shrubs but primarily *Salix*, *Bay*, *Blackthorn* and *Ivy* see appendix D

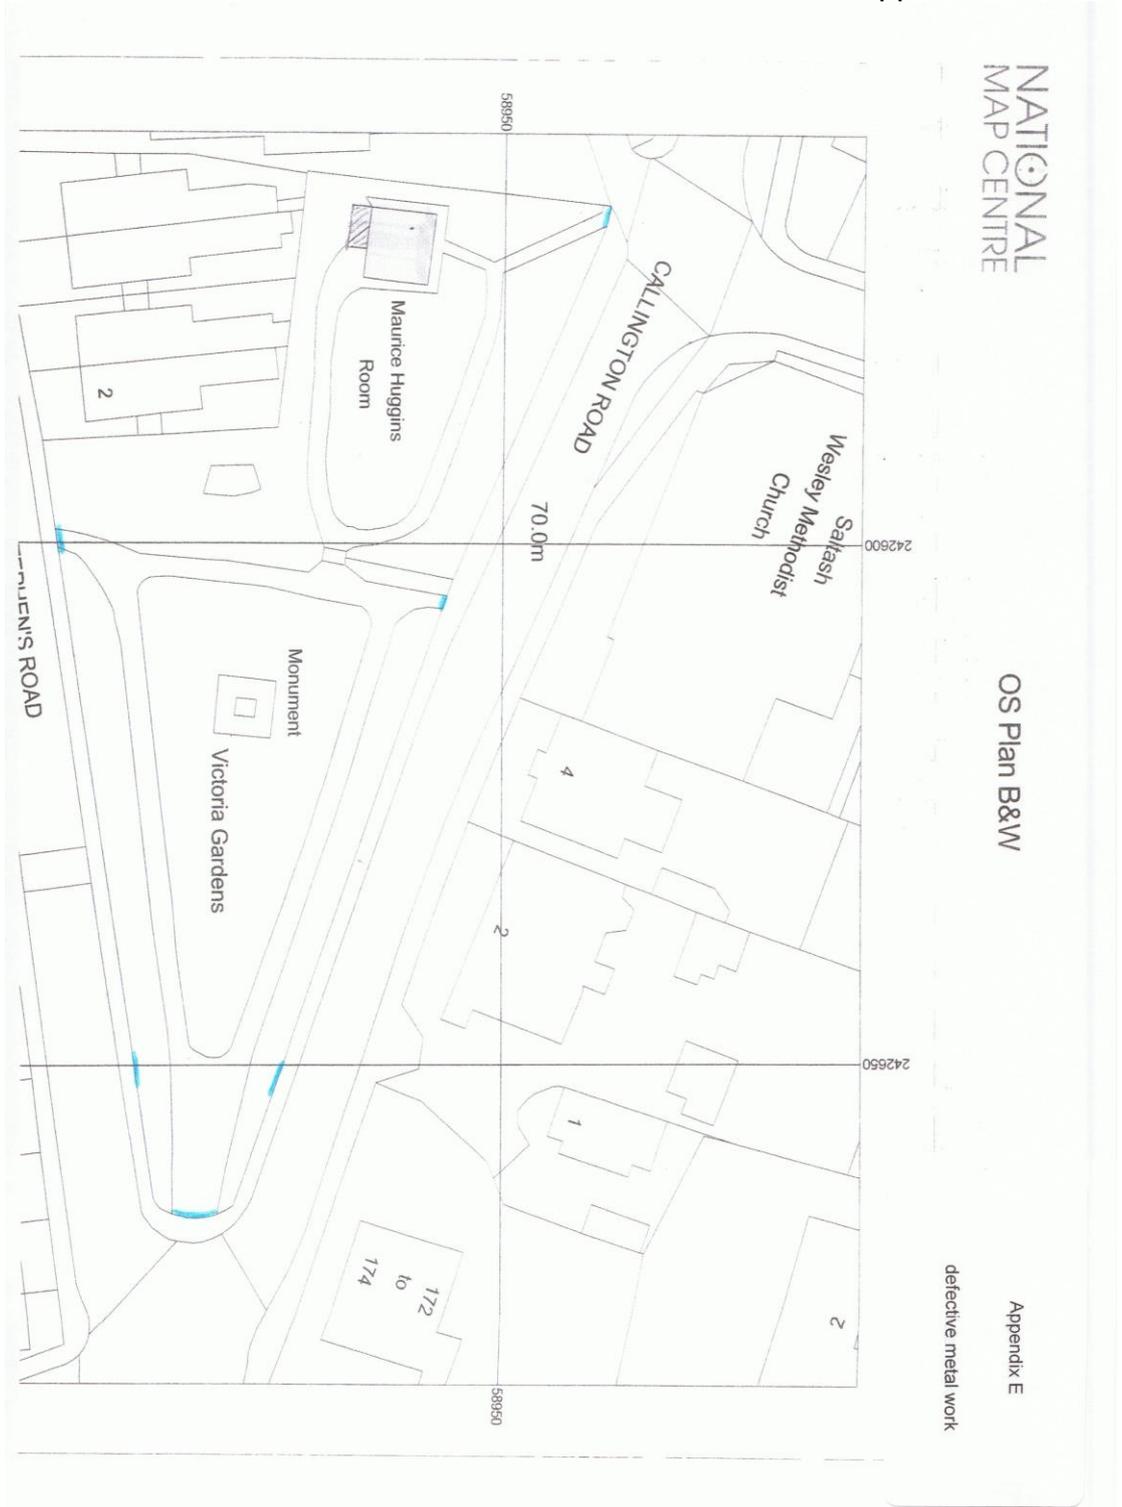
appendix E

There are, however, some parts of the balustrade where severe corrosion has taken place and repairs/replacement are required – see positions on Appendix E.

I recommend a complete preparation and redecoration of the balustrade.

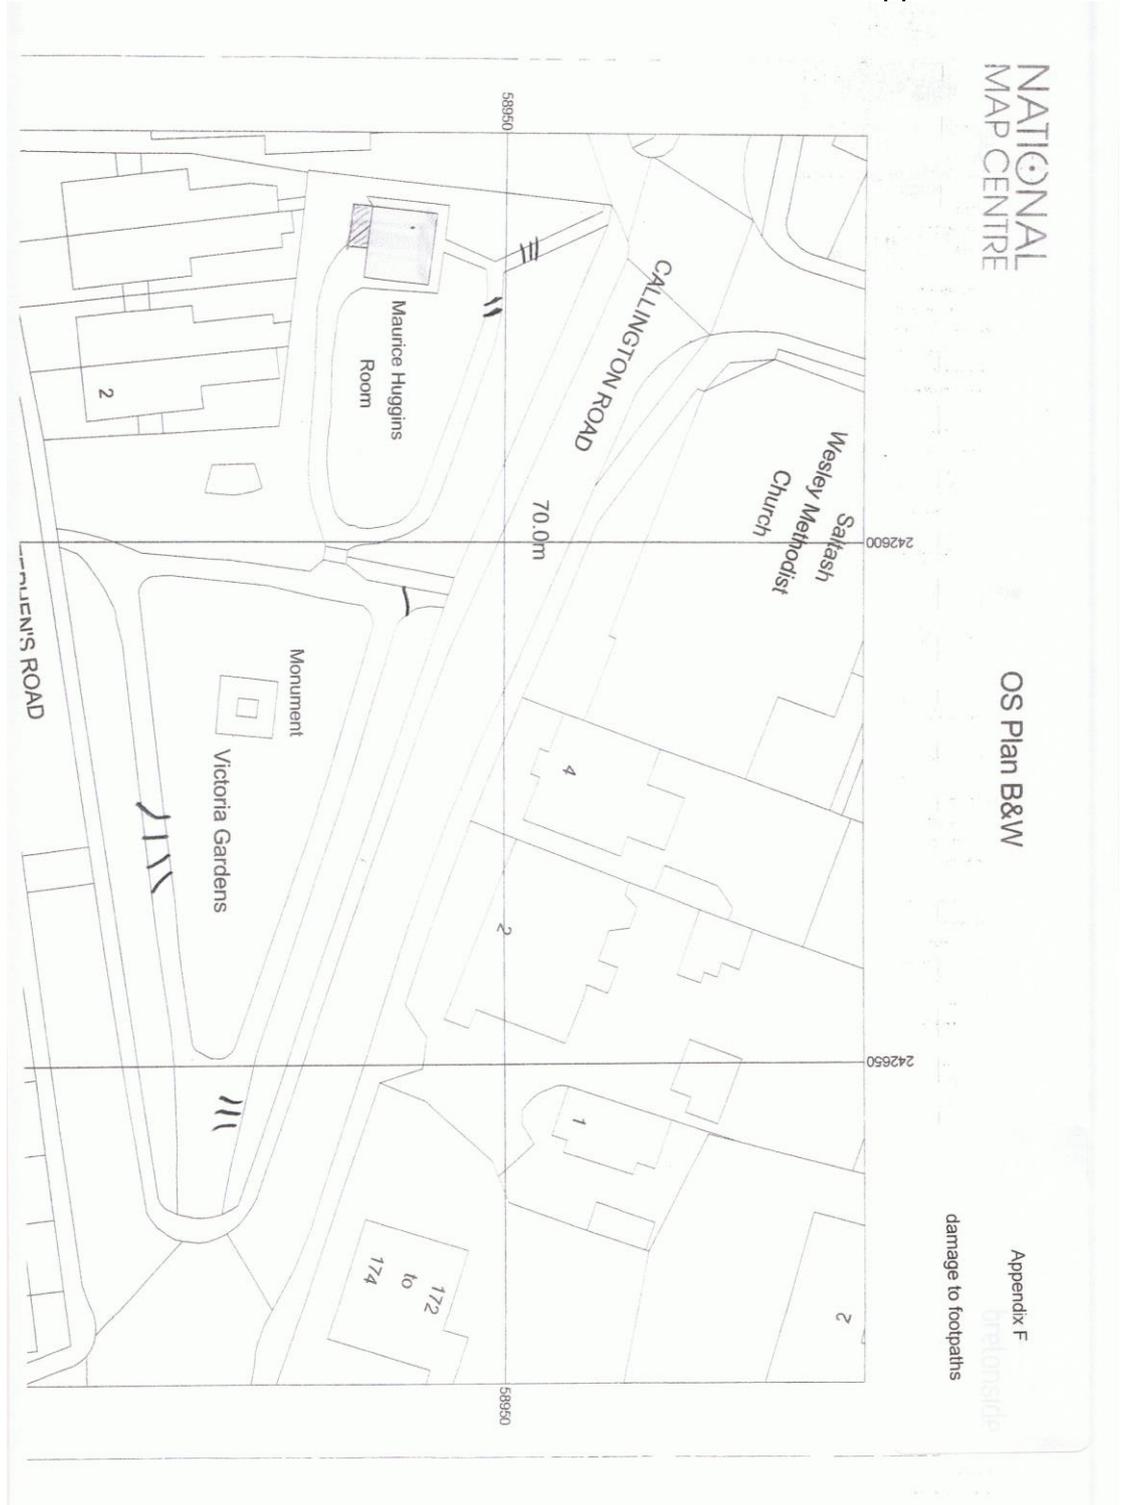
appendix F

Pathways are primarily finished with tarmac, although there are some minor areas of concrete, and generally are in reasonable condition. Exceptions are shown on Appendix F and these areas have been damaged because of tree roots. These areas require taking up and relaying.

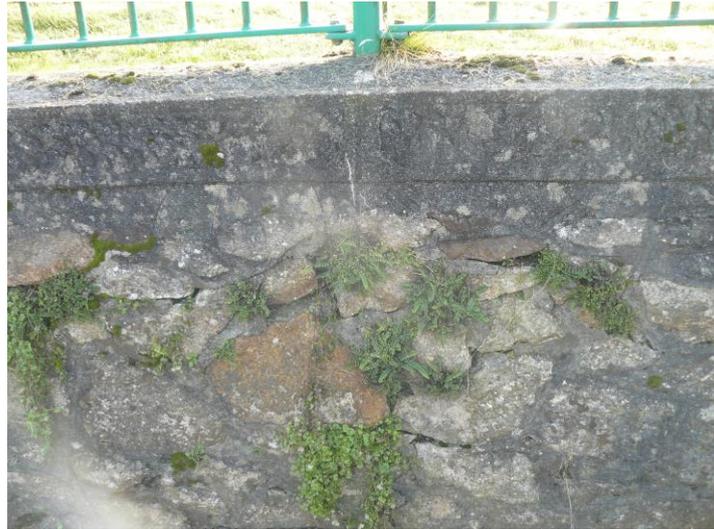
example of weed growth & defective pointing

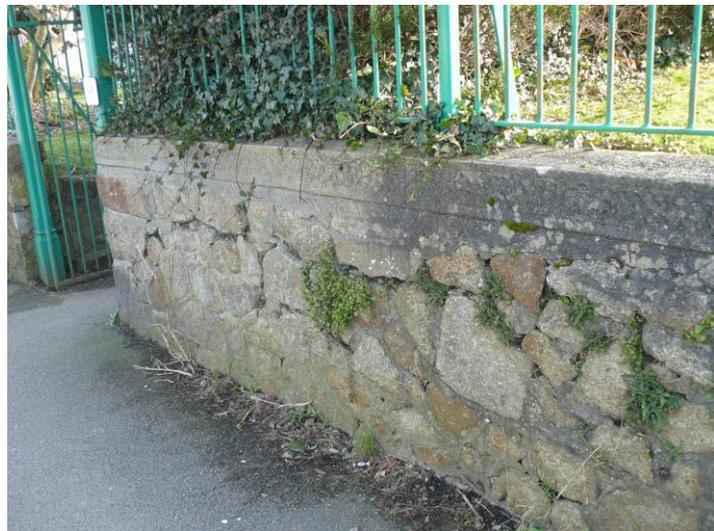
example of weed growth & defective pointing

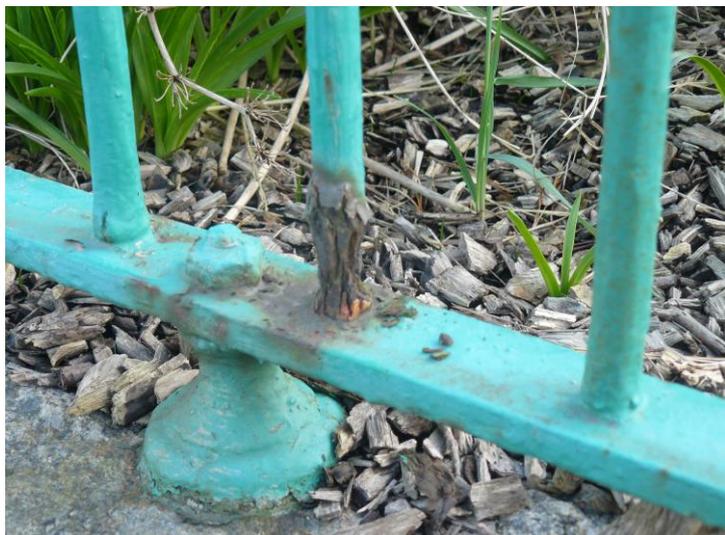
On the top of the north and south boundary walls is a 'bow topped' wrought iron railing – generally in sound condition although paintwork is beginning to deteriorate and this will lead to corrosion of the metalwork.

example of corrosion to metal railings

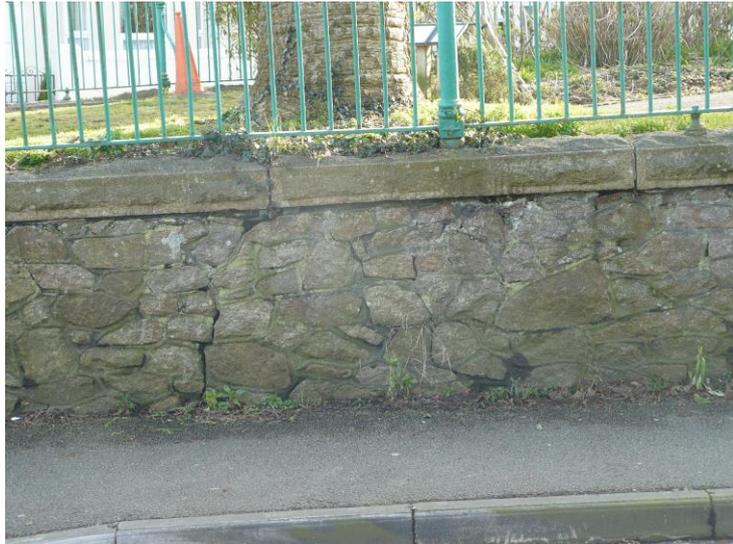
displaced masonry adjacent to *Araucaria Araucana* tree

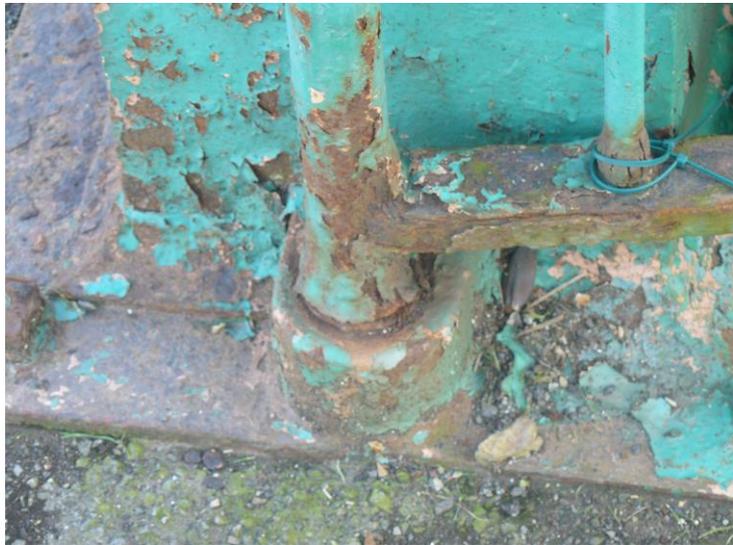
corrosion to east gate

Remaining entrance gates all require some minor adjustment. The decorative condition is the same as the railings and I recommend a full preparation and redecoration of all areas.

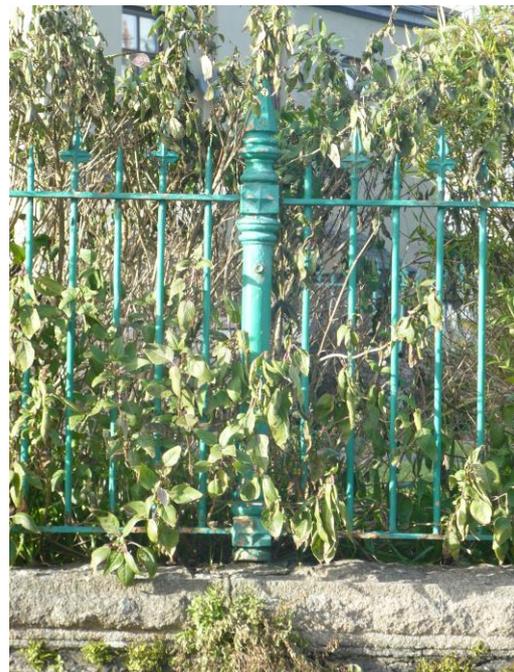
corroded newel post on southern boundary

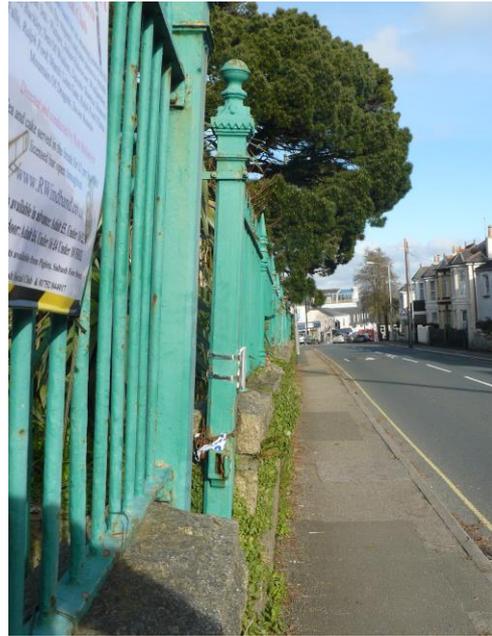
railing and wall leaning into St Stephen's Road

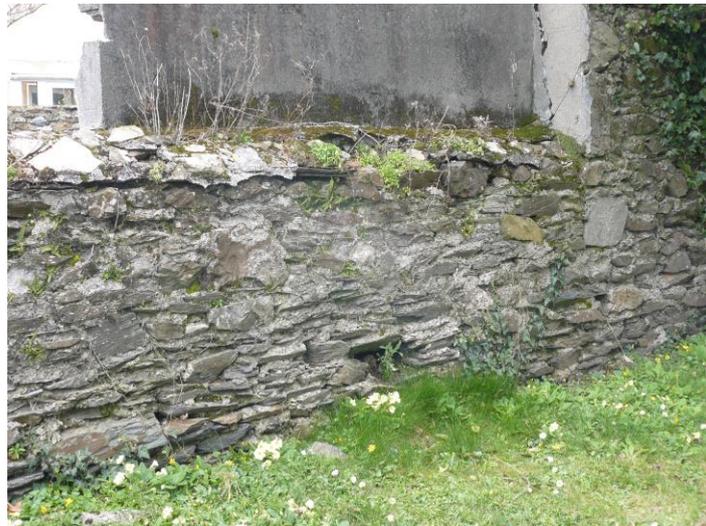
From the rear of no. 8 St Stephen's Road the wall then turns another 90 degrees and becomes a party structure between Victoria Gardens and Malvern House. This is also of random-coursed solid masonry and forms a retaining wall for Victoria Gardens. Behind the Maurice Huggins Room the wall is hidden by hedgerow, similar to that on other boundaries, but the masonry is exposed to the north of the Maurice Huggins Room as far as the north boundary to the Gardens.

wall between Victoria Gardens and Malvern House

Here the wall is generally poor with loose stones and copings and I recommend all loose stones and copings be removed and parts of the wall be rebuilt to match the existing.

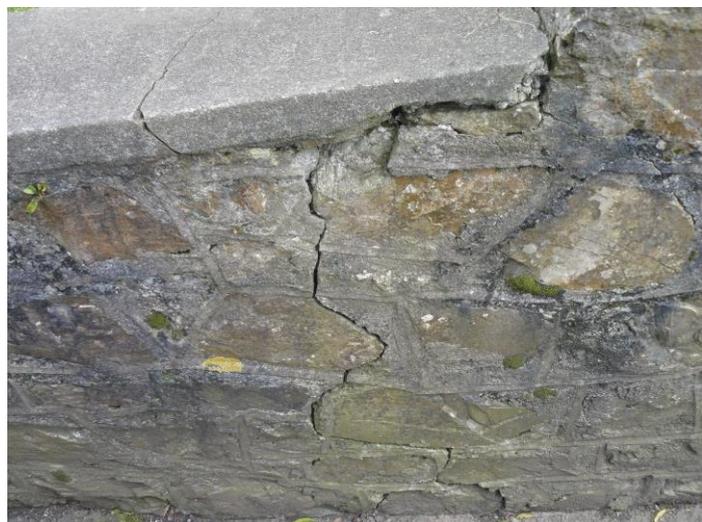
settlement of wall adjacent to higher Callington Road entrance

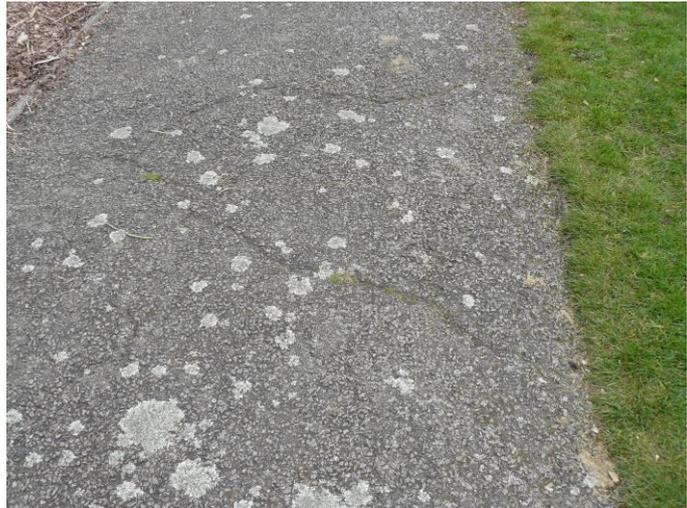
displaced tarmac adjacent to *Araucaria Araucana* tree

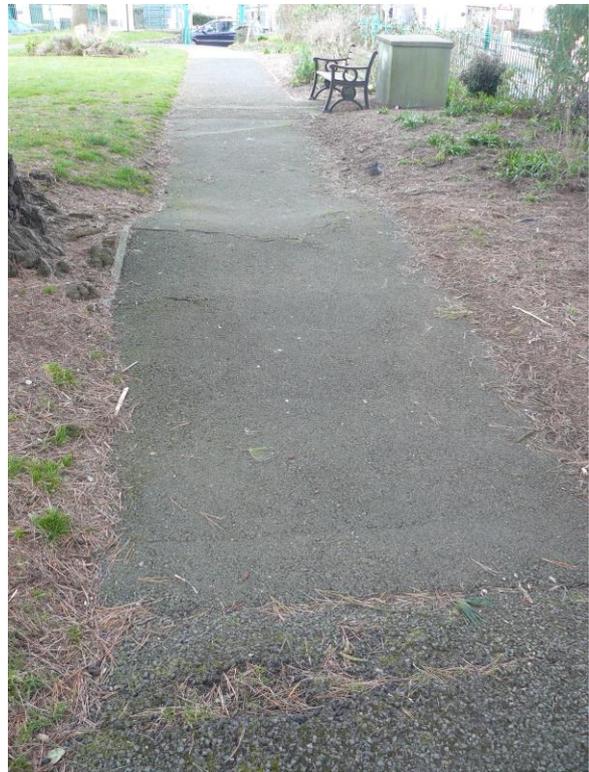
displaced tarmac adjacent to fir tree
