To receive an update on Isambard House building snags and consider any actions and associated expenditure

Update from Cormac:

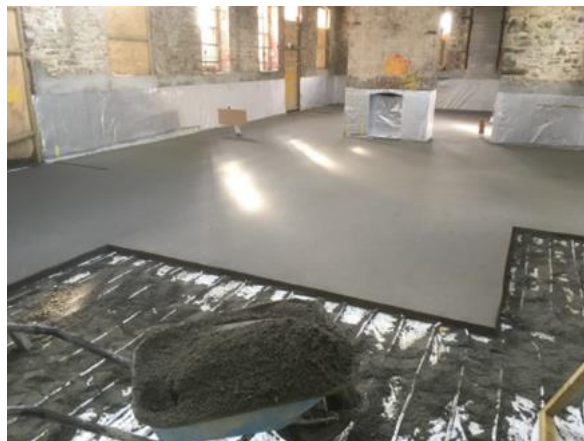
I do not believe that the cracking seen at the surface of Saltash Station floor is due to reflective cracking as a result of anything below the insulation boards or due to the boards themselves as the boards are staggered in the direction across the room and the crack is relatively straight, photos 1 & 4.

My recommendation is to install a straight 10mm deep movement joint in the top layer of screed in the location of the surface crack between the corners of the doormat wells, and where the crack deviates from this line it could be filled with concrete repair grout of a similar colour to the screed. The cracks in the café floor could also be repaired with the concrete repair grout without the need for a movement joint.

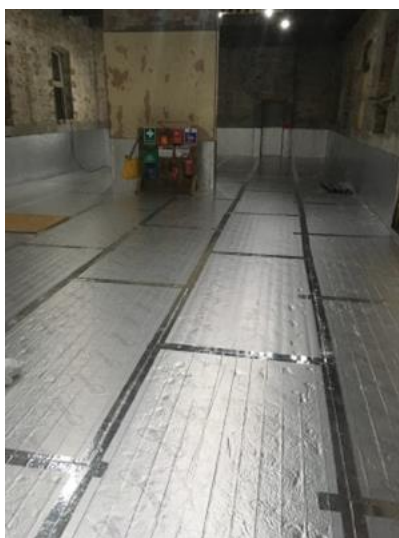
Looking at photo 2, it can be seen that the heating pipes bend almost directly beneath the edge of the screeded bay, it is possible that the edge of the screeded bay would be a weak line in the screed and so if the screed were to shrink a crack would form there. The bends in the heating pipes may restrain the screed around them causing the screed along the line of the bay edge to break up and form a larger crack. The screeding bays probably resulted in the crack in the lower layer of screed, the line of which is shown in photo 3 with tape over it. This tape would have distributed the stress concentration at the crack in the lower screed and prevented a crack along the same line, known as reflective cracking, from forming in the top 10mm layer of screed.
