**BARRON**  
**SURVEYING SERVICES**  
CHARTERED BUILDING SURVEYORS

**REPORT ON BUILDING AND HARD LANDSCAPING FABRIC**

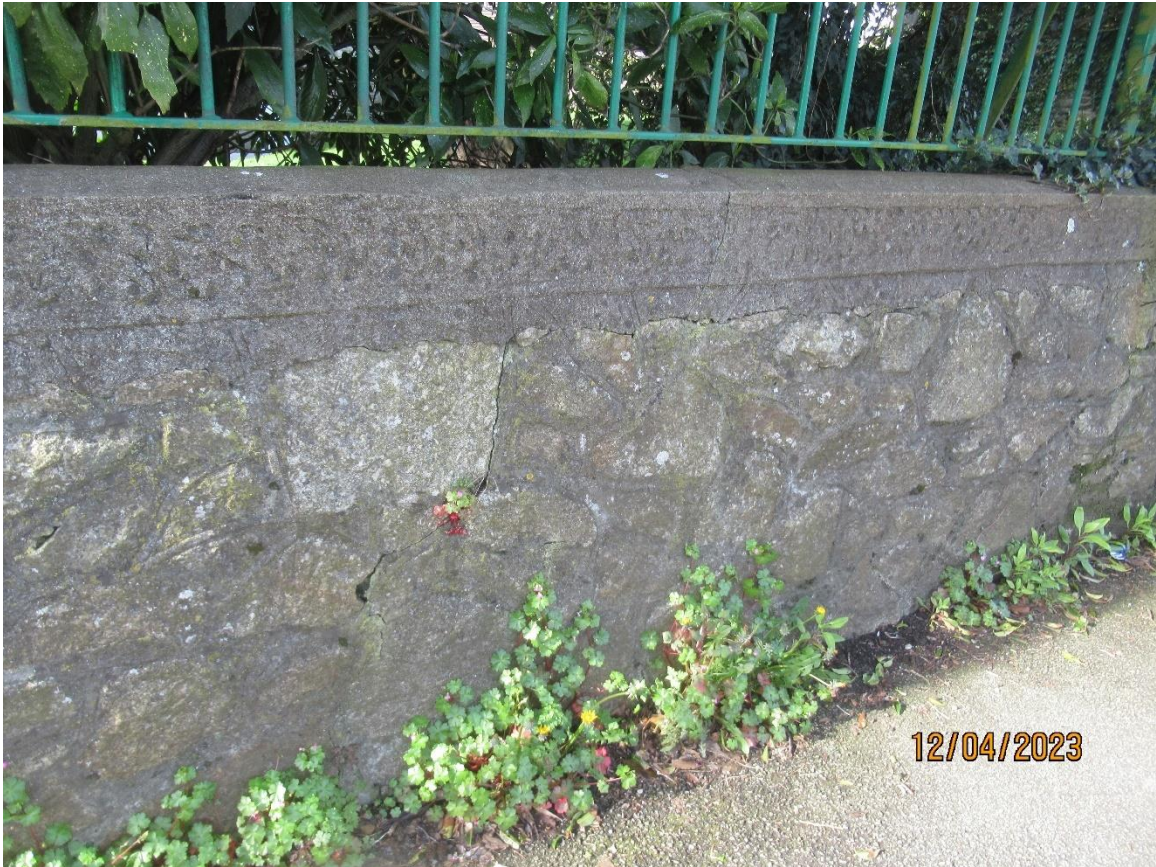
**P2 – diagonal crack in wall**

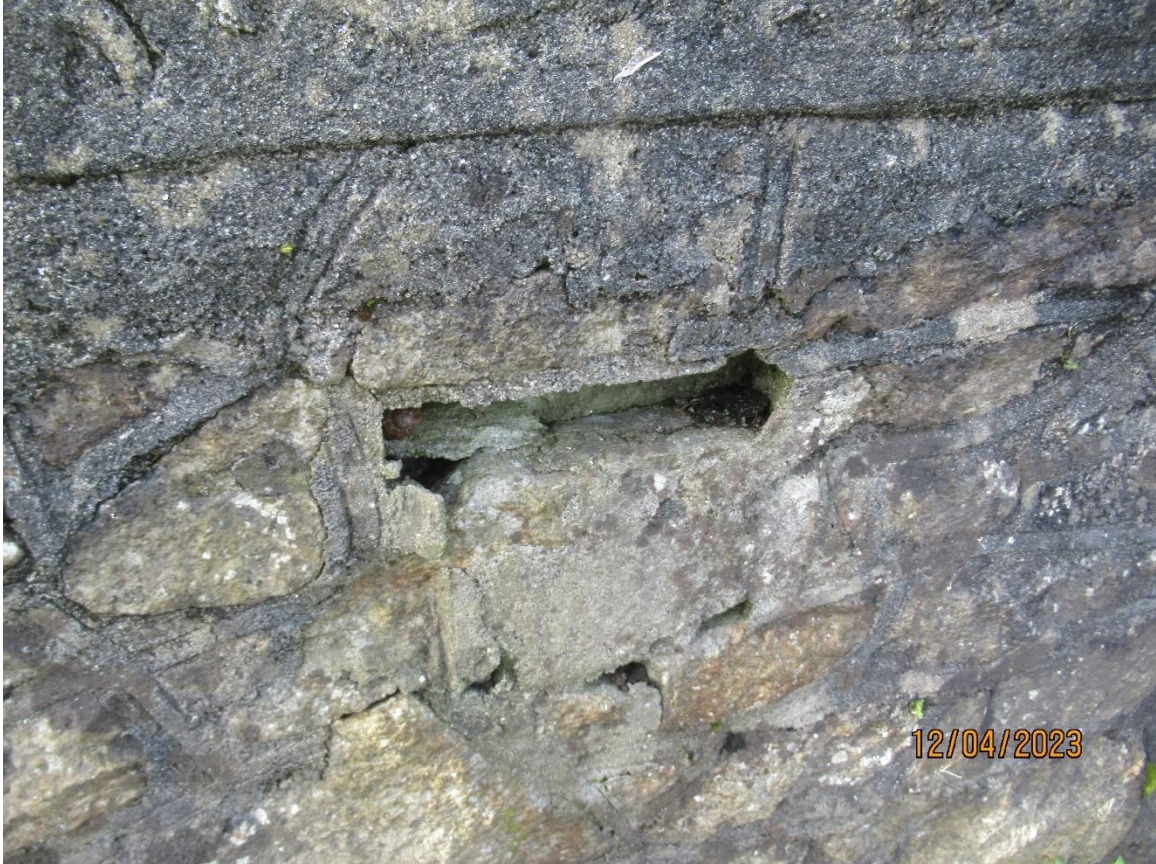
**P3 – vegetation and poor jointing**

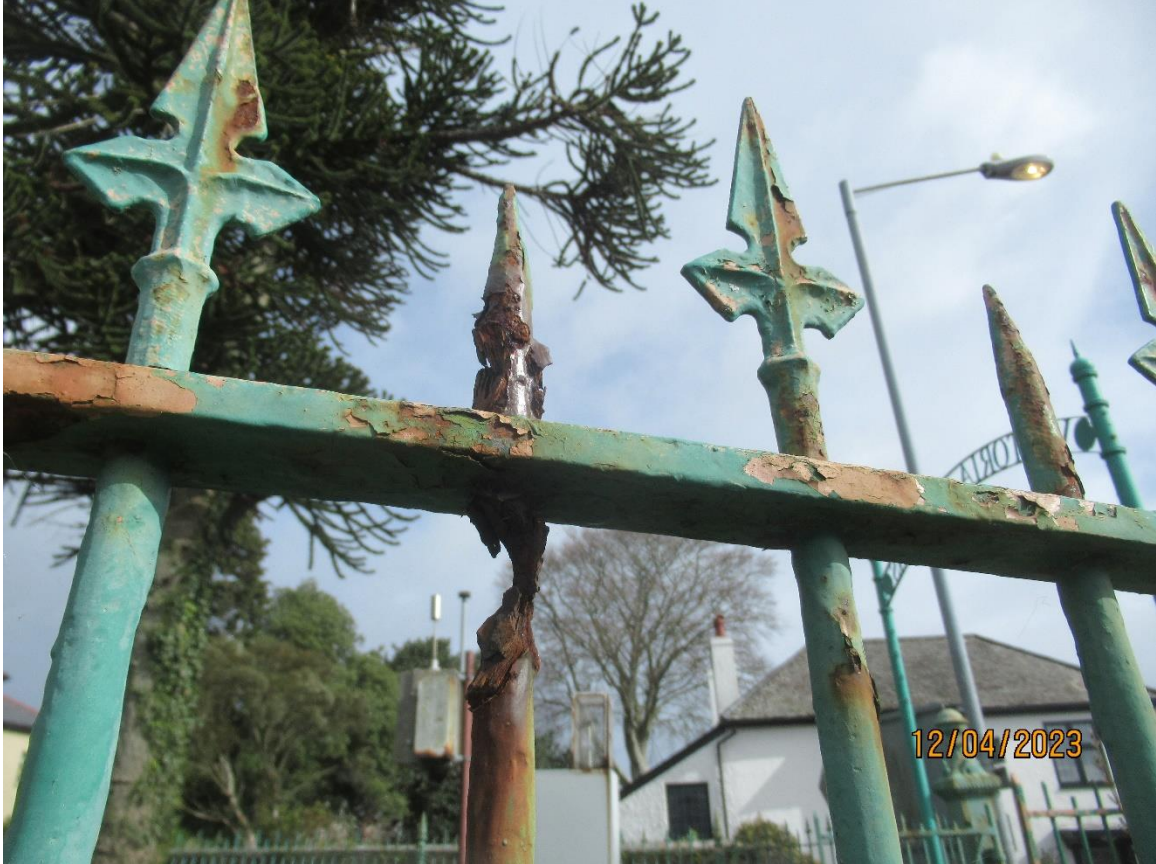
**P15 – corroded St Stephens Road railings**

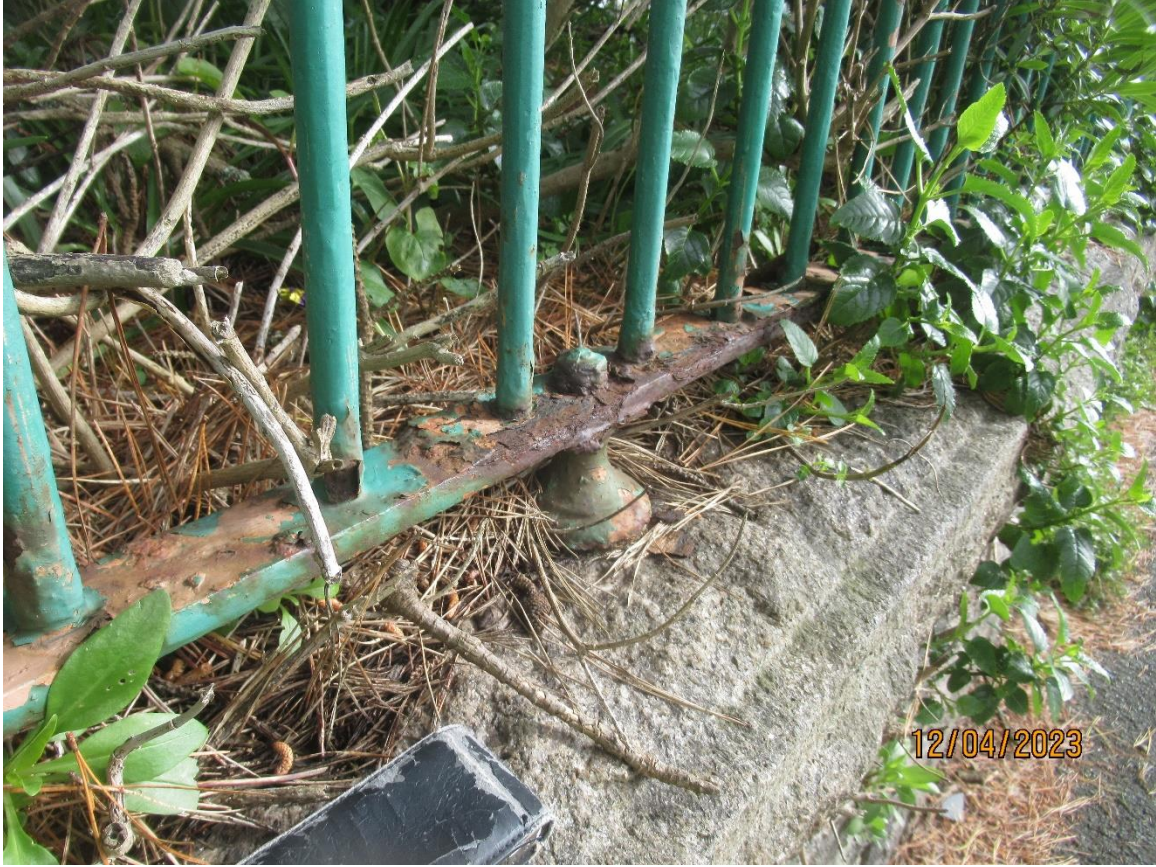
**P16 – base of railings**

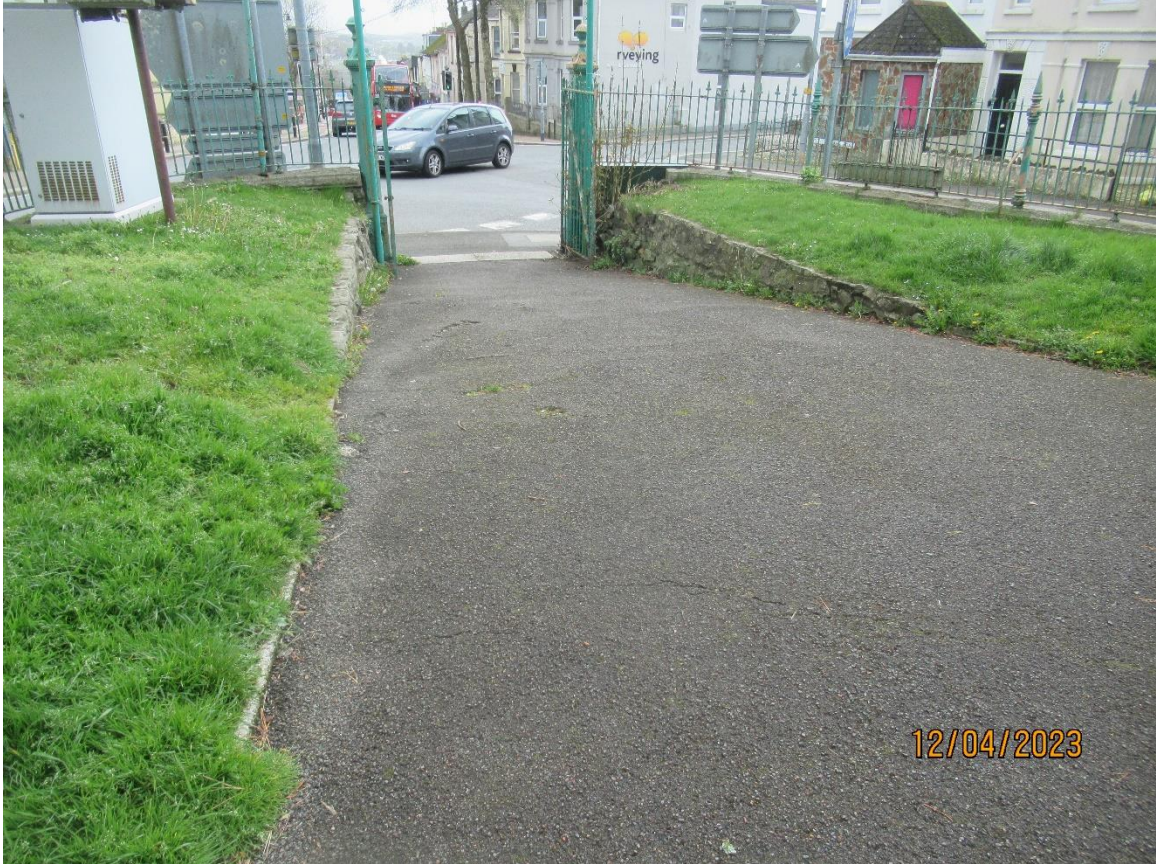
**P20 – cracked path**

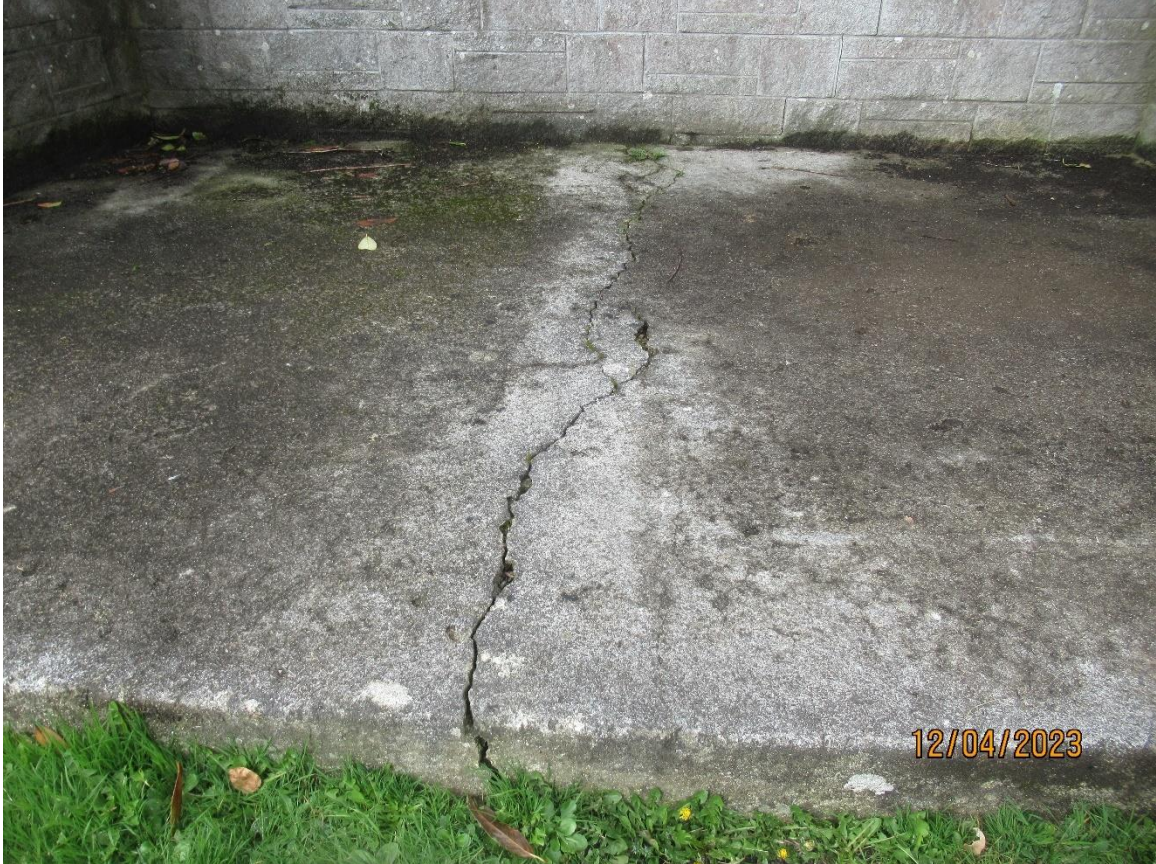
**P21 – cracked floor slab to bandstand**

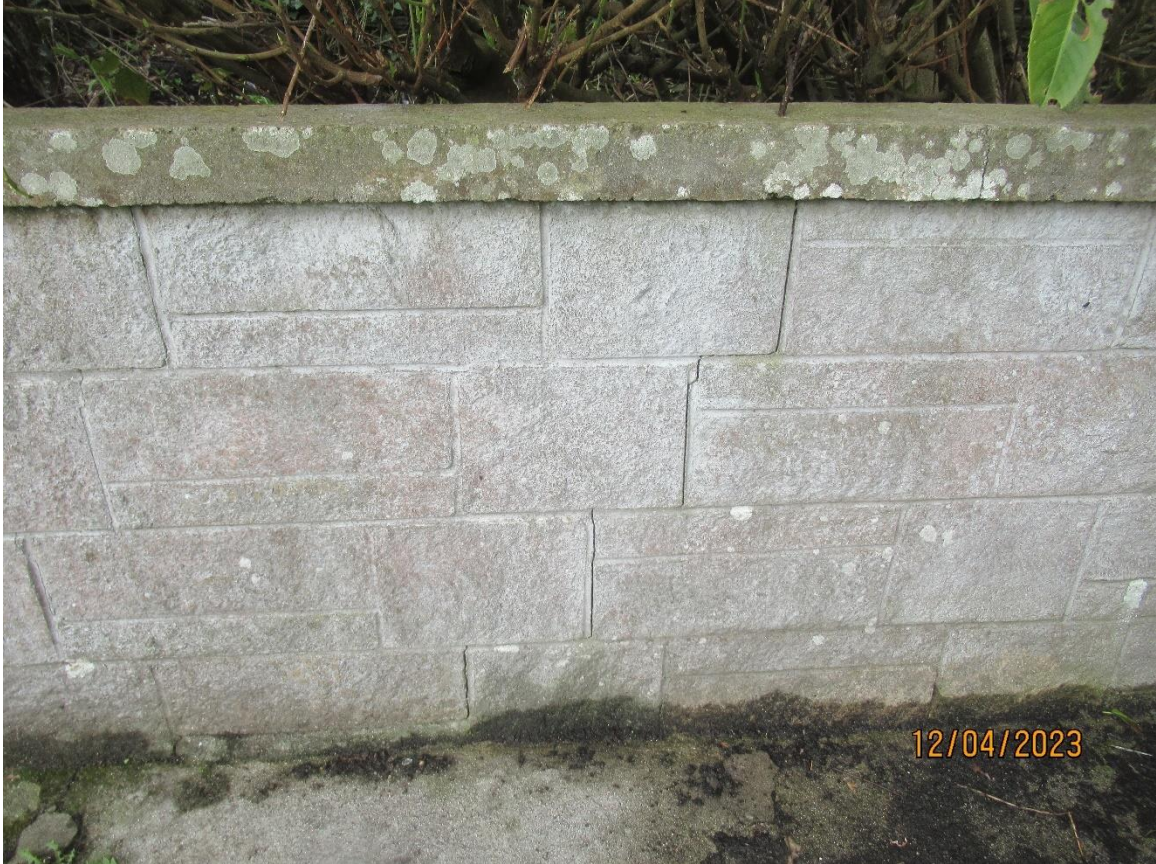
**P22 – walling to bandstand**

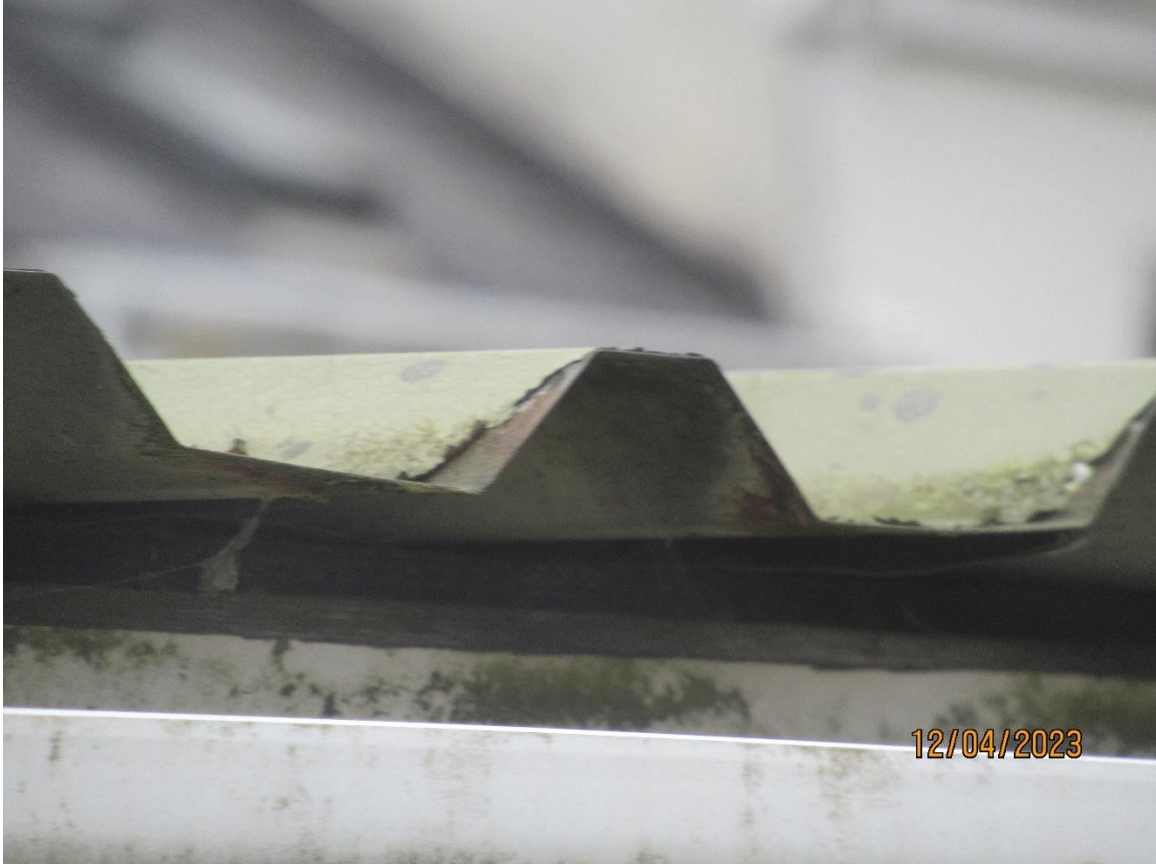
**P24 – corroding sheet edges**

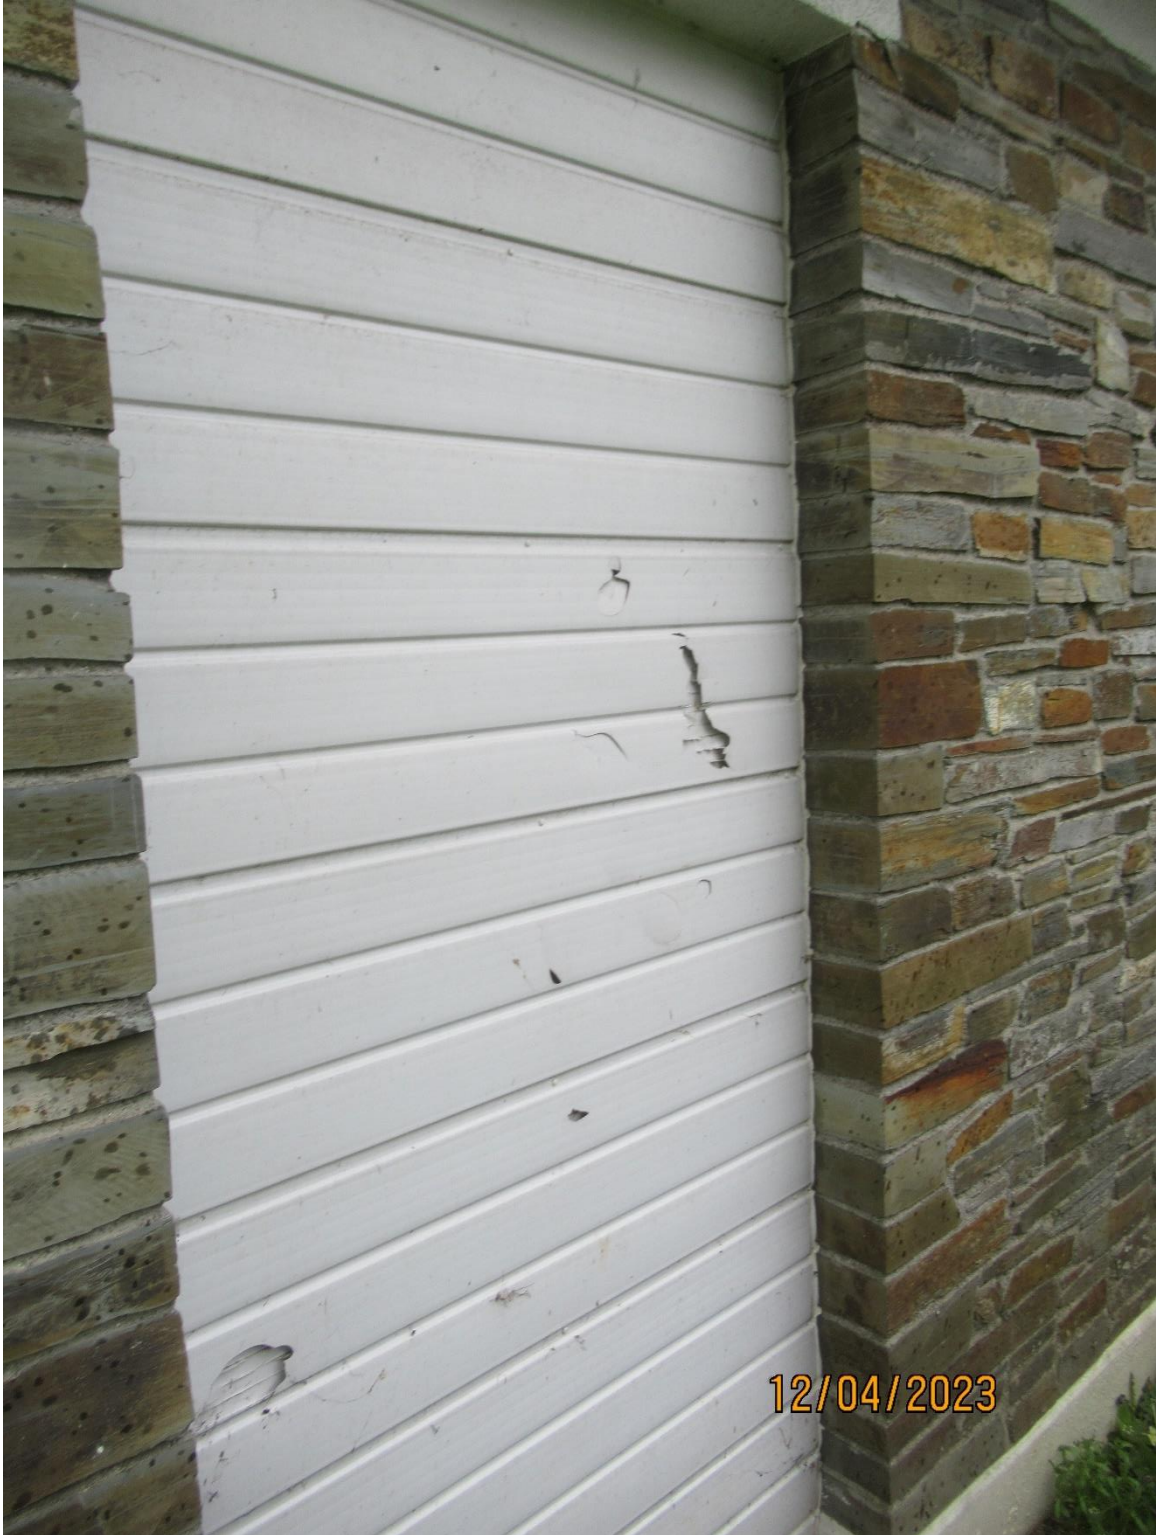
**P25 – damaged fascia panels**
