Project 31/05/2025, 09:16
completion report, Saltash Jubilee pontoons
Saturday, 31 May 2025
Prepared For Saltash Council
24 Pages

SALTASH JUBILEE PONTOON

COMPLETION OF PRODUCT SALTASH JUBILEE PONTOON

Repair work carried out of the Saltash Jubilee Pontoon:

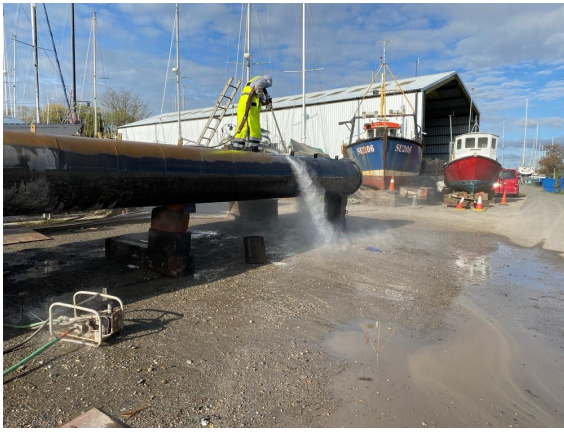
2. All decking boards removed ready for cleaning. All sub frames removed from floats, damage's sub frames noted for replacing. marine mollusks was removed from floats prior to "hydro-blasting".

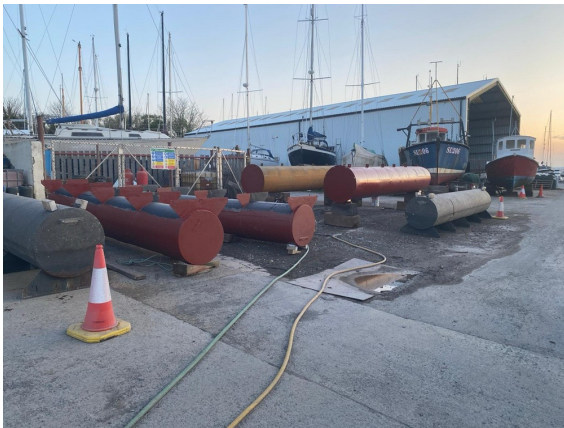
3. "hydro-blasting" was used to removed all protective coatings back to bare metal.

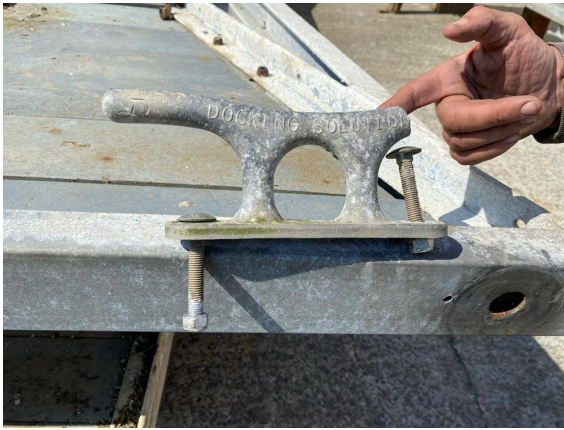
11. Marina access Bridge Where the wheels roll on access pontoon Metal under the skids was found rotten. This was chopped and replaced. Then New nylon hard wearing. Skids was fitted

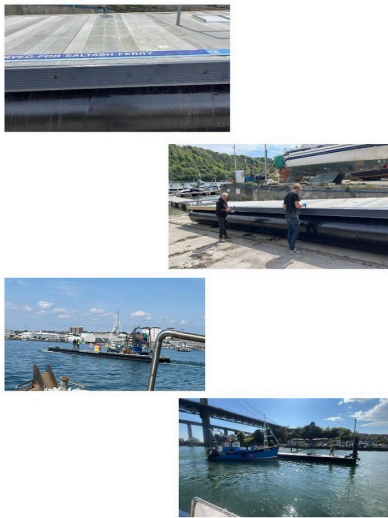
RE FLOATING THE PONTOONS FOR TRANSIT TO SALTASH FOR RE INSTALLING MARINA

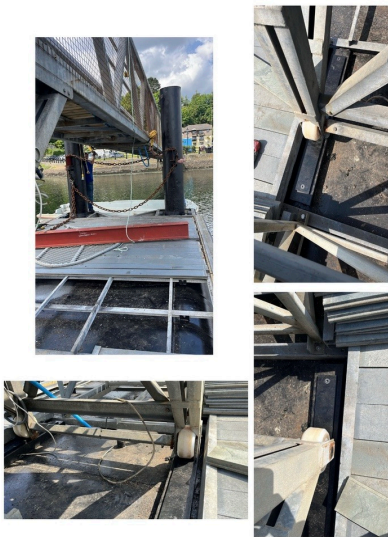
All pontoons were towed in turn and connected.
