A388 Carkeel Traffic Calming

Feasibility Report

EDG2085_RP2

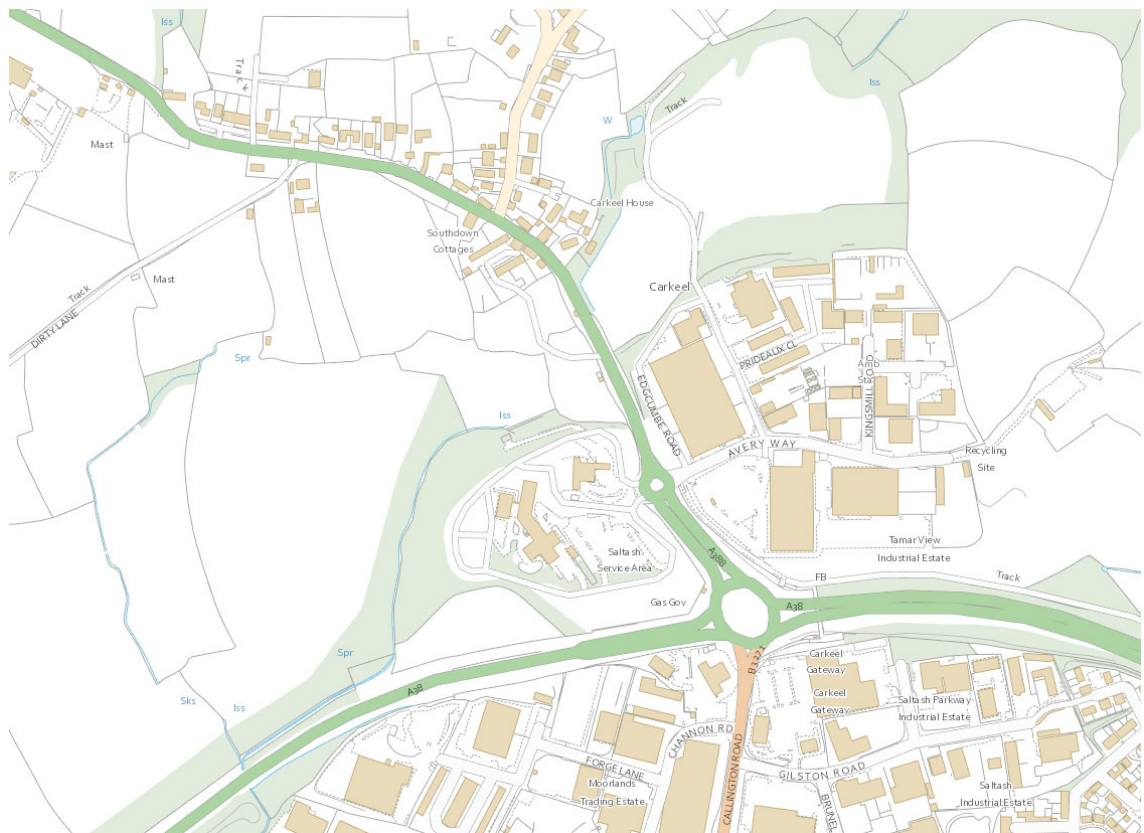
Fig 2.1 – Village extents

2.1.2 The assessment has been commissioned following the Broadmoor Farm/Treleden development to the south of the A388 and in line with comments provided by local stakeholders. Figure 2.1 identifies the geographical context of the assessment.

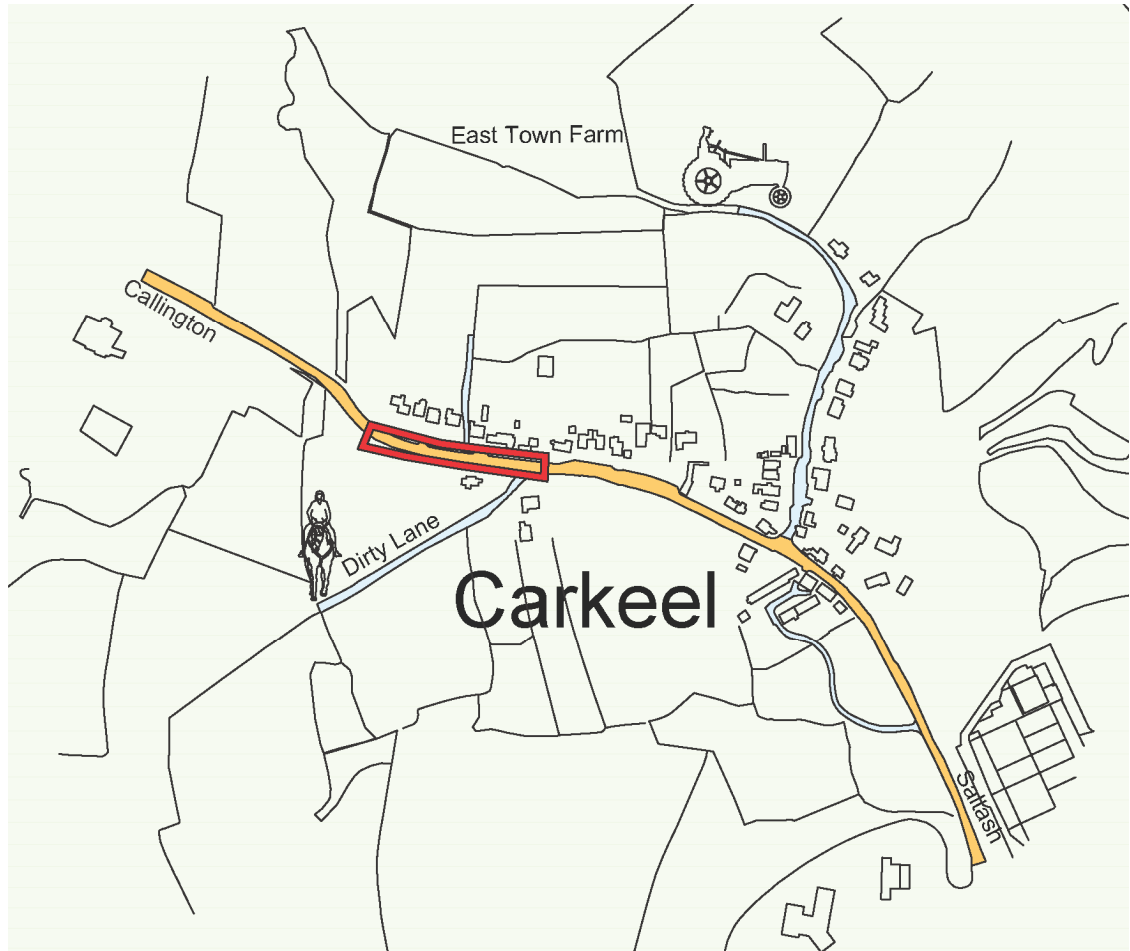
Fig 4.1 – Option 1 extents

On the western side of Carkeel it is observed that a number of residential properties have growing hedges that have overgrown into the footway. In some places these overgrown hedges have reduced the available footway width by half.

- 4.6.1 Whilst Cornwall Council's policy is to encourage residents to maintain their own boundaries, the option remains for Cornwall Council's highway maintenance teams to clear the boundaries instead.
- 4.6.2 The proposal would be for the Highway's Network Manager to write to the effected residents requesting that maintenance be undertaken, but failing that undertake the maintenance themselves.
- 4.6.3 Areas of proposed boundary clearance can be seen on drawing 0001.

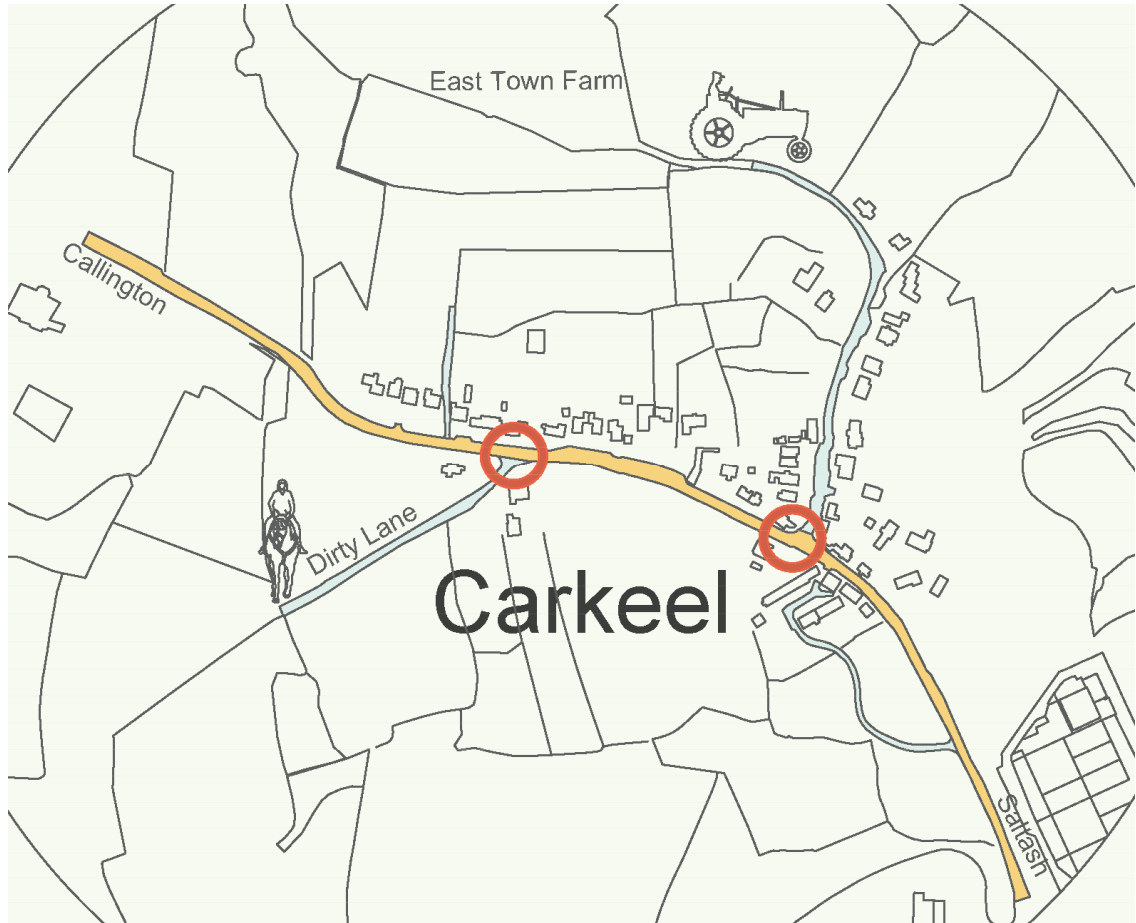
Fig 4.3 – Option 3 extents

- 4.8.1 The proposal would be to place two additional Vehicle Activated Signs (VAS's) within the village, in addition to the one currently placed on the western side of the village.

- 4.8.2 The current VAS currently monitors and provides speed warnings to eastbound traffic as it enters the village. The proposal would be to install an additional VAS to the west of the village, possibly by the entrance to Dirty Lane in order to monitor westbound traffic as it travels along the main straight through the village. The third VAS is proposed just to the west of the northern side road and would look to monitor eastbound vehicle speeds.
- 4.8.3 Drawing 0003 indicates the proposed positions of the recommended VAS's.

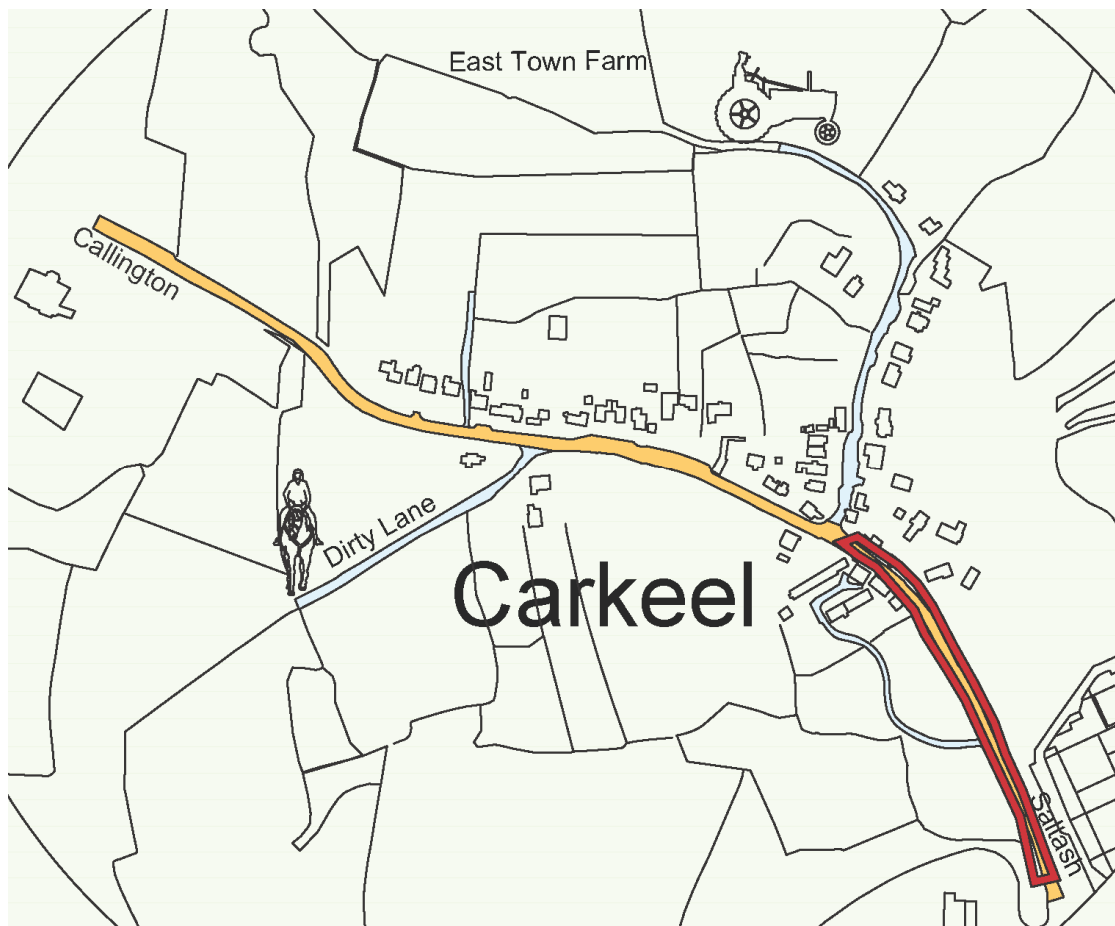
Fig 4.5 – Option 5 extents

- 4.10.2 The proposal would be to extend the northern footway further east to a point where a pedestrian crossing could be better located, or else extend the northern footway all the way to the Tamar View Industrial Estate.

- 4.10.3 The proposal would involve purchase part of the frontage of Eales Bungalow and possibly part of the field east of the bungalow in order to provide space for the new footway, as well as protecting or diverting a number of underground services that are evidenced as crossing this frontage.
- 4.10.4 A number of streetlights are within the verge east of Eales Bungalow, a number of which would need to be relocated, depending on how far the proposed footway extended.
- 4.10.5 The proposed new footway can be seen on drawing 0005.

- 4.10.7 During the course of investigating for this options report, it was established that the extension of the northern footway has both been examined and recommended previously. It was found that the previous recommendation did not proceed due to the then owners of Eales Bungalow being unwilling to sell the land required for this scheme. However, during the site meeting on the 13th January, one of the local stakeholders was of the opinion the property may have changed ownership, which may open up the possibility of land purchase being re-examined.

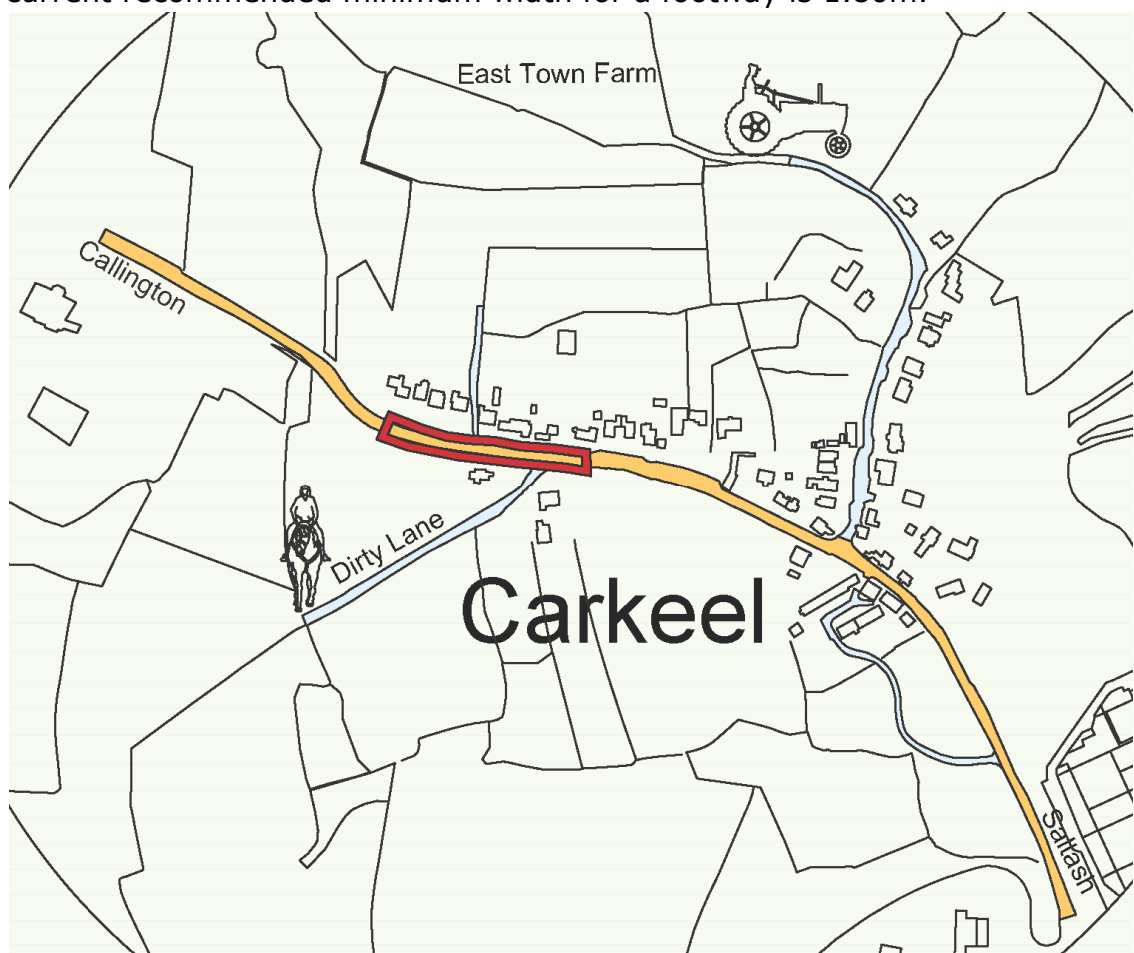
Fig 4.6 – Option 6 extents

- 4.11.1 Currently most of the footways within Carkeel do not meet the widths requirements stated within Cornwall Council's highway design standards. The current recommended minimum width for a footway is 1.80m.

- 4.11.2 Less than desirable footway widths are not uncommon in towns and villages where their initial construction pre-dates the latest guidance, however, where possible footway widths should be brought up to standard when viable to do so.
- 4.11.3 At Carkeel there is approximately 100m of footway which can be brought up to current standard by increasing its width by an average of 600mm.
- 4.11.4 This section of footway is located to the west of the village, where existing grass verges may be used to accommodate the required widening.
- 4.11.5 Areas of proposed footway widening can be seen on drawing 0006.

- 4.11.7 Currently Cornwall Council's intranet mapping shows all the grass verges within this area as being "publicly maintained verges", meaning that using part of these verges to increase footpath width would not require any additional permissions. However, if this option were to be progressed, it would be prudent to check on the legal ownership of this land.

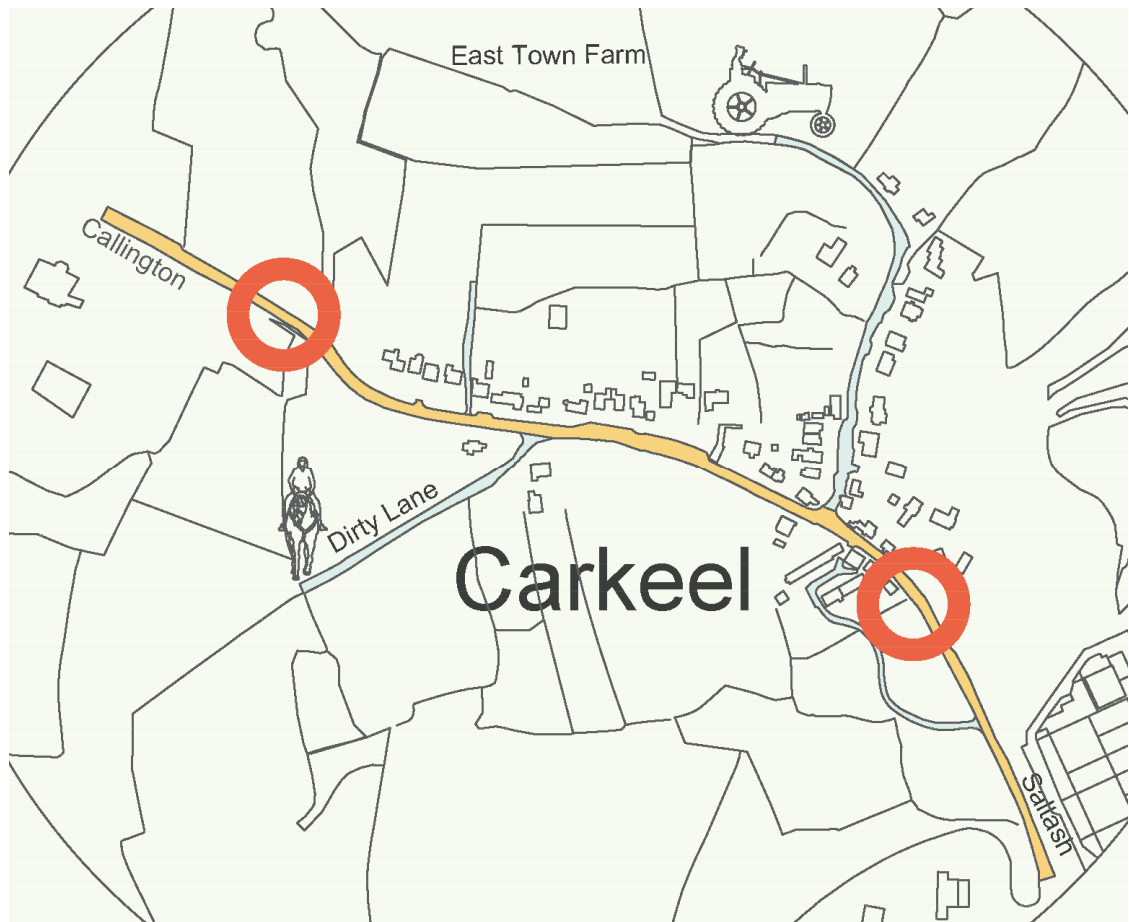
Fig 4.10 – Option 10 extents

- 4.15.1 The proposal would be to place an average speed camera at each approach to the village with the aim of controlling vehicle speeds through the village.

- 4.15.2 Unlike speed activated signs traditional speed cameras that only influence vehicle speeds at a specific location, average speed cameras can have a slowing effect over an extended length, depending on how far apart the cameras are placed.
- 4.15.3 Whilst speed activated signs do tend to reduce mean speeds by between 3 to 4mph, average speed cameras tend to have a more significant effect on reducing mean speeds.
- 4.15.4 Possible average camera locations are shown on drawing 0010.
