# ***Saltash Town Council***

# Schedule of Condition

We have been instructed by Saltash Town Council to prepare a schedule of condition of the windows and doors to the Grade II listed building Saltash Library, Callington Road, Saltash, PL12 6DX. Instructions were received on 6<sup>th</sup> October 2022. The schedule of condition will be used to support a planning and listed building consent application for the following works:

# Heritage Impact Assessment

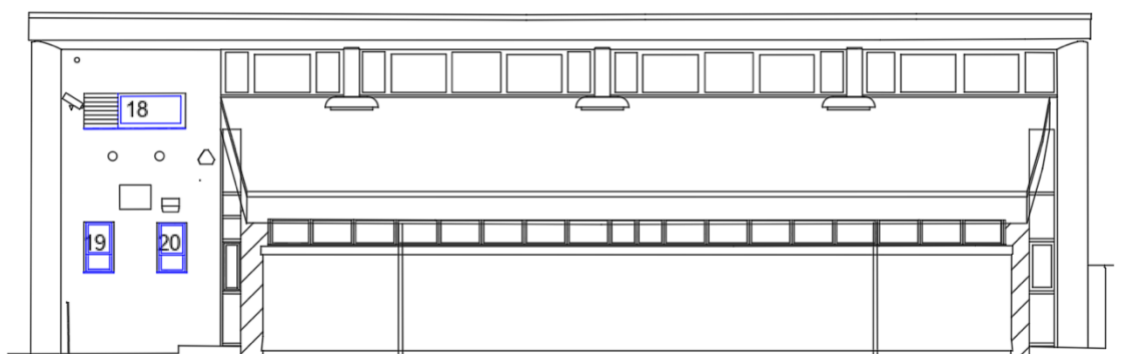
**Figure 3: East elevation**

Steel crittall windows are installed within deep external reveals to the office, WC and store areas at the southwest and north west corners of the building (see figures 1, 2 & 3). These are painted white and have asymmetrically configured mullions and single glazing. The steel crittall windows appear to have retained their original appearance and painted colour, although have become somewhat degraded with age. Window 18 has also been heavily modified within insertion of a steel louvre grill, to facilitate ventilation into the boiler room. In many cases the openers and catches have seized or are difficult to operate and the frames are showing signs in initial corrosion. Decorative finishes are also severely degrading. The single glazed steel crittall windows will be prone to condensation and heat loss. Consideration should be given to replacing the windows to reduce future maintenance and energy loss.

Steel crittall windows to southern end of the building are also beginning to degrade and require urgent maintenance. Whilst immediate replacement is not considered necessary, these will likely reach the end of their useful lives in the coming decade. Replacement of steel crittall windows could potentially be undertaken using modern replicas by the same suppliers, to retain the architectural integrity of the building.

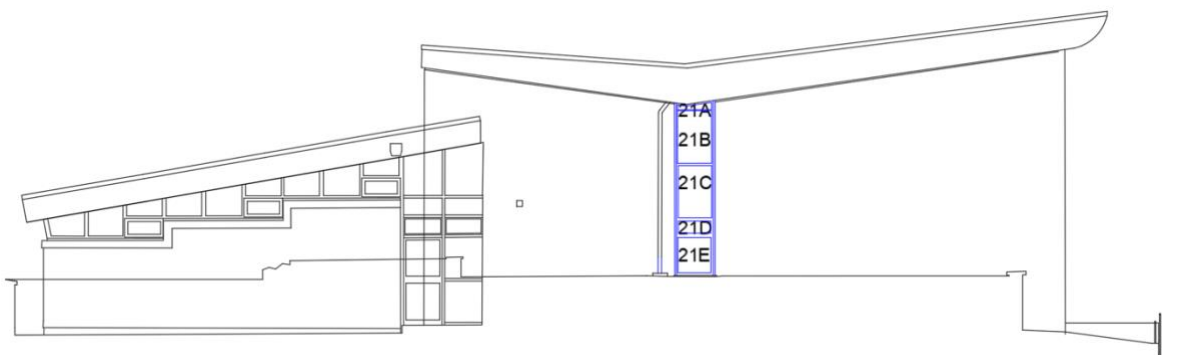
**Figure 4: North elevation**

The projecting bays to the north and south walls are set between the roughcast rendered walls with hardwood timber linings (see figures 2 & 4). The glazed casements are divided with steel box sectional columns, which are fixed to the concrete upper roof structures, although do not penetrate the lower level concrete slabs. These are painted white with flaking paint over galvanised steel, matching those to the principal curtain walling. Improvements to the columns are recommended to include brushing back loose paint and corrosion and decorating with galvanising paint.

The glazed bays display similar levels of degradation to the principal curtain walling, with corrosion to casements, seized openers, degrading putties and beads and misted double glazing. Again these are considered to have reached the end of their useful lifespans.

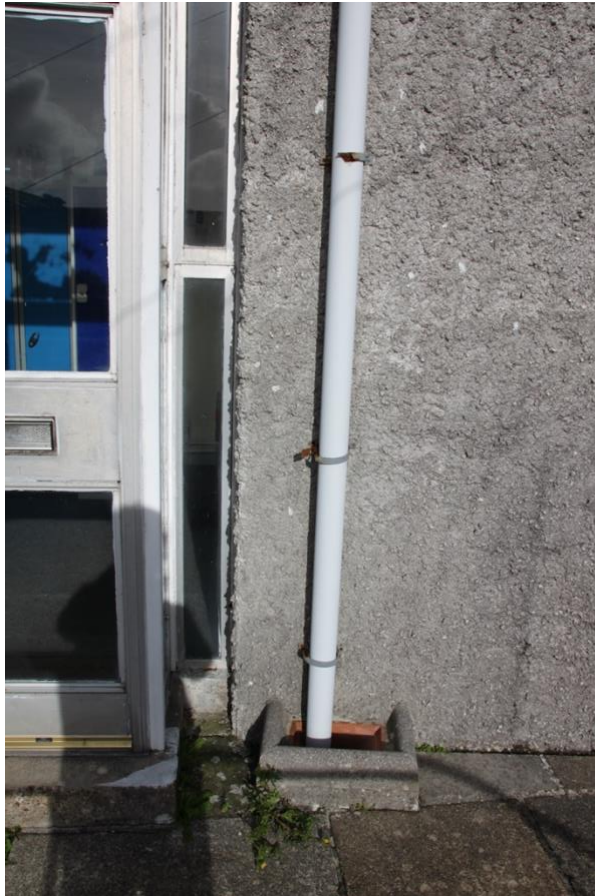
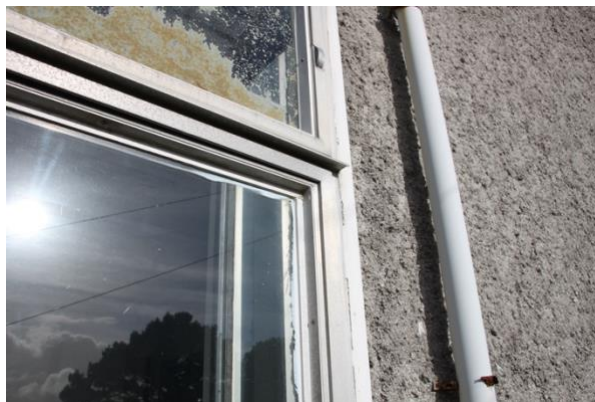
Bay window 17

<b>17A</b>	Row of 5 windows forming a projecting bay with side cheeks and margin lights. Aluminium framed casements with single glazing fixed with putty. The central flat front to the bay is split with a transom where the upper section is shaped to the v of the butterfly roof. The lower section is a top hung opener.	Corrosion to external surfaces of frame. Glazing putty degrading. Opener serviceable but stiff to operate.	Replace casements and glazing.
<b>17B</b>	Row of 5 aluminium framed casements with single glazing sealed with putty.	Corrosion to external surfaces of frame. Glazing putty degrading.	Replace casements and glazing.
<b>17C</b>	Row of 5 aluminium framed casements with single glazing sealed with putty.	Corrosion to external surfaces of frame. Glazing putty degrading.	Replace casements and glazing.
<b>17D</b>	Row of 5 aluminium framed casements with single glazing sealed with putty. Glass obscured due to first floor level.	Corrosion to external surfaces of frame. Glazing putty degrading.	Replace casements and glazing.

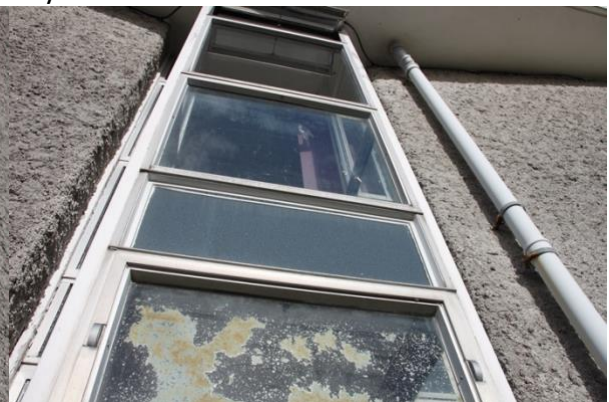
Window 17E

<b>17E</b>	Row of 5 aluminium framed casements with a mixture of single glazing and slim line double glazing inserted and sealed with putty. Transoms to side panels drop lower past door beneath.	Corrosion to external surfaces of frame. Glazing putty degrading.	Replace casements and glazing.
<b>17F</b>	Door to centre set within aluminium frames with low level lights to each side. Glazed door with central aluminium transom section. Glazing formed with single glazed panels set in putty to door and side panels with aluminium battens. Banafix film to door and side panel.	Corrosion to external surfaces of frame. Glazing putty degrading. Door serviceable but lock and catch are stiff.	Replace casements, door and glazing.

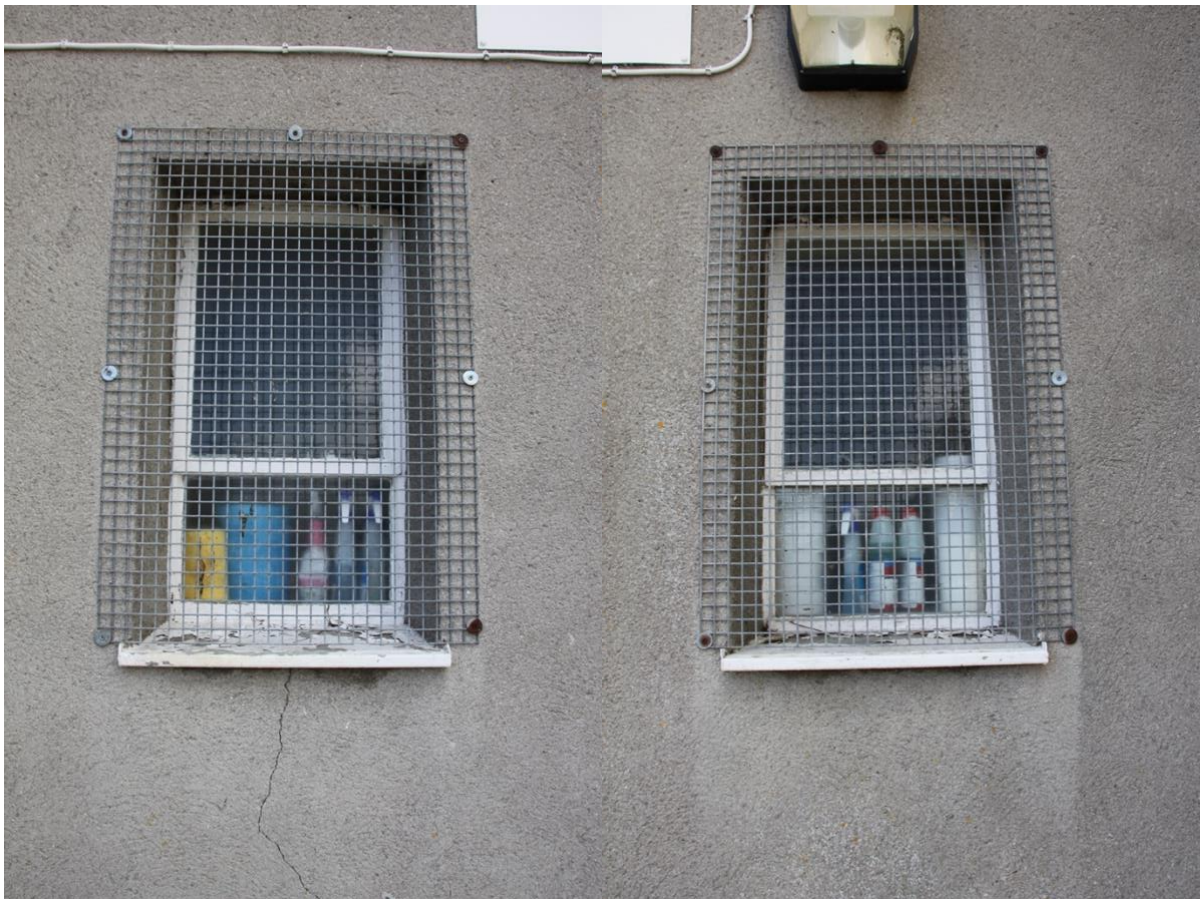
Window 18

Ref	Description	Condition	Recommended Repairs
18	First floor asymmetric horizontally orientated steel Crittall window with single glazing. The southern light has been replaced with a steel louvre to provide continuous ventilation to the boiler room internally. The adjacent light to the north is a centrally hinged hopper with catch. Painted white and set in deep reveals.	Window intact but paintwork degrading. Hinges and catches to stiff but serviceable. Louvres basic but serviceable.	Ensure decorations are renewed on a 3-4 year cycle. Ease and lubricate hinges and catches.
19	Steel Crittall window with obscure single glazing lighting the WC on the ground floor. Top hung opener with a modern lock internally. External galvanised steel security grill secured to the external wall.	Window intact but paintwork degrading. Hinges and catches to stiff but serviceable.	Ensure decorations are renewed on a 3-4 year cycle. Ease and lubricate hinges and catches.

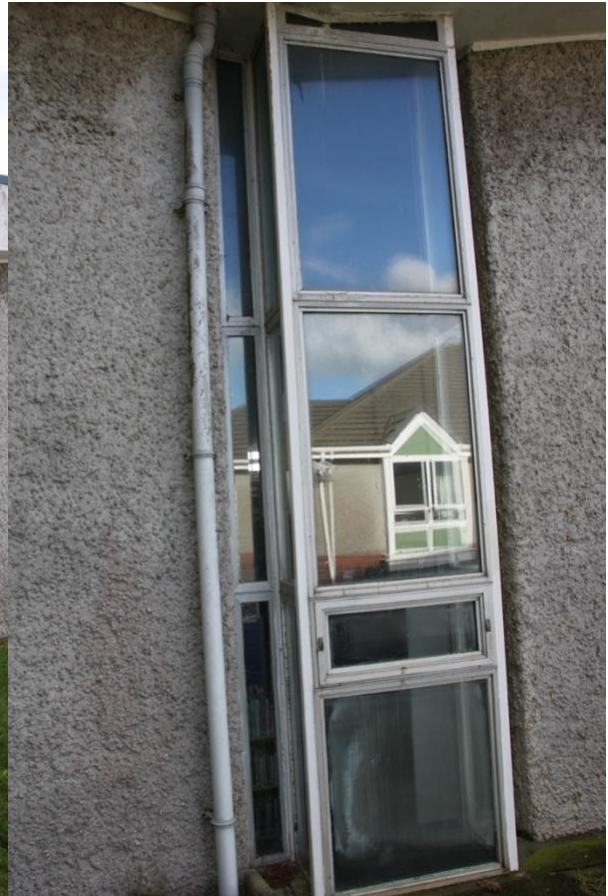
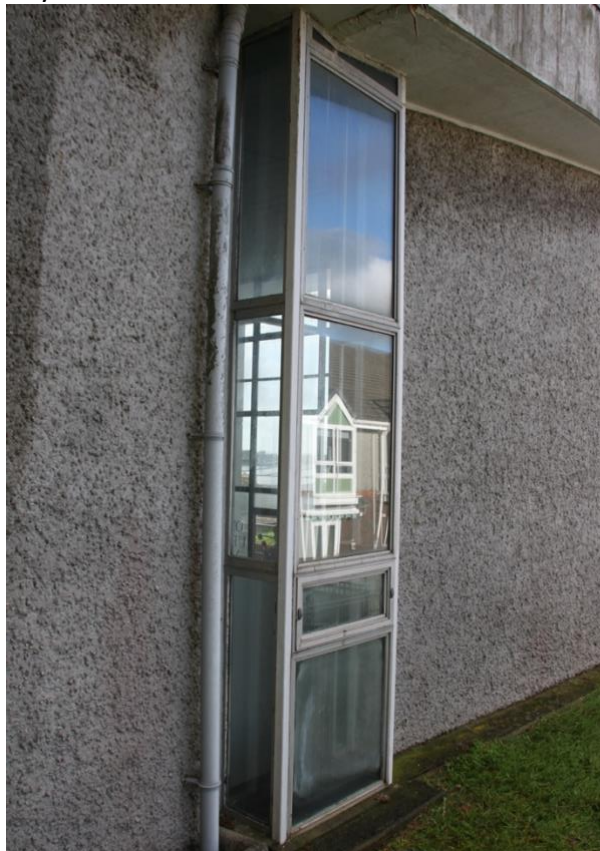
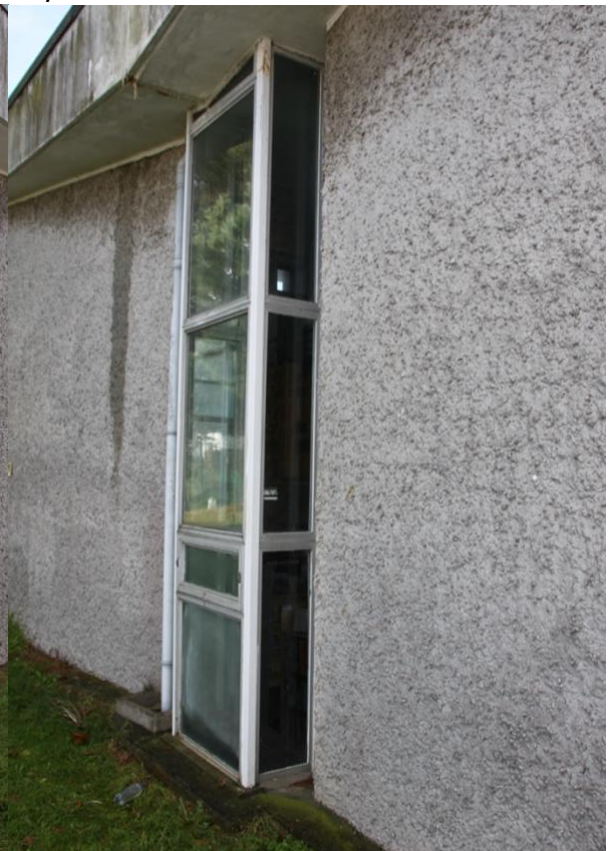
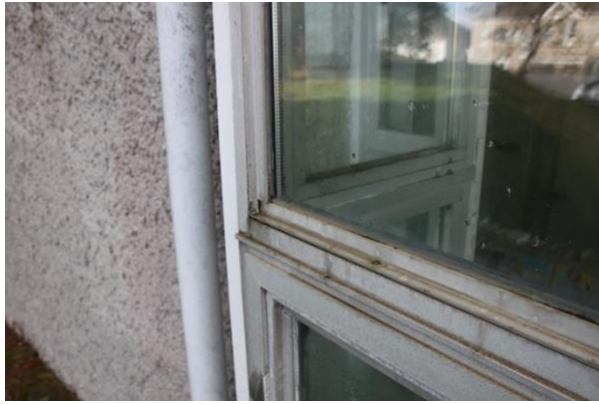
Bay window 21

Ref	Description	Condition	Recommended Repairs
<b>21A</b>	Row of 5 windows forming a projecting bay with side margin lights. Aluminium framed casements with slim line double glazing inserted and sealed with putty. The central flat front to the bay is split with a transom where the upper section is shaped to the v of the butterfly roof.	Corrosion to external surfaces of frame. Glazing putty degrading. Double glazing misted.	Replace casements and glazing.
<b>21B</b>	Row of 5 aluminium framed casements with slim line double glazing inserted and sealed with putty.	Corrosion to external surfaces of frame. Glazing putty degrading.	Replace casements and glazing.
<b>21C</b>	Row of 5 aluminium framed casements with slim line double glazing inserted and sealed with putty. The central flat front to the bay is split with a transom where the upper section is a top hung opener.	Corrosion to external surfaces of frame. Glazing putty and battens degrading. Double glazing misted. Opening window seized and inoperable.	Replace casements and glazing.
