*Damage inspection*

***Saltash Town Council /  
Jubilee Pontoon***

*Inspection location: Jubilee Pontoon, Jubilee Green, Saltash, Cornwall, PL12 6JD*

# *‘Jubilee Pontoon’*

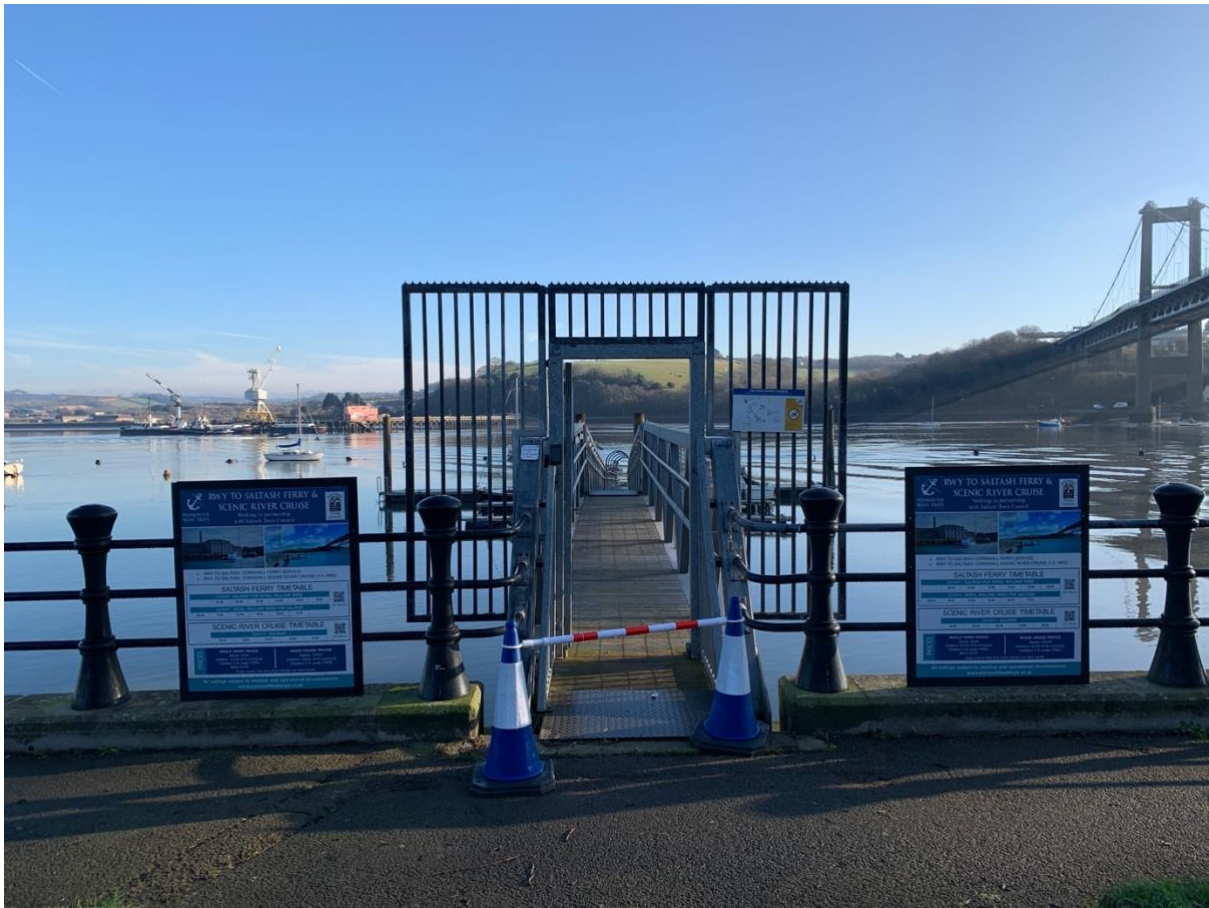
- The pontoon arrangement is accessed using a galvanised steel brow from the shore. The gate to it had been closed off to the public because of the damage.
- The brow extends over and in parallel with one of two main pontoons and has two, small finger pontoons on each side. This is referred to as the walkway pontoon in this report. The other main pontoon section runs at 90 degrees to the brow and pontoon below, creating a T shape. This is referred to as the waterfront pontoon.

Entrance to Jubilee Pontoon

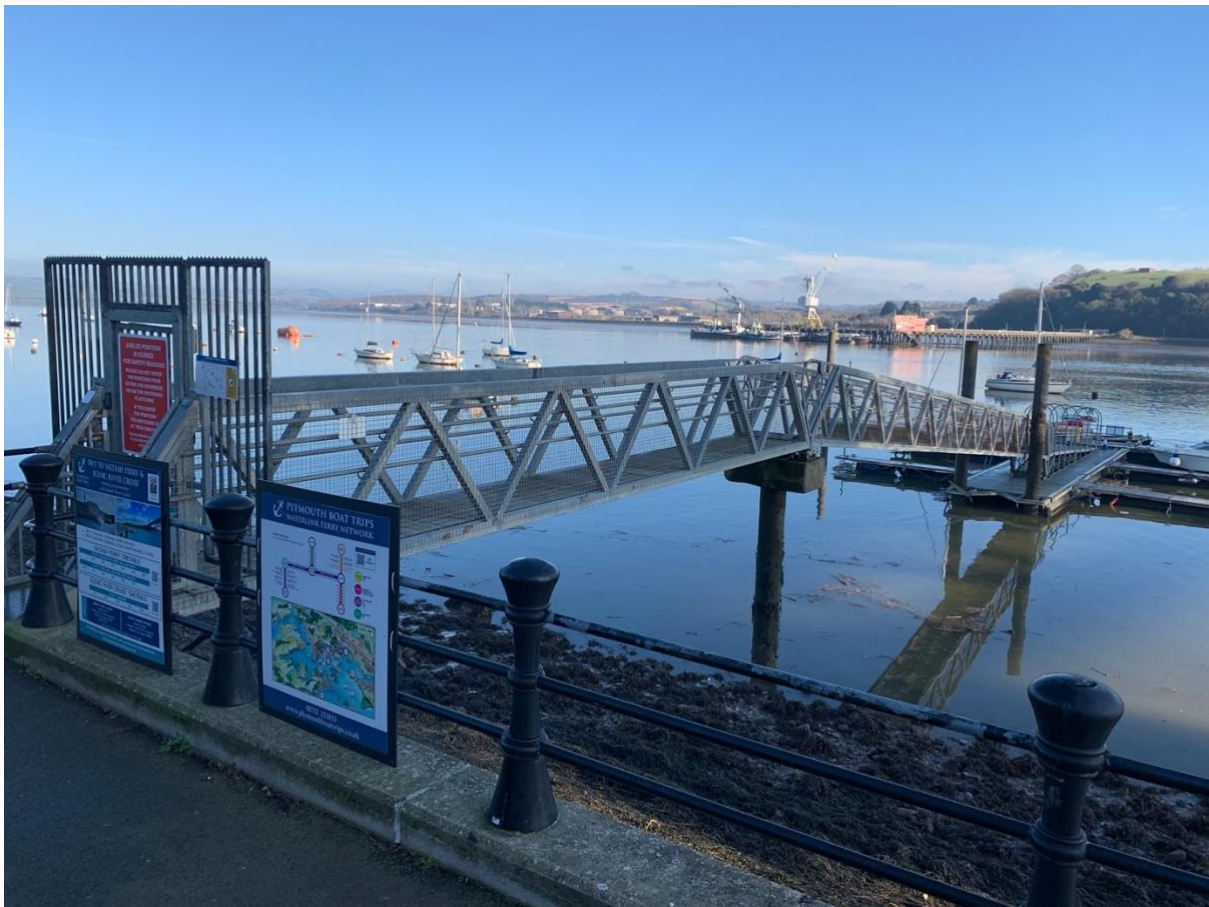
Brow to pontoon
