Schedule of Condition

Windows and Doors at Saltash Library

9th November 2022

6.0 Schedule of Condition

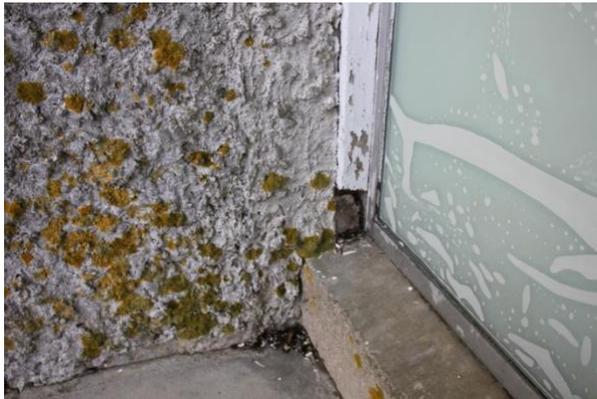
Window 1E

1E	Aluminium framed fixed casement with slim line double glazing inserted and sealed with putty. Banafix window safety film fitted externally.	Corrosion to external surfaces of frame. Glazing putty degrading. Window film bubbled.	Replace casement and glazing.
2A	Aluminium framed fixed casement with slim line double glazing inserted and sealed with putty.	Corrosion to external surfaces of frame.	Replace casement and glazing.
2B	Aluminium framed fixed casement with slim line double glazing inserted and sealed with putty.	Corrosion to external surfaces of frame. Double glazing misted.	Replace casement and glazing.
2C	Aluminium framed fixed casement with slim line double glazing inserted and sealed with putty.	Corrosion to external surfaces of frame. Glazing putty degrading.	Replace casement and glazing.
2D	Aluminium framed fixed casement with slim line double glazing inserted and sealed with silicone mastic.	Corrosion to external surfaces of frame.	Replace casement and glazing.

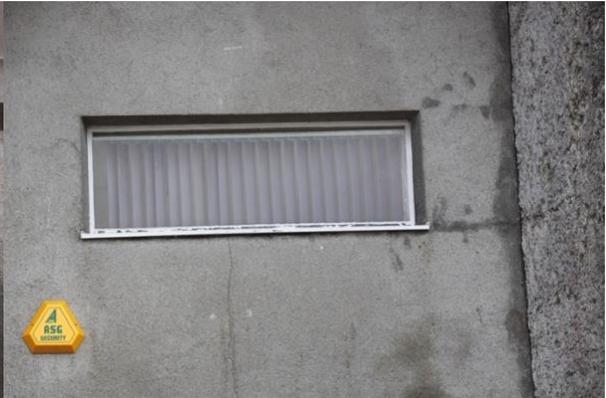
Window 14

Steel crittall windows are installed within deep external reveals to the office, WC and store areas at the southwest and north west corners of the building (see figures 1, 2 & 3). These are painted white and have asymmetrically configured mullions and single glazing. The steel crittall windows appear to have retained their original appearance and painted colour, although have become somewhat degraded with age. Window 18 has also been heavily modified within insertion of a steel louvre grill, to facilitate ventilation into the boiler room. In many cases the openers and catches have seized or are difficult to operate and the frames are showing signs in initial corrosion. Decorative finishes are also severely degrading. The single glazed steel crittall windows will be prone to condensation and heat loss. Consideration should be given to replacing the windows to reduce future maintenance and energy loss.

Steel crittall windows to southern end of the building are also beginning to degrade and require urgent maintenance. Whilst immediate replacement is not considered necessary, these will likely reach the end of their useful lives in the coming decade. Replacement of steel crittall windows could potentially be undertaken using modern replicas by the same suppliers, to retain the architectural integrity of the building.

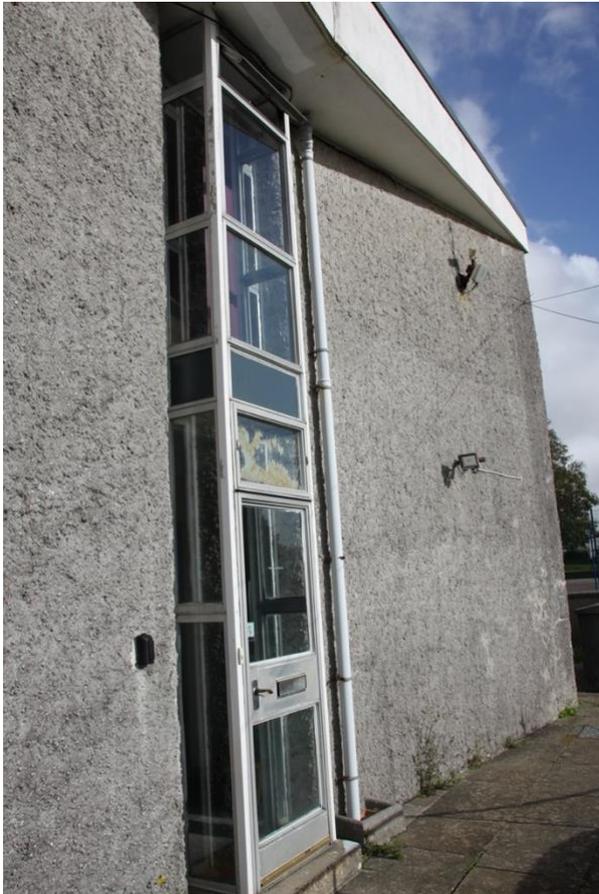
Bay window 17

The projecting bays to the north and south walls are set between the roughcast rendered walls with hardwood timber linings (see figures 2 & 4). The glazed casements are divided with steel box sectional columns, which are fixed to the concrete upper roof structures, although do not penetrate the lower level concrete slabs. These are painted white with flaking paint over galvanised steel, matching those to the principal curtain walling. Improvements to the columns are recommended to include brushing back loose paint and corrosion and decorating with galvanising paint.

The glazed bays display similar levels of degradation to the principal curtain walling, with corrosion to casements, seized openers, degrading putties and beads and misted double glazing. Again these are considered to have reached the end of their useful lifespans.

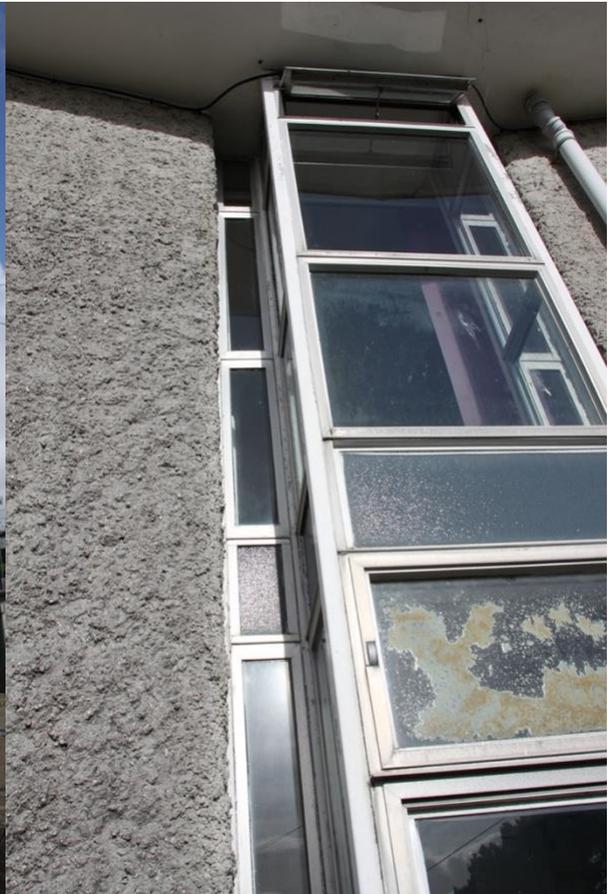
Bay window 17

17A	Row of 5 windows forming a projecting bay with side cheeks and margin lights. Aluminium framed casements with single glazing fixed with putty. The central flat front to the bay is split with a transom where the upper section is shaped to the v of the butterfly roof. The lower section is a top hung opener.	Corrosion to external surfaces of frame. Glazing putty degrading. Opener serviceable but stiff to operate.	Replace casements and glazing.
17B	Row of 5 aluminium framed casements with single glazing sealed with putty.	Corrosion to external surfaces of frame. Glazing putty degrading.	Replace casements and glazing.
17C	Row of 5 aluminium framed casements with single glazing sealed with putty.	Corrosion to external surfaces of frame. Glazing putty degrading.	Replace casements and glazing.
17D	Row of 5 aluminium framed casements with single glazing sealed with putty. Glass obscured due to first floor level.	Corrosion to external surfaces of frame. Glazing putty degrading.	Replace casements and glazing.

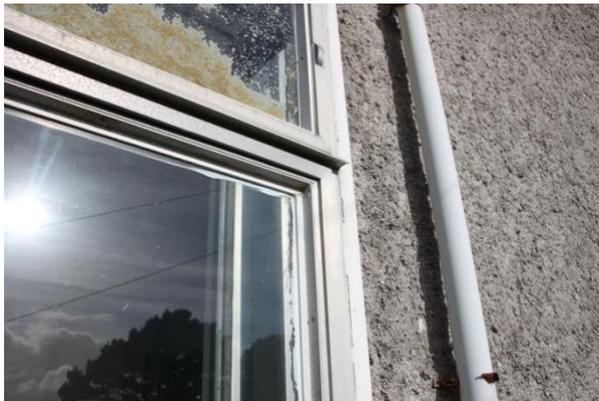
Window 17E

17E	Row of 5 aluminium framed casements with a mixture of single glazing and slim line double glazing inserted and sealed with putty. Transoms to side panels drop lower past door beneath.	Corrosion to external surfaces of frame. Glazing putty degrading.	Replace casements and glazing.
17F	Door to centre set within aluminium frames with low level lights to each side. Glazed door with central aluminium transom section. Glazing formed with single glazed panels set in putty to door and side panels with aluminium battens. Banafix film to door and side panel.	Corrosion to external surfaces of frame. Glazing putty degrading. Door serviceable but lock and catch are stiff.	Replace casements, door and glazing.

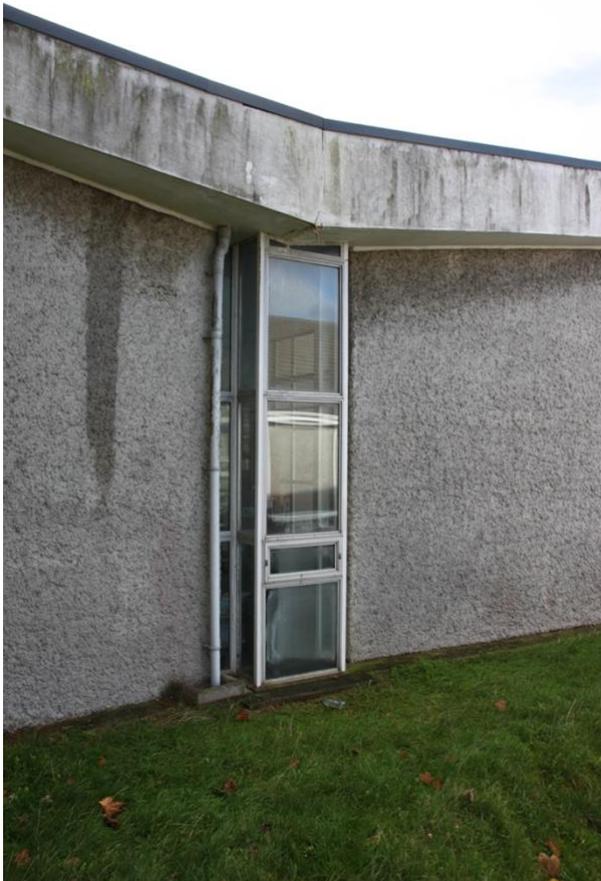
Bay window 21

Ref	Description	Condition	Recommended Repairs
21A	Row of 5 windows forming a projecting bay with side margin lights. Aluminium framed casements with slim line double glazing inserted and sealed with putty. The central flat front to the bay is split with a transom where the upper section is shaped to the v of the butterfly roof.	Corrosion to external surfaces of frame. Glazing putty degrading. Double glazing misted.	Replace casements and glazing.
21B	Row of 5 aluminium framed casements with slim line double glazing inserted and sealed with putty.	Corrosion to external surfaces of frame. Glazing putty degrading.	Replace casements and glazing.
21C	Row of 5 aluminium framed casements with slim line double glazing inserted and sealed with putty. The central flat front to the bay is split with a transom where the upper section is a top hung opener.	Corrosion to external surfaces of frame. Glazing putty and battens degrading. Double glazing misted. Opening window seized and inoperable.	Replace casements and glazing.

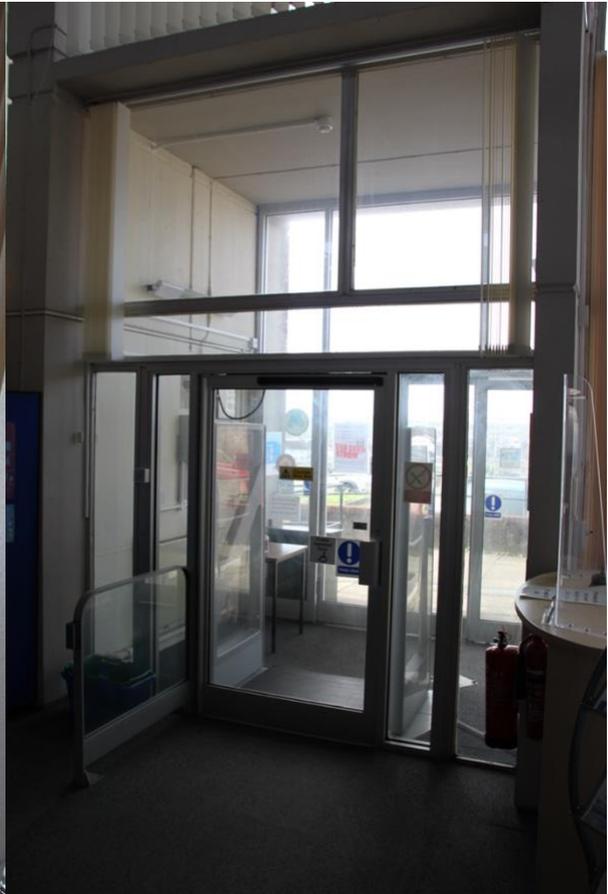
Door 11B

11B	Modern powder coated aluminium symmetrical frames with central automatic opening sliding door. Fitted with single glazed panels in rubber seals.	Intact and serviceable.	Clean and renew seals within 5 years. Ensure opening mechanisms and runners are regularly lubricated and serviced.
12A	Aluminium framed fixed casement with slim line double glazing inserted and sealed with putty.	Corrosion to external surfaces of frame. Glazing putty degrading.	Replace casement and glazing.
12B	Aluminium framed fixed casement with slim line double glazing inserted and sealed with putty.	Corrosion to external surfaces of frame. Glazing putty degrading.	Replace casement and glazing.
12C	Aluminium framed fixed casement with slim line double glazing inserted and sealed with putty.	Corrosion to external surfaces of frame. Glazing putty degrading.	Replace casement and glazing.
12D	Aluminium framed fixed casement with slim line double glazing inserted and sealed with putty.	Corrosion to external surfaces of frame. Glazing putty degrading. Double glazing misted.	Replace casement and glazing.

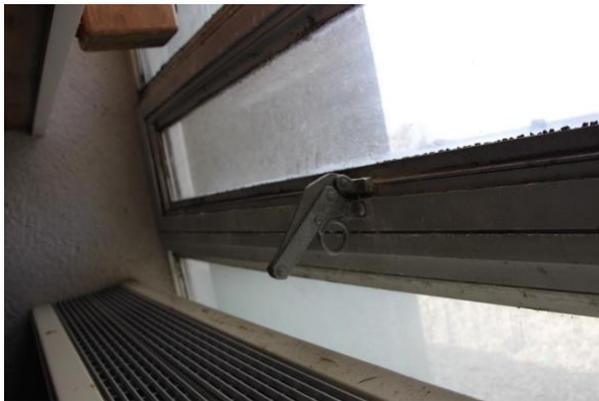
Window 13D

13D	Aluminium framed split casement with a transom at low level and top hinged opener to base. Slim line double glazing inserted and sealed with putty.	Corrosion to external surfaces of frame. Hinges and catch to opener seized shut. Both panes of glazing misted over.	Replace casement and glazing.
13E	Aluminium framed fixed casement with slim line double glazing inserted and sealed with putty.	Corrosion to external surfaces of frame. Glazing putty degrading. Double glazing misted.	Replace casement and glazing.

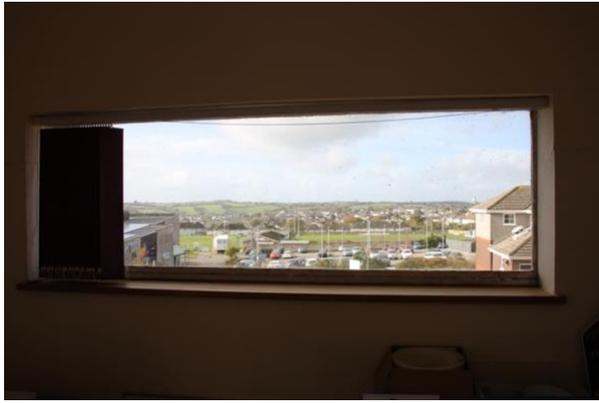
Window 14

14	High level horizontally orientated fixed steel Crittall window with single glazing. Painted white and set in deep reveals.	Window intact but paintwork degrading.	Ensure decorations are renewed on a 3-4 year cycle. Consider double glazing for improved thermal efficiency.
-----------	--	--	--

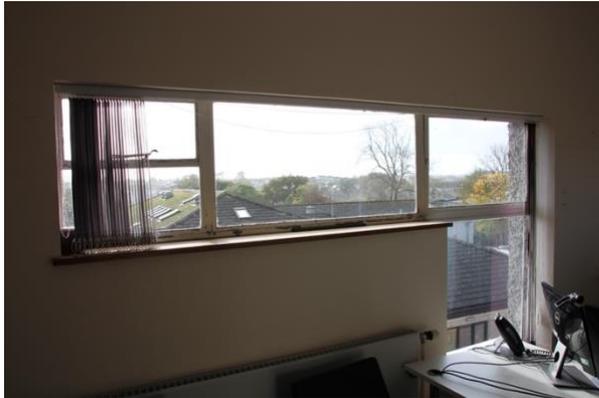
Window 15

Ref	Description	Condition	Recommended Repairs
15	High level asymmetric horizontal L-shaped steel Crittall window with single glazing and an asymmetric layout. Painted white and set in deep reveals. Two top hung openers giving ventilation to the first floor office.	Window intact but paintwork degrading. Hinges and catches to openers very stiff.	Ensure decorations are renewed on a 3-4 year cycle. Ease and lubricate hinges and catches. Consider double glazing for improved thermal efficiency.
16	Ground floor asymmetric horizontally orientated steel Crittall window with single glazing. Painted white and set in deep reveals. Single top hung opener. Security bar system to the internal reveals. Rendered reveals to the steel Crittall windows were generally intact at the time of inspection indicating that these windows are original.	Window intact but paintwork degrading. Hinges and catches to seized and inoperable.	Ensure decorations are renewed on a 3-4 year cycle. Ease and lubricate hinges and catches. Consider double glazing for improved thermal efficiency.

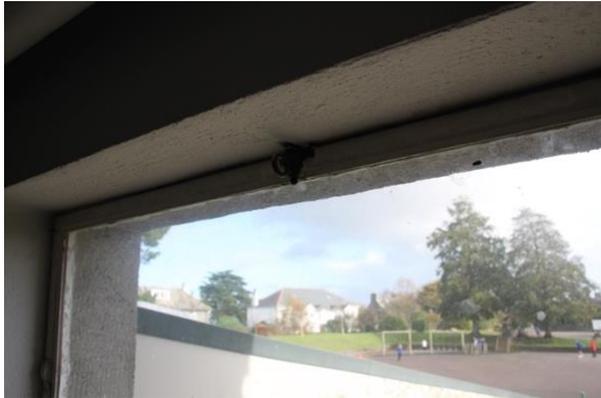
Window 18

Ref	Description	Condition	Recommended Repairs
18	First floor asymmetric horizontally orientated steel Crittall window with single glazing. The southern light has been replaced with a steel louvre to provide continuous ventilation to the boiler room internally. The adjacent light to the north is a centrally hinged hopper with catch. Painted white and set in deep reveals.	Window intact but paintwork degrading. Hinges and catches to stiff but serviceable. Louvres basic but serviceable.	Ensure decorations are renewed on a 3-4 year cycle. Ease and lubricate hinges and catches.
19	Steel Crittall window with obscure single glazing lighting the WC on the ground floor. Top hung opener with a modern lock internally. External galvanised steel security grill secured to the external wall.	Window intact but paintwork degrading. Hinges and catches to stiff but serviceable.	Ensure decorations are renewed on a 3-4 year cycle. Ease and lubricate hinges and catches.
