To receive an update on Isambard House building snags and consider any actions and associated expenditure

Update from Cormac:

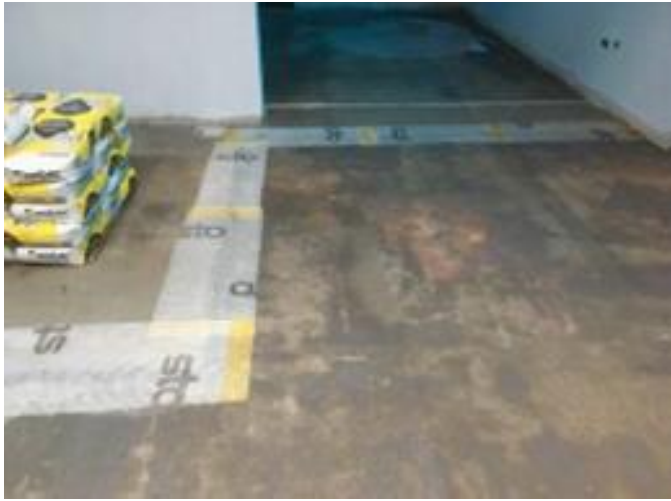
I do not believe that the cracking seen at the surface of Saltash Station floor is due to reflective cracking as a result of anything below the insulation boards or due to the boards themselves as the boards are staggered in the direction across the room and the crack is relatively straight, photos 1 & 4.

Looking at photo 2, it can be seen that the heating pipes bend almost directly beneath the edge of the screeded bay, it is possible that the edge of the screeded bay would be a weak line in the screed and so if the screed were to shrink a crack would form there. The bends in the heating pipes may restrain the screed around them causing the screed along the line of the bay edge to break up and form a larger crack. The screeding bays probably resulted in the crack in the lower layer of screed, the line of which is shown in photo 3 with tape over it. This tape would have distributed the stress concentration at the crack in the lower screed and prevented a crack along the same line, known as reflective cracking, from forming in the top 10mm layer of screed.

I believe that the crack in the top layer of screed is independent of the crack in the lower screed and that the lower screed does not require any further work.

My recommendation is to install a straight 10mm deep movement joint in the top layer of screed in the location of the surface crack between the corners of the doormat wells, and where the crack deviates from this line it could be filled with concrete repair grout of a similar colour to the screed. The cracks in the café floor could also be repaired with the concrete repair grout without the need for a movement joint.
