**To receive an update on the curtain walling works and consider any actions and associated expenditure**

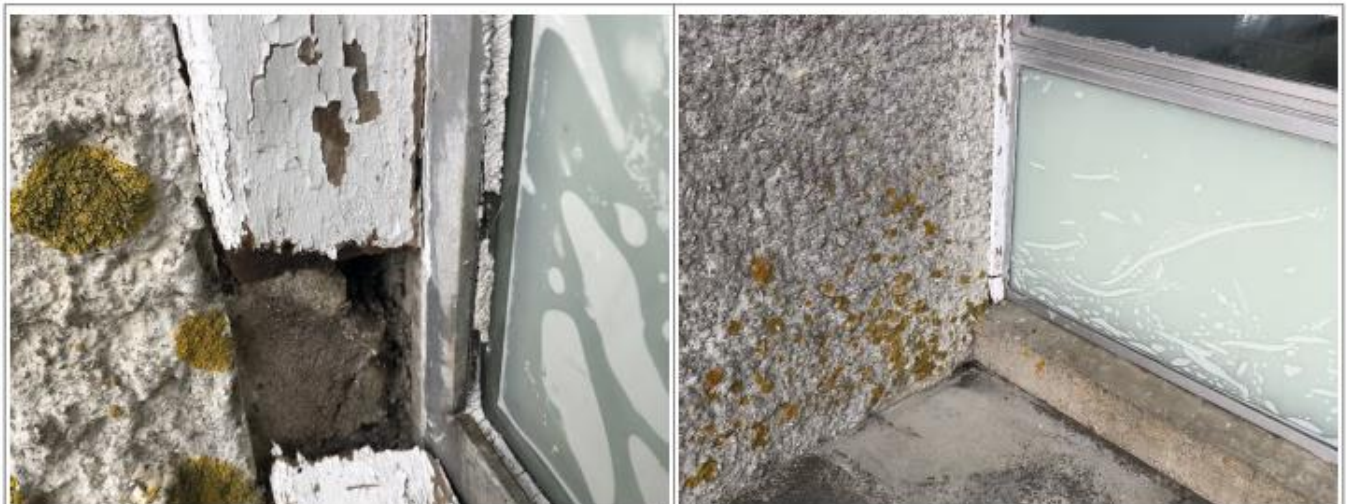
**Main Building > External > > Damp proof course beyond timber trim to windows/ doors**

Material	Bitumen	Extent	265lm
Strategy / Sample Id	Sample / 18	Fibre Type	Chrysotile
Recommendation	Remove if planned works may disturb		
General Comments	Unable to inspect beyond positive item.

Material Assessment

Product Type (or Debris from Product)	1	Extent of Damage / Deterioration	1
Surface Type / Treatment	0	Asbestos Type	1
Material Score	3 / Very Low

*The report does state that the material is to be removed if disturbed by the work. It would seem very likely to me that the removal of the old windows will disturb this material. As a 'Chrysotile' fibre, is it not a licenced material so shouldn't be overly difficult to work with.*

*I think you should ask Bailey Partnership to advise you how the identified asbestos impacts on the removal and replacement of the windows, and assuming the asbestos needs to be removed, for a method statement on how this is to be done. If it is a damp proof course sitting behind the timber trim to the windows, it might be possible to remove the asbestos before the windows are removed meaning no real impact on the inside of the building.*

The process for the asbestos removal is currently under discussion between Bailey Partnership and Horizon windows and we await the Sub Contractors Method Statement, qualifying certificates and insurance certs. This will be fed into the Town Council Risk Assessment when received.
