Report

Client: Saltash Town Council

Fore Street Sound System

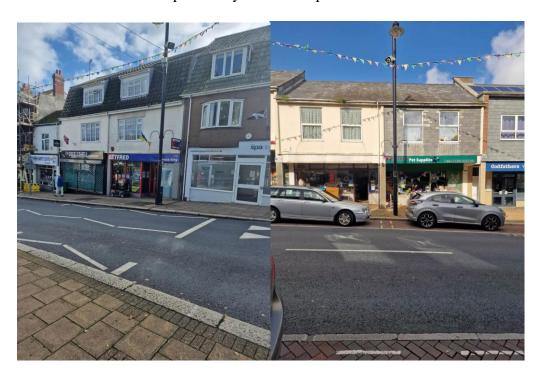
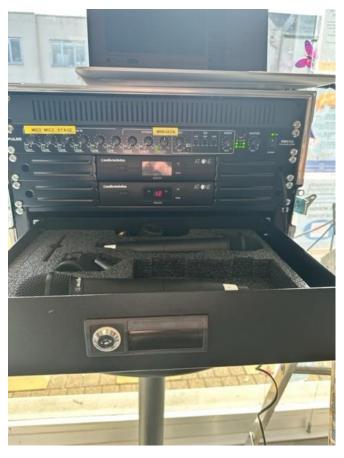
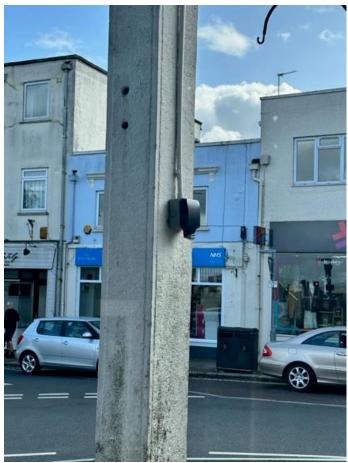
The sound system was set up and all items of equipment tested and checked. Both wireless microphones were tested and are fully operational. The 3.5mm jack cable for music input was tested on a laptop and was fully functioning. However, there was an Apple thunderbolt adaptor which appeared not to work and requires replacement.

A walk test was carried out from one end of the street to the other. All speakers are functioning with the exception of two situated roughly half-way up the street but these have been disconnected previously due to complaints.
